Preliminary Information

PIP5676 MIL Due To P06DE and may also have P0521

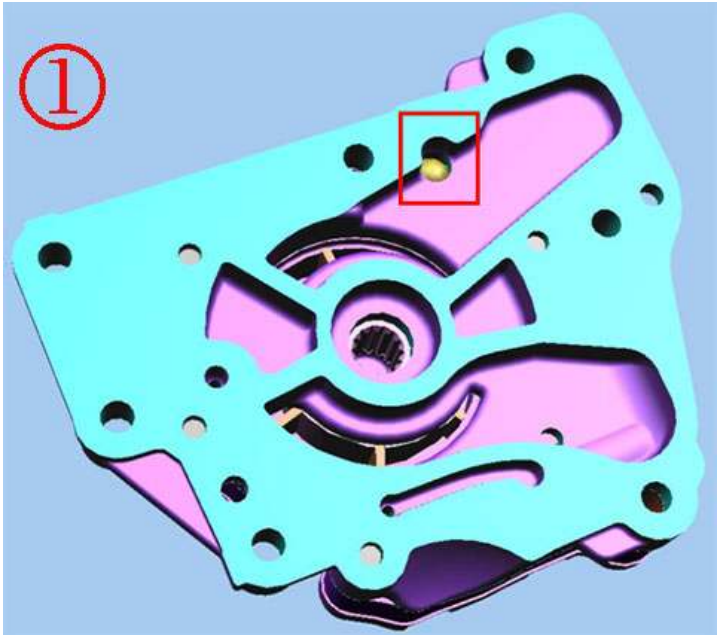
Engine oil pump cold checkball and seat location

| Cause | The cause of this concern may be foreign material stuck between the cold start checkball and its seat. |

When following SI diagnostics for P06DE, if diagnostics lead to inspecting the oil pump or the engine oil pressure is in specification but very low or below specification, inspect the cold start checkball and seat for having foreign material stuck between them. The checkball should be seated fully against the seat in the pump. Look very close because the foreign material can be very small.

If foreign material is found between the cold start checkball and seat, remove the foreign material and reinstall the engine oil pump and road test the vehicle.

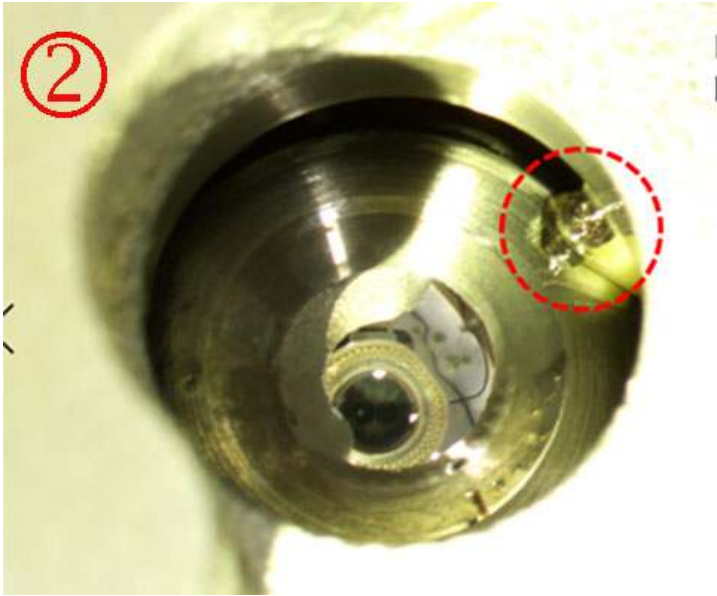
Foreign debris

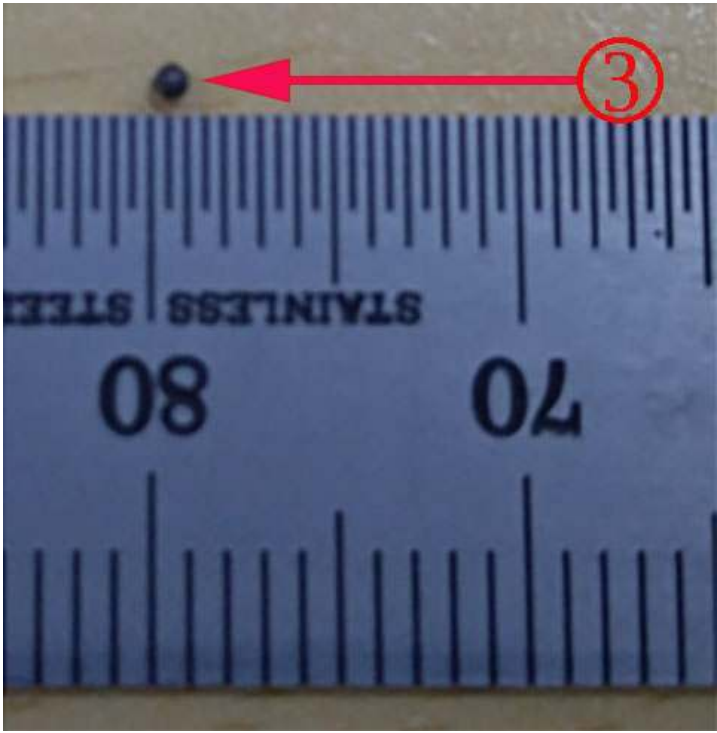
The foreign debris can be very small
