Preliminary Information

PIP5676A MIL Due To P06DE and may also have P0521

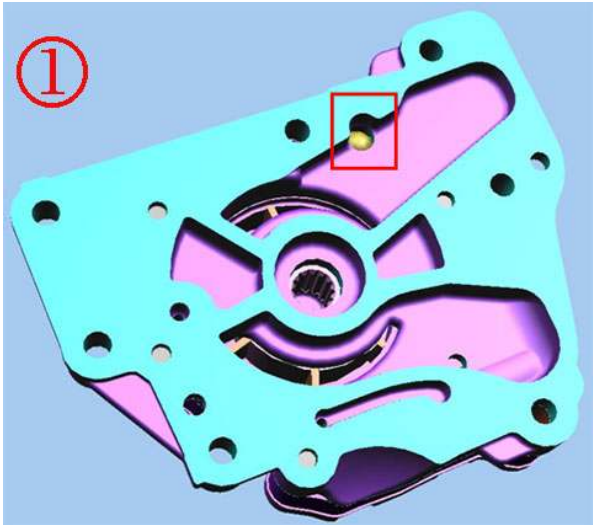
Engine oil pump cold checkball and seat location

| Cause | The cause of this concern may be foreign material stuck between the cold start checkball and its seat. |

When following SI diagnostics for P06DE, if diagnostics lead to inspecting the oil pump or the engine oil pressure is in specification but very low or below specification, inspect the cold start checkball and seat for having foreign material stuck between them. The checkball should be seated fully against the seat in the pump. Look very close because the foreign material can be very small.

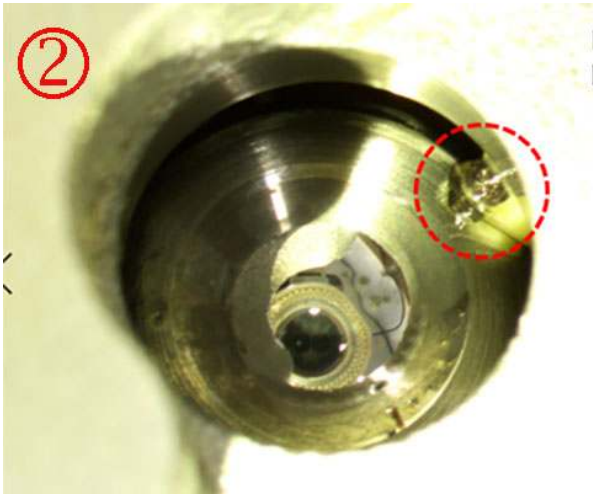
Foreign debris

If foreign material is found between the cold start checkball and seat, remove the foreign material and reinstall the engine oil pump and road test the vehicle.

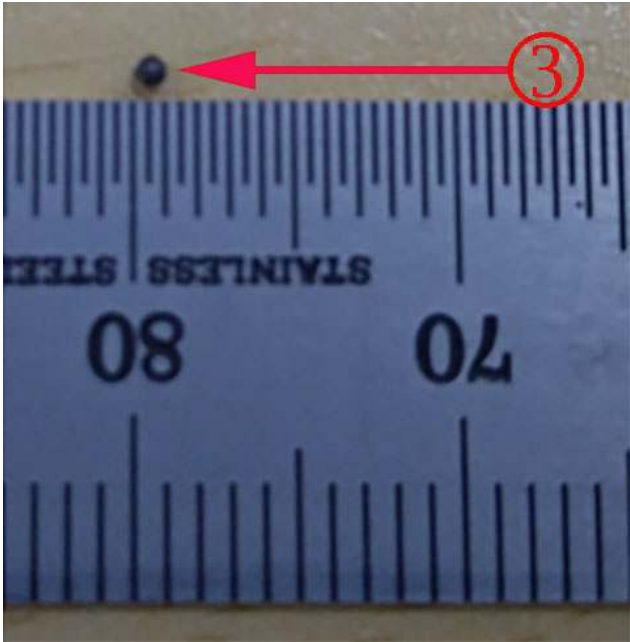
The foreign debris can be very small
