Preliminary Information

PIT5278E Power Lift-gate Erratic Operation will not Power Close  
DTC B153A and/or Motor Running but Does Not Move

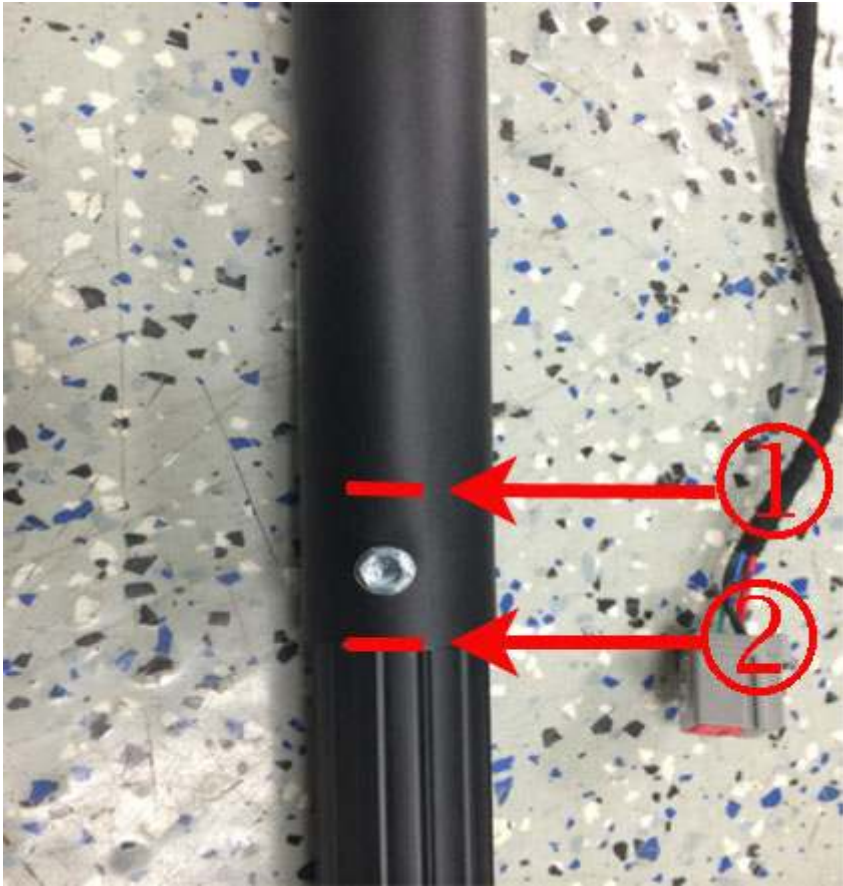
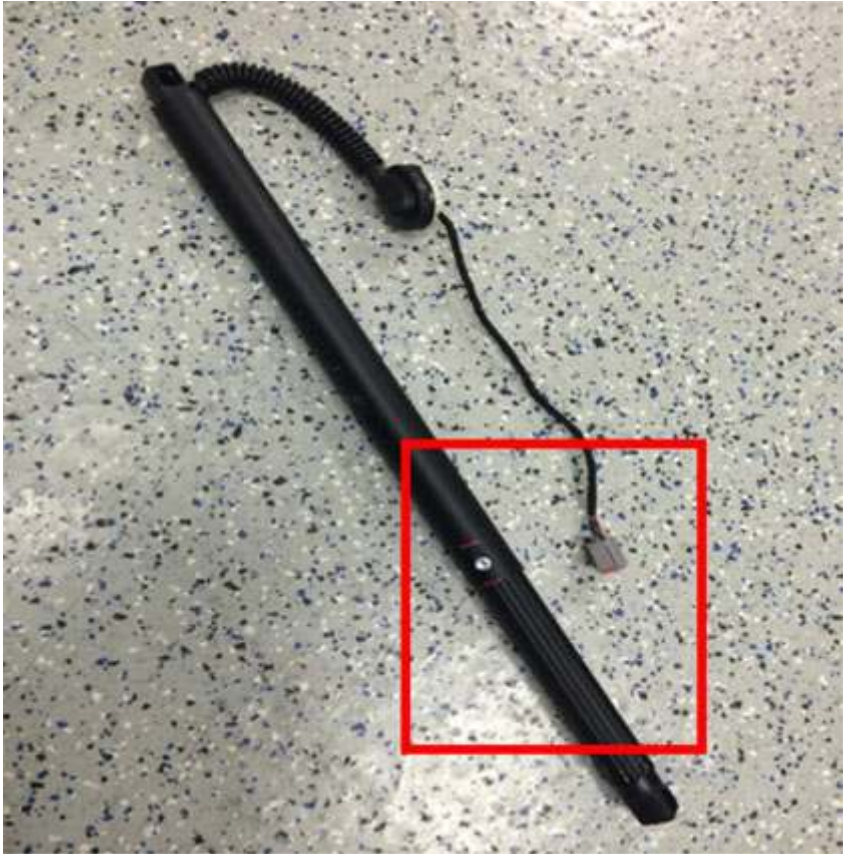
These concerns may occur if the left liftgate actuator is internally coming apart. It will need to be replaced, but care must be taken when removing the left liftgate actuator from the vehicle. There is an assist spring inside the left actuator. If the internal portion of the actuator has completely separated, and if it is removed from the vehicle without following the procedure listed below, the end of the actuator can become a projectile.

1. Obtain one #8 self-tapping screw 1 1/2 inches long.
2. Fully open the liftgate.
3. Install the self-tapping screw any place in the 30 mm space (from the bottom of the smooth tube) between location 1 and 2. As reflected below, a location of 20 mm (approximately 3/4") is ideal to secure the tubes.

**Note:** The screw will hold the actuator together for removal.
