GLOBAL SAFETY FIELD INVESTIGATIONS  
DCS5147  
URGENT - DISTRIBUTE IMMEDIATELY

Subject: N192266190 – Service Update  
Potential reduced Power or Stall

Models: 2018 Buick Lacrosse, Enclave  
2018 Cadillac XT5  
2018 Chevrolet Traverse

## N192266190 Potential Reduced Power or Stall

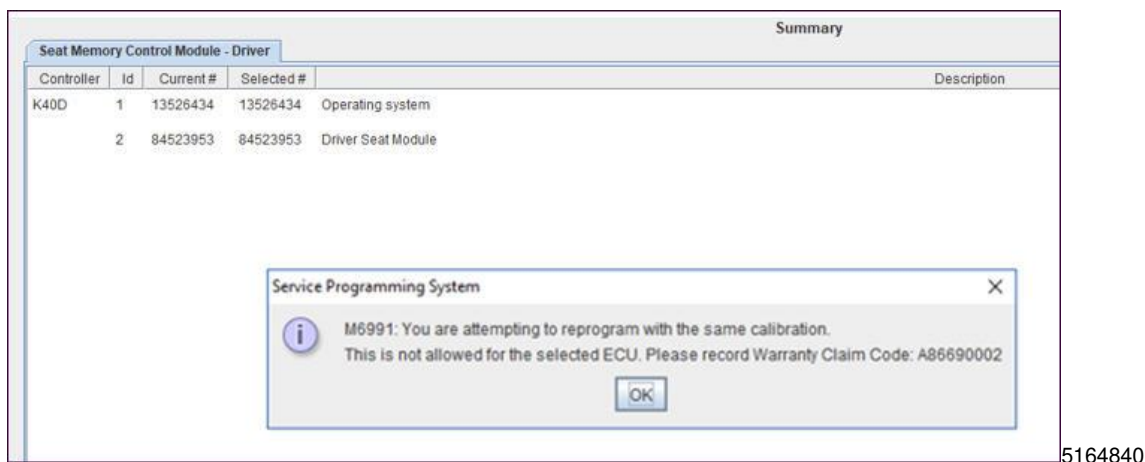
- Stable battery voltage is critical during programming. Any fluctuation, spiking, over voltage or loss of voltage will interrupt programming. Install a GM Authorized Programming Support Tool to maintain system voltage. Refer to [www.gmdesolutions.com](http://www.gmdesolutions.com) for further information. If not available, connect a fully charged 12V jumper or booster pack disconnected from the AC voltage supply. DO NOT connect a battery charger.
- Turn OFF or disable systems that may put a load on the vehicles battery such as; interior lights, exterior lights (including daytime running lights), HVAC, radio, etc.
- Clear DTCs after programming is complete. Clearing powertrain DTCs will set the Inspection/Maintenance (I/M) system status indicators to NO.

**Note:** If the Same Calibration/Software Warning is noted on the SPS Summary screen, record the warranty claim code (WCC) and select OK and follow screen instructions. After a successful programming event, the WCC is located in the Service Programming System dialogue box of the SPS Summary screen. No further action is required. Refer to the Warranty section of the bulletin.
