# Service Bulletin

Bulletin No.: 18-NA-186

**Subject:** Loss of Propulsion or No Start with Malfunction Indicator Lamp Illuminated DTC P0A3F or P1B03 Set

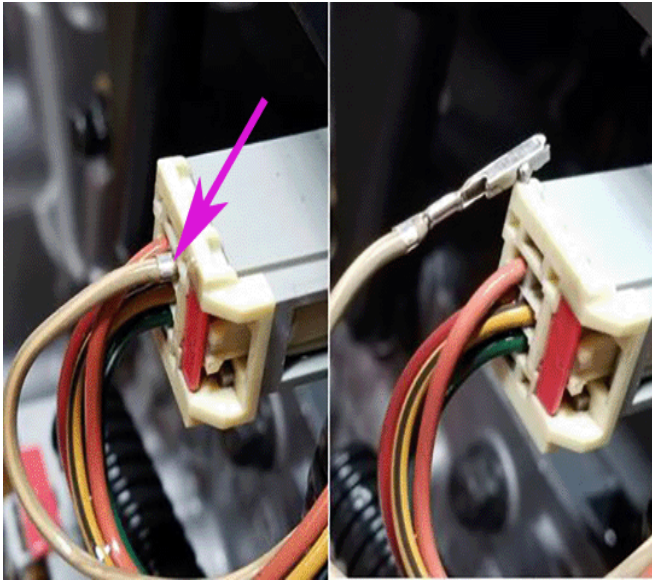
5051615

The motor control module monitors the angular position, speed and direction of the drive motor rotor based upon the signals of the resolver-type position sensor. The drive motor position sensor circuits operate at very low current. These circuits are susceptible to moisture intrusion, backed out terminal(s) (shown), poor terminal connections or damage, poor crimps and corrosion. The harness **cannot be repaired** for any of these conditions, it **must be replaced**.
