# Technical Service Bulletin

**DTC B14F0:76 STORED AND i-ACTIVSENSE WARNING LIGHT  
(AMBER) ON AFTER BCM REPLACEMENT**

**Bulletin No.:** 15-003/19

**APPLICABLE MODEL(S)/VINS**  
2019 Mazda3

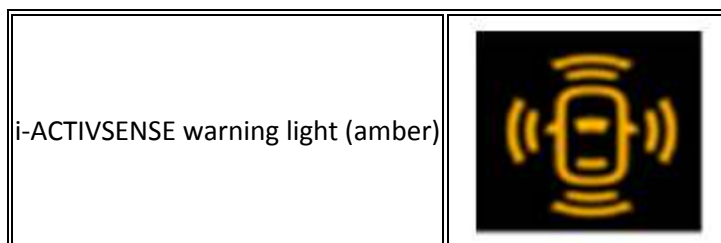
Some vehicles may exhibit DTC B14F0:76 [VCM] (Forward sensing camera (FSC) deviation) stored in memory and the i-ACTIVSENSE warning light (amber) on after BCM replacement.

This is caused by the learning value of the forward sensing camera (FSC) aiming being initialized after BCM replacement due to a software malfunction of the FSC. To correct this concern, the FSC software will be modified to not initialize the value of the FSC aiming after BCM replacement.

2. Perform the FSC aiming according to the instructions on MGSS (FORWARD SENSING CAMERA (FSC) AIMING).
