## SERVICE INFORMATION BULLETIN

**APPLICABILITY:** 2018MY Legacy and Outback

**NUMBER:** 15-225-18R

**SUBJECT:** DTC B2242 “UART COMMUNICATION”

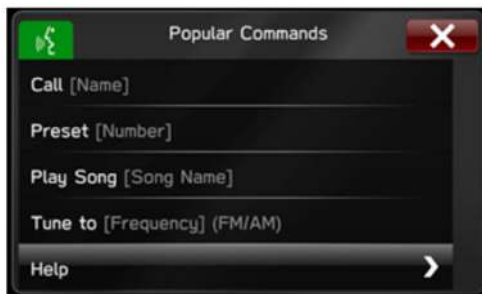
**Step 3:** Confirm the Popular Commands screen is displayed and that the list is shown in English.

- If the list is not shown in English, access “General Settings” after pressing “Settings” on the Home screen, scroll down the list to “System Language” and select the applicable “English” option.

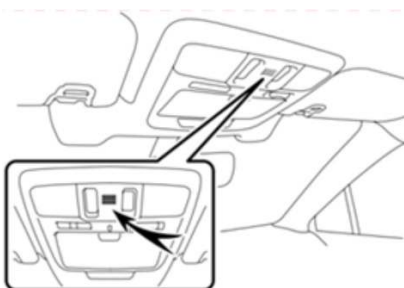
**Step 4:** In a normal voice, say “Auto AC on” into the microphone located in center of the overhead console.

- If the system responds with “OK Turning Auto AC on”, proceed to **Step 5**.
- If any other response is provided or a command is requested again, repeat **Step 4**.
- If the system still does not respond with “OK Turning Auto AC on” and the command list has disappeared from the screen, try again starting with **Step 2**.
