# Technical Service Bulletin

## 37 Transmission malfunction, DTC P17F600, U008000, and/or U010100 stored in the TCM or ECM

37 19 89 2053878/5 October 22, 2019. Supersedes Technical Service Bulletin Group 37 number 19-88 dated August 14, 2019 for reasons listed below.

| Model(s) | Year | VIN Range | Vehicle-Specific Equipment |
|---|---|---|---|
| A6, A7 | 2019 | 000001 - 121296 | 3.0TFSI |

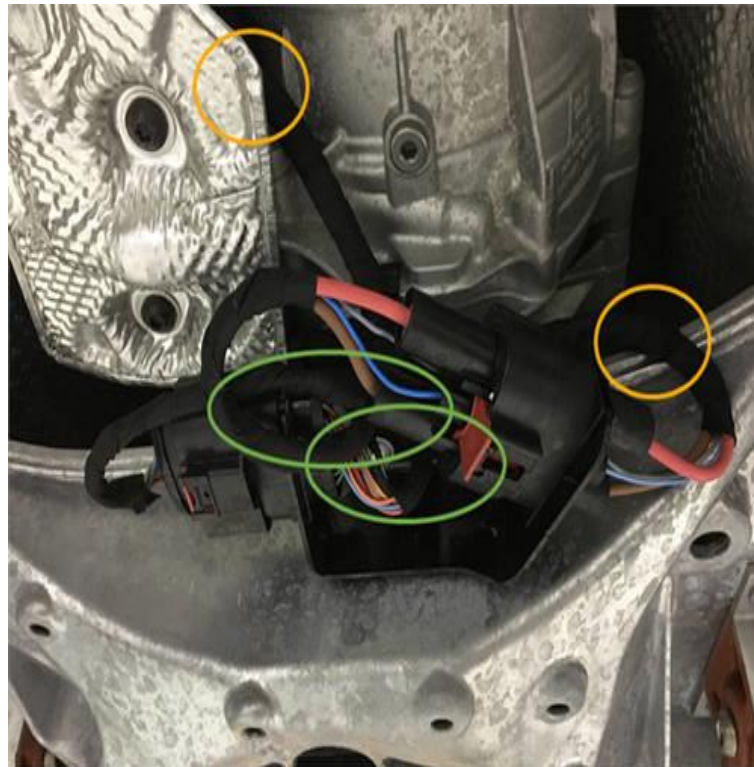
The transmission harness can come in contact with the transmission crossmember and could be damaged.

1. Inspect for damage to the transmission harness (Figures 1 - 4).
  - Thoroughly inspect the transmission wiring harness and routing to determine if the routing is the new or the original concept (Figures 1, 7, and 8).
  - Inspect the body harness and transmission harness for damage near the areas indicated in Figure 1.
  - Harness damage can be very subtle. Even a light chafing of the harness wrap can cause the DTCs.

*Figure 1. Common areas for harness damage. Also depicted is the original routing concept.*

If **transmission harness damage** is found and/or the original routing concept is in place, proceed to step 3.

If **body harness damage** is found regardless of the transmission harness routing, create a TAC case for further instruction. Include photos of the original harness routing, area of damage, close up of damage and a clear description of your findings.

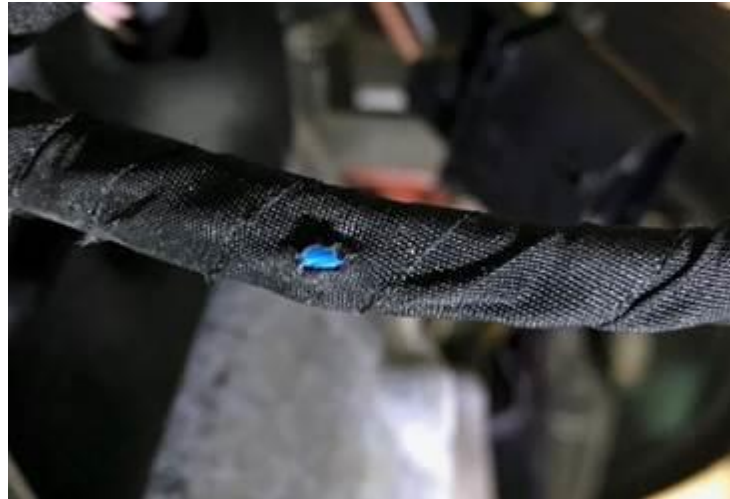
*Figure 2. Example of a small rip in the protective tape.*

3. Replace the original transmission harness with a new part and reroute the transmission harness. The transmission harness should not be repaired.
  - Remove the original transmission harness in the vehicle.
  - Wrap the exposed wires on the new transmission harness as shown in Figure 7.
  - Mount and route the new transmission harness as shown in Figure 8.

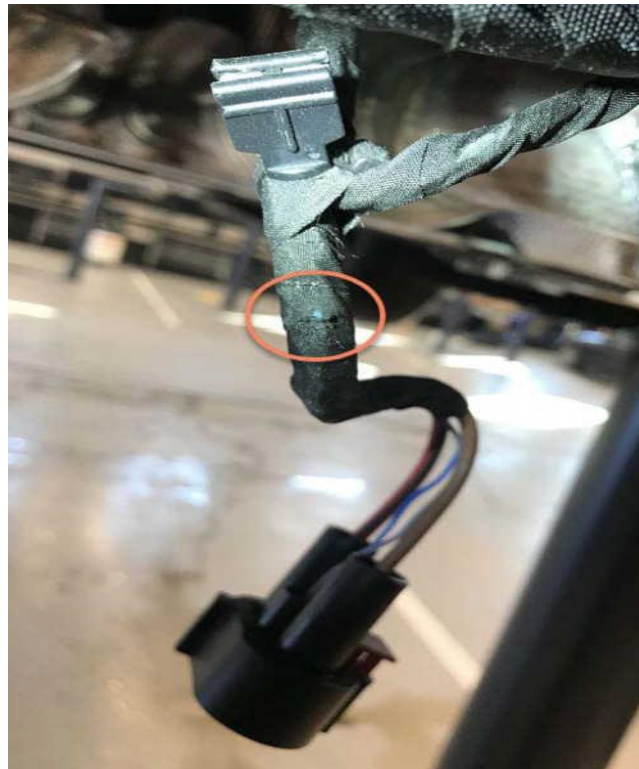
*Figure 3. The damage on the original harness might be difficult to spot.*

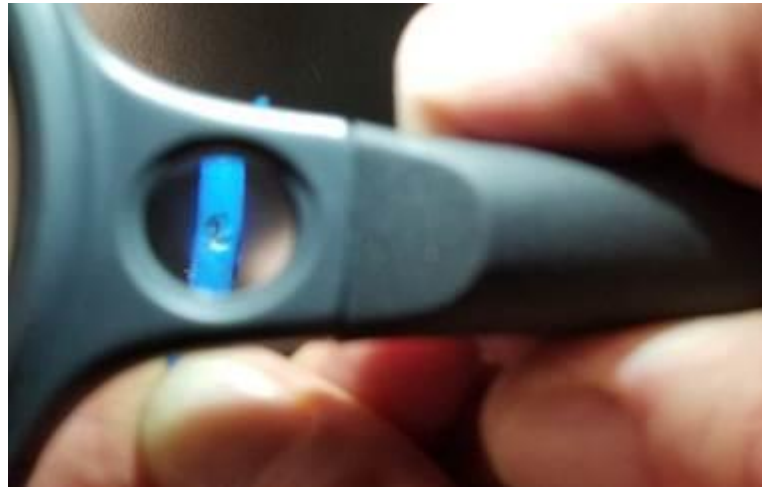
*Figure 4. The cause of the DTC may be as small as a pinhole.*

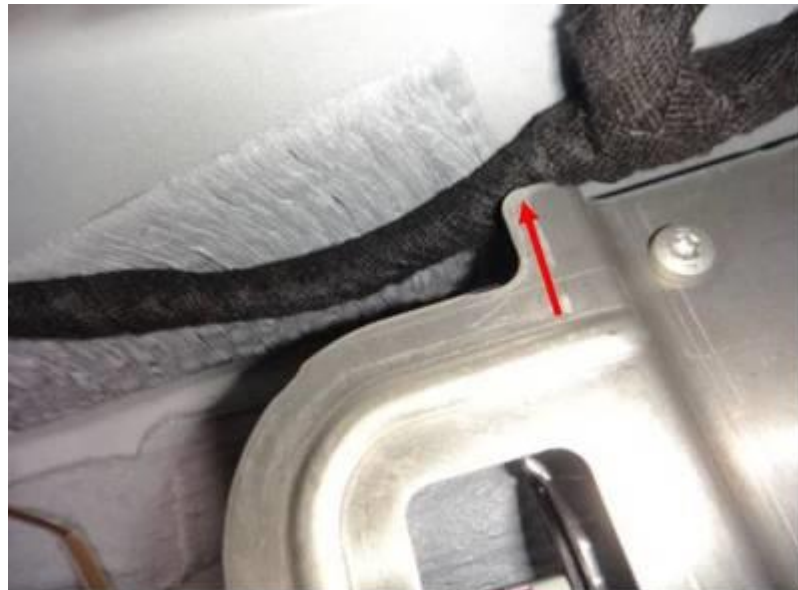
The body harness containing the FlexRay circuit to the transmission may rub against the mounting bracket of the driver assist systems control module, J1121 (address word 00A5).

If there is no damage found and DTC U11B000 (FlexRay data bus branch 2 faulty) is stored, inspect the area shown in Figure 5 and 6.

*Figure 5. The area where the body harness may rub.*

If damage is found in this area then create a TAC case, include photos, and a clear description of your findings.

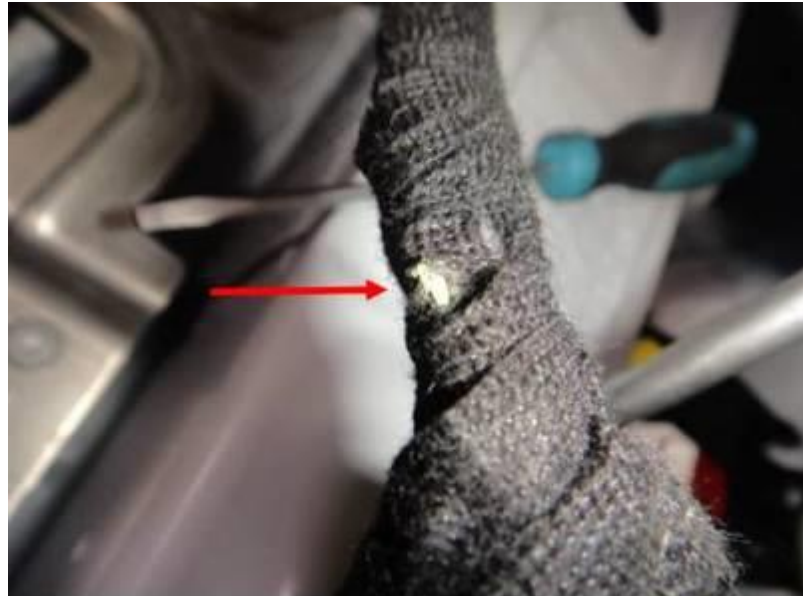
**Figure 6.** Shows the rub mark on the wiring harness.

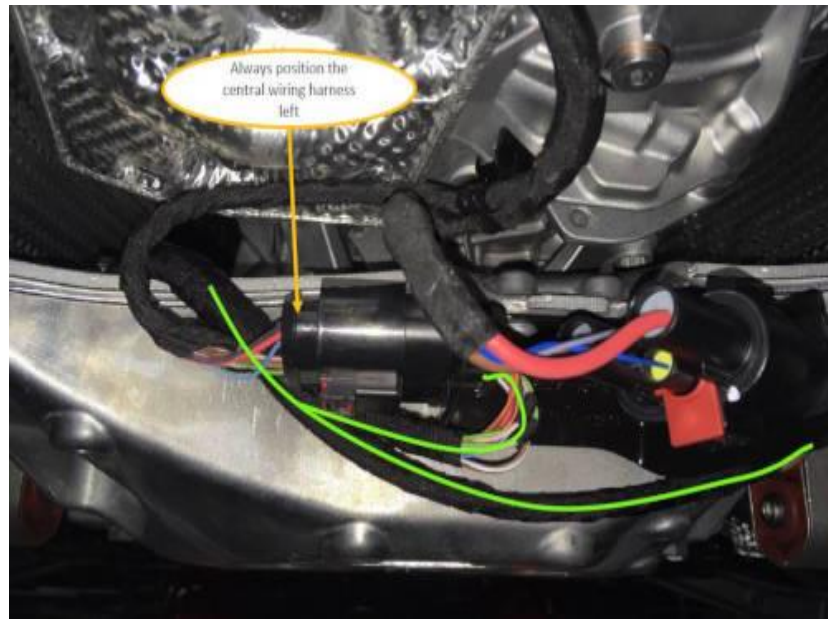
**Figure 7.** New routing and wrapping of the aft part of the transmission harness.

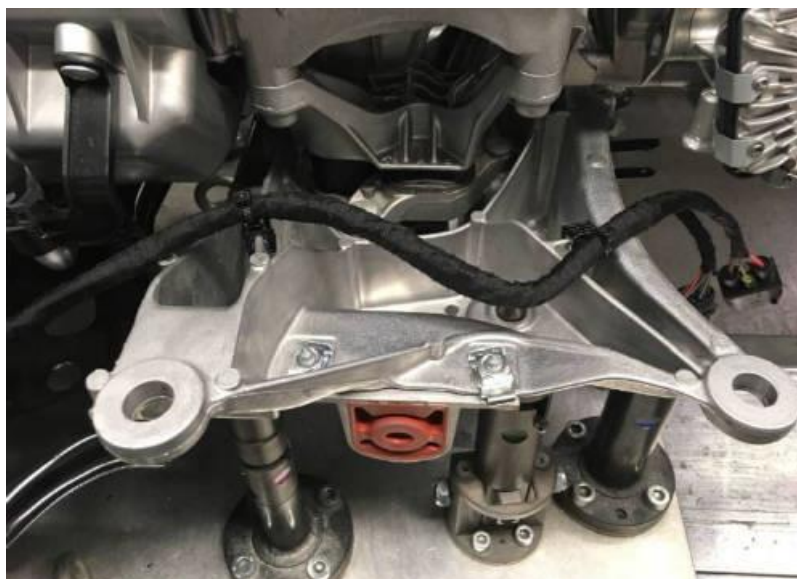
**Figure**

**8.** Routing and mounting of the transmission harness behind the crossmember.

4. The crossmember is shown dismounted in Figure 8 to show the new mounting points more clearly. For mounting and installation of the new transmission harness, the crossmember does not have to be disassembled.
