| <b>HYUNDAI</b><br><b>Technical Service Bulletin</b> | GROUP<br><b>BODY ELECTRICAL</b> | NUMBER<br><b>19-BE-016H</b> |
| | DATE<br><b>OCTOBER 2019</b> | MODEL(S)<br><b>ELANTRA (ADa)</b> |
| <b>SUBJECT:</b> BLIND-SPOT RADAR REPLACEMENT, AND MOUNTING ANGLE VALIDATION | | |

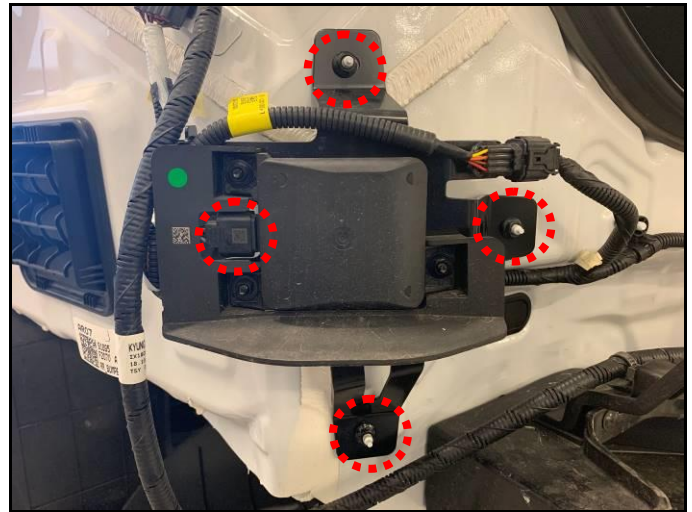
6. Remove the LH Blind-Spot radar assembly.

Disconnect the radar connector, remove the 10mm mounting nuts, and then remove the Blind-Spot radar.

Be careful to not damage the Blind-Spot radar bracket during the removal and installation process.

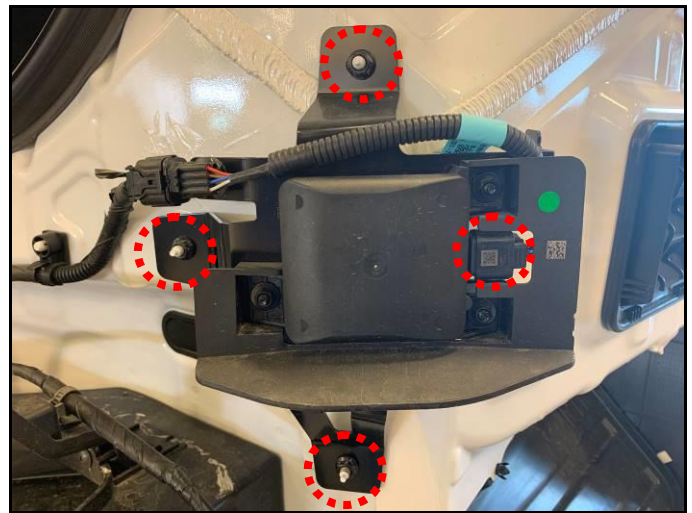
7. Remove the RH Blind-Spot radar assembly.

Disconnect the radar connector, remove the 10mm mounting nuts, and then remove the Blind-Spot radar.

Be careful to not damage the Blind-Spot radar bracket during the removal and installation process.

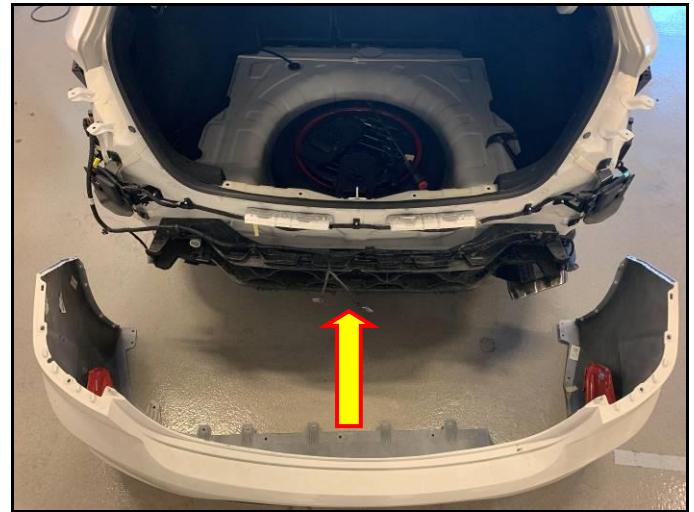
11. After the Blind-Spot radar angles have been calibrated, reinstall the rear bumper in reverse order of removal.

If the Blind-Spot radar is not within specification, then use washer(s) to shim the Blind-Spot radar bracket(s) to adjust the mounting angles.
