| | GROUP<br><b>ELE</b> | MODEL<br><b>2018-2019MY<br/>Niro (DE EV/PHEV)</b> |
| | NUMBER<br><b>186 (Rev 1, 10/14/2019)</b> | DATE<br><b>September 2019</b> |
| <b>TECHNICAL SERVICE BULLETIN</b> | | |
| SUBJECT: <b>SERVICE ACTION: ELECTRIC WATER PUMP<br/>INSPECTION AND REPAIR (SA394)</b> | | |

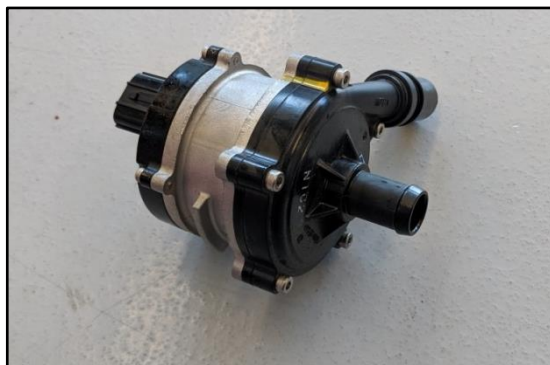
This bulletin provides the procedure to inspect and repair the Electric Water Pump(s) (EWP) on some 2018-2019MY Niro (DE) HEV, PHEV, and EV vehicles produced between November 24, 2018 through January 30, 2019, which may exhibit a MIL ON (DTC U1116 and/or U1118) due to a coolant leak from the EWP Can Case. Follow the procedure in this bulletin to inspect and repair the EWP. Before conducting the procedure, verify that the vehicle is included in the list of affected VINs.
