MODEL  
2017-2018MY  
Forte (YDm) 2.0L MPI

NUMBER  
181 (Rev 1, 10/16/2019)

## TECHNICAL SERVICE BULLETIN

**SUBJECT:** SERVICE ACTION: IGNITION COIL OR COIL RFI  
SPRING REPLACEMENT FOR DTC P0300, P0301, P0302, P0303,  
AND/OR P0304 (SA321)

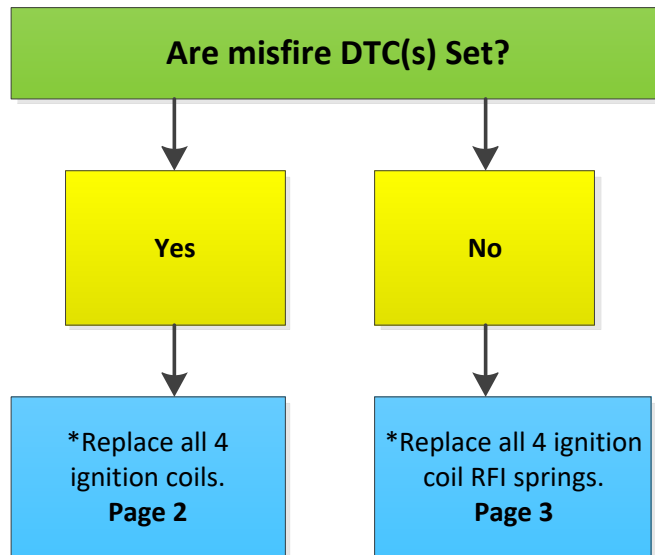
**Inspection/Replacement Procedure:****Diagnosis/Repair Flowchart**

This bulletin provides the procedure to replace all four (4) ignition coils or replace all four (4) coil radio frequency interference (RFI) springs on some 2017-2018MY Forte (YDm) 2.0L MPI vehicles, produced from May 16, 2016 through September 7, 2017, which may experience a malfunction indicator lamp illumination (MIL) ON with DTC P030X (P0300, P0301, P0302, P0303, or P0304). To correct this concern, follow the procedure outlined in this bulletin to replace all four (4) ignition coils if a misfire DTC (P030X) has been set, or replace all four (4) coil RFI springs if the MIL is not ON or a non-misfire related DTC is set. Before conducting the procedure, verify that the vehicle is included in the list of affected VINs.

**\*Do Not perform TSB [ENG208](#) at this time.**

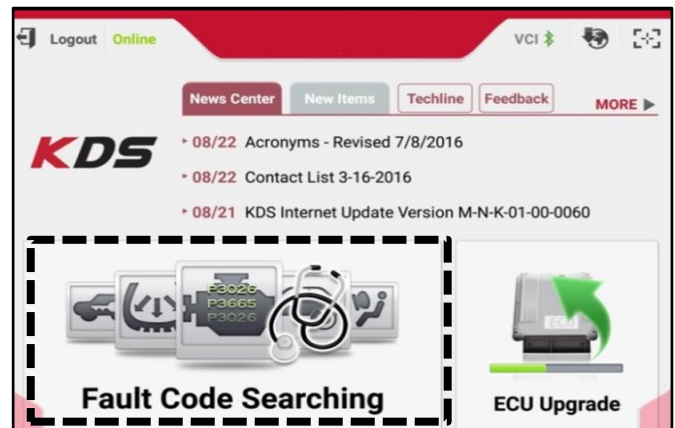
1. If the MIL is on, perform a Fault Code Search for any Engine related DTCs then proceed to the next step (2).

If the MIL is not on, proceed to the RFI Replacement Procedure below.
