| | GROUP<br><b>ENG</b> | MODEL<br><b>2017-2018MY<br/>Forte (YDm)</b> |
| | NUMBER<br><b>208 (Rev 1, 10/16/2019)</b> | DATE<br><b>June 2019</b> |
| <b>TECHNICAL SERVICE BULLETIN</b> | | |
| <b>SUBJECT: ECU LOGIC IMPROVEMENT FOR P0300, P0301, P0302, P0303, P0304 AND/OR P219C00, P219D00, P219E00, P219F00</b> | | |

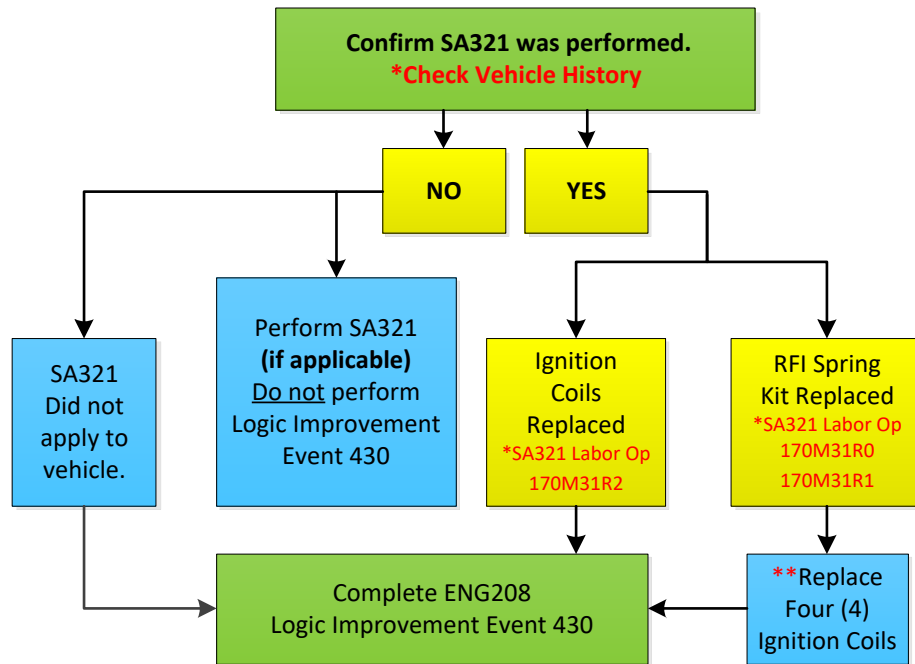
**Refer to Flowchart on page 2: Prior to upgrading the ECU Logic confirm SA321 has been completed.**

\*Check Vehicle History \*\*Refer to LTS for Labor Op and Time to replace the ignition coils.
