Preliminary Information

PIP5495K Check Engine Light On With P0299 Or P0234

| Cause: | Misdiagnosis Leading to Returned Turbochargers with NTF |

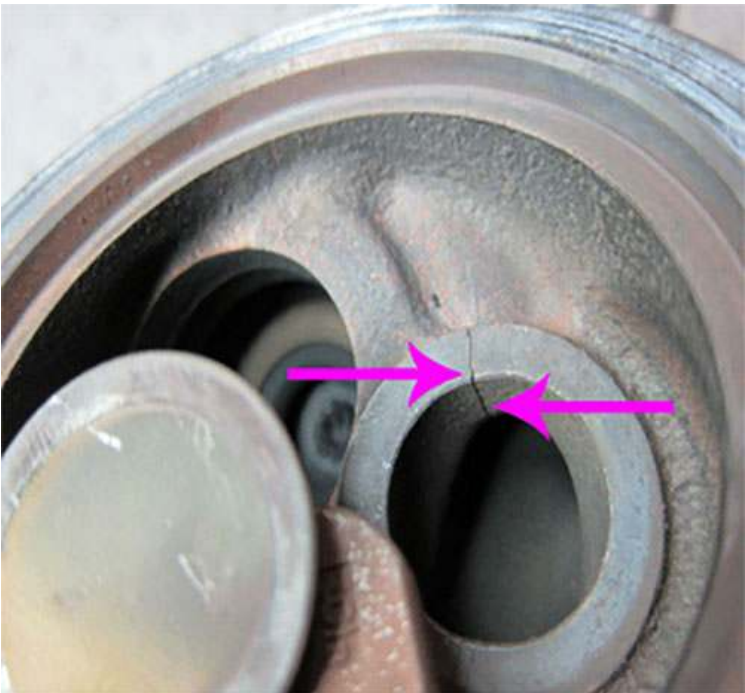
Crack(s) at the wastegate valve port (this is normal and does not affect performance)

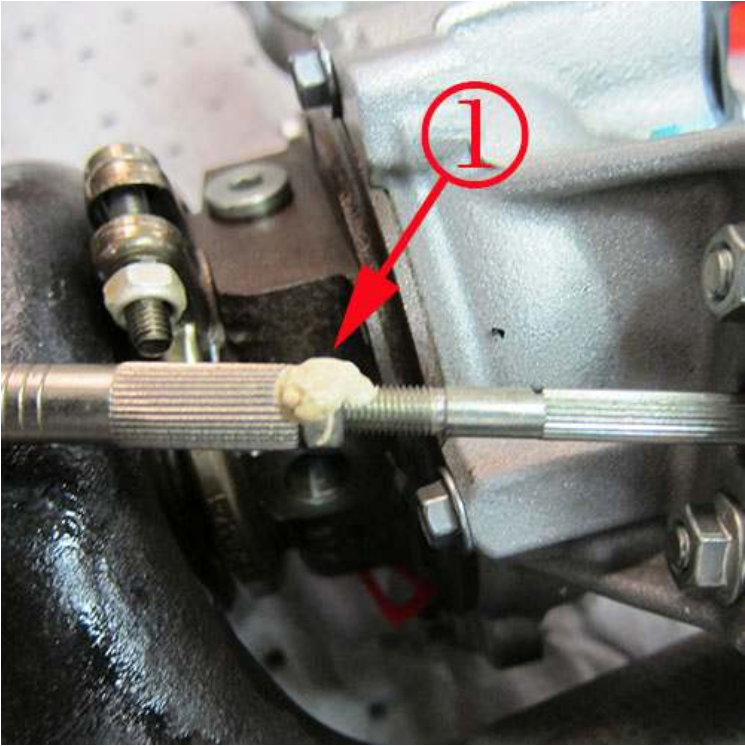
If the tamper paint seal is broken or missing, check the vehicle for any additional sign of modification to the induction, exhaust, or engine calibrations as this may indicate an attempt to adjust the wastegate arm to modify the powertrain operation.

If found, review the powertrain warranty status with your service manager prior to performing repairs

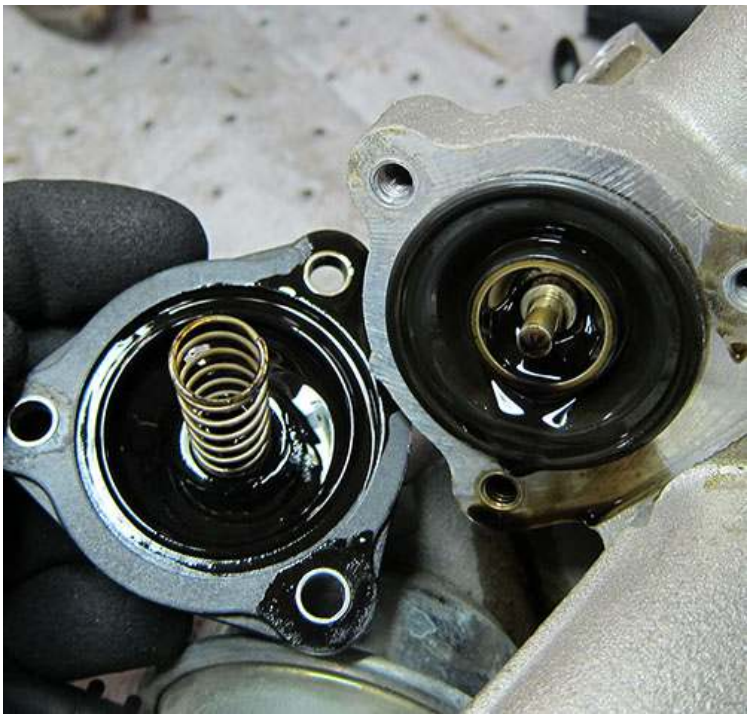
Bypass (recirculation) valve cover port broken or water/oil found inside the valve (clean the components, if necessary replace bypass (recirculation) valve assembly - released for service)

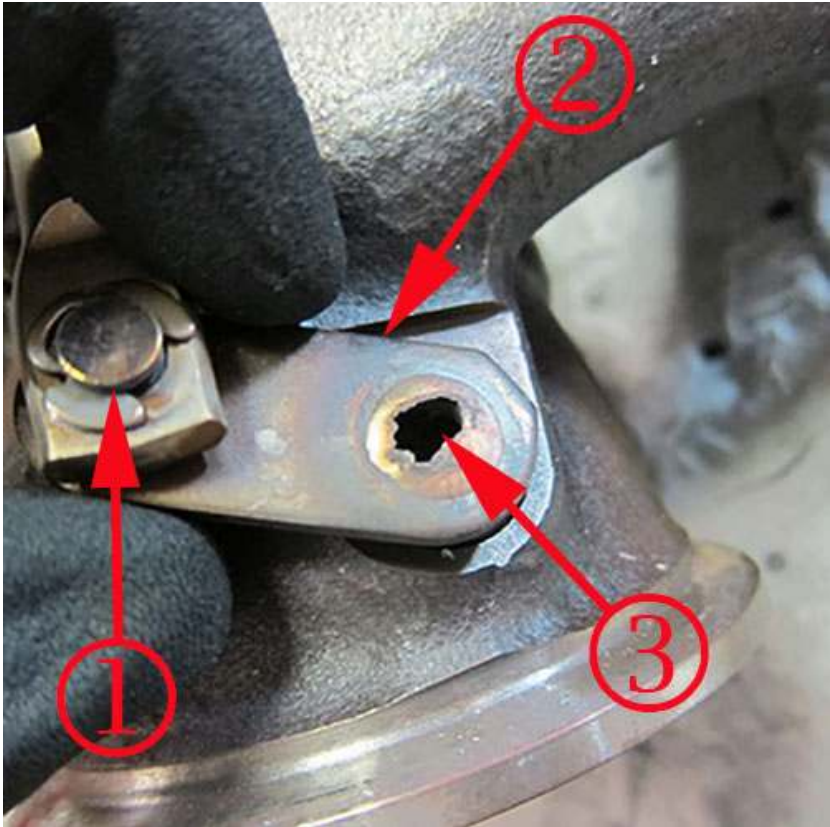
Replace the turbocharger if P0299 is set and at least one of the following is present:  
If the following failures are identified, it is not necessary to perform the Turbocharger Boost Control Test.  
Disconnected wastegate lever arm (crank) (2) from the shaft (3).

Disconnected wastegate lever arm pin (1) from the lever arm (crank) (2).  
Wastegate valve/linkage seized (cannot move).  
Turbine wheel not rotating, turbine wheel shaft broken or missing wheel nut.  
If wheel nut is missing, be sure to locate prior to turbocharger replacement.  
If the Wastegate lever arm (crank) (2) is bent, performing the Turbocharger Boost Control Test is required.  
Insufficient wastegate preload.  
Wastegate lever arm (1) moves with little effort in the direction as shown (2) while the actuator rod remains static, see picture below "Wastegate Preload Inspection".

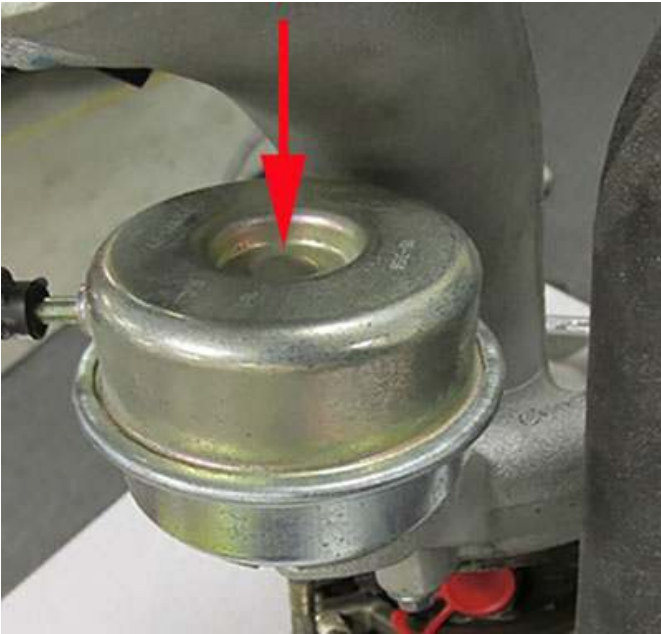
The original equipment wastegate actuator found on 2011 and 2012 model years shown below, has a recessed stop at the head of the actuator.

Original equipment actuator is found on 2011 and 2012 model years.

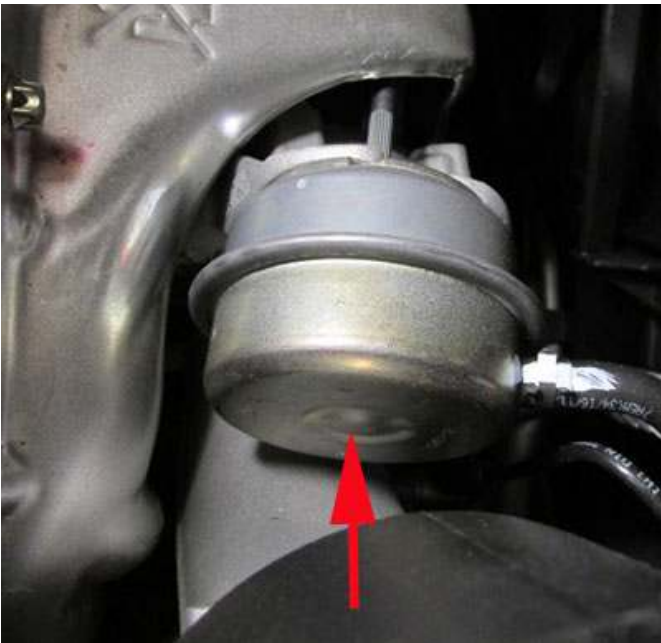
The updated design actuator show below has a stop that is not recessed and allows 5mm more travel in the closed direction.

With this updated design, it is very unlikely that an insufficient preload issue exists.

Updated design.

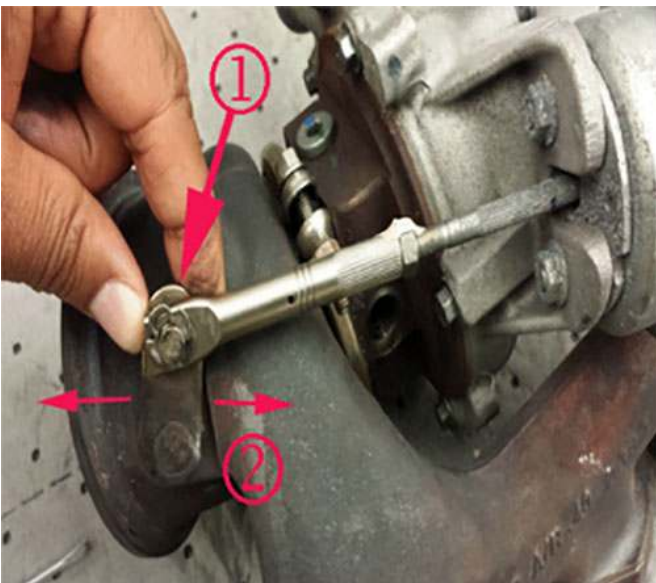
Wastegate Preload Inspection.

If the lever wiggles with little effort while the actuator rod remains static, the pre-load is insufficient and the turbocharger must be replaced.

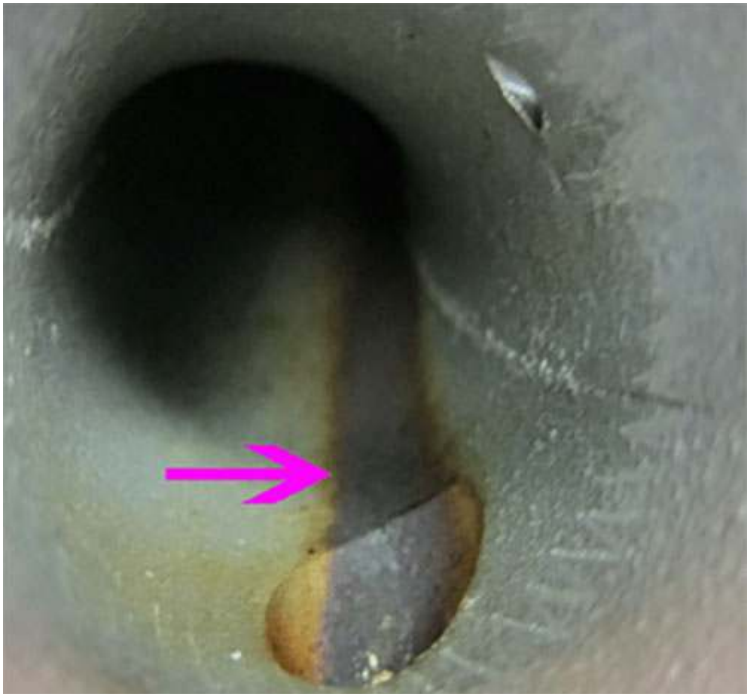
Notice: The view shown below indicates NORMAL oil staining in the turbocharger outside air inlet. This dry stain does not represent an oil leak.

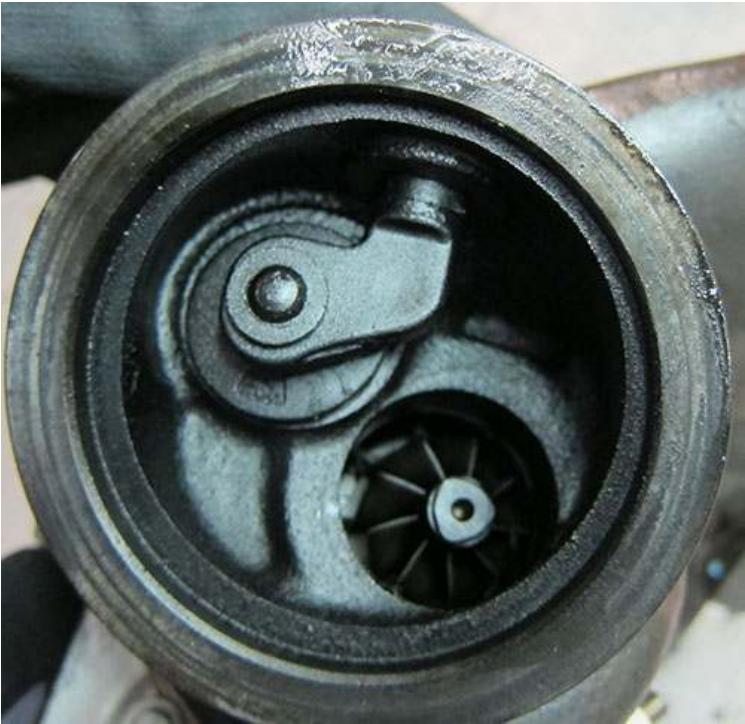
Inspect for the presence of oil in the exhaust system.

If oil is present in the exhaust system, then inspect the turbocharger turbine and compressor wheels to be sure that they are not broken off.

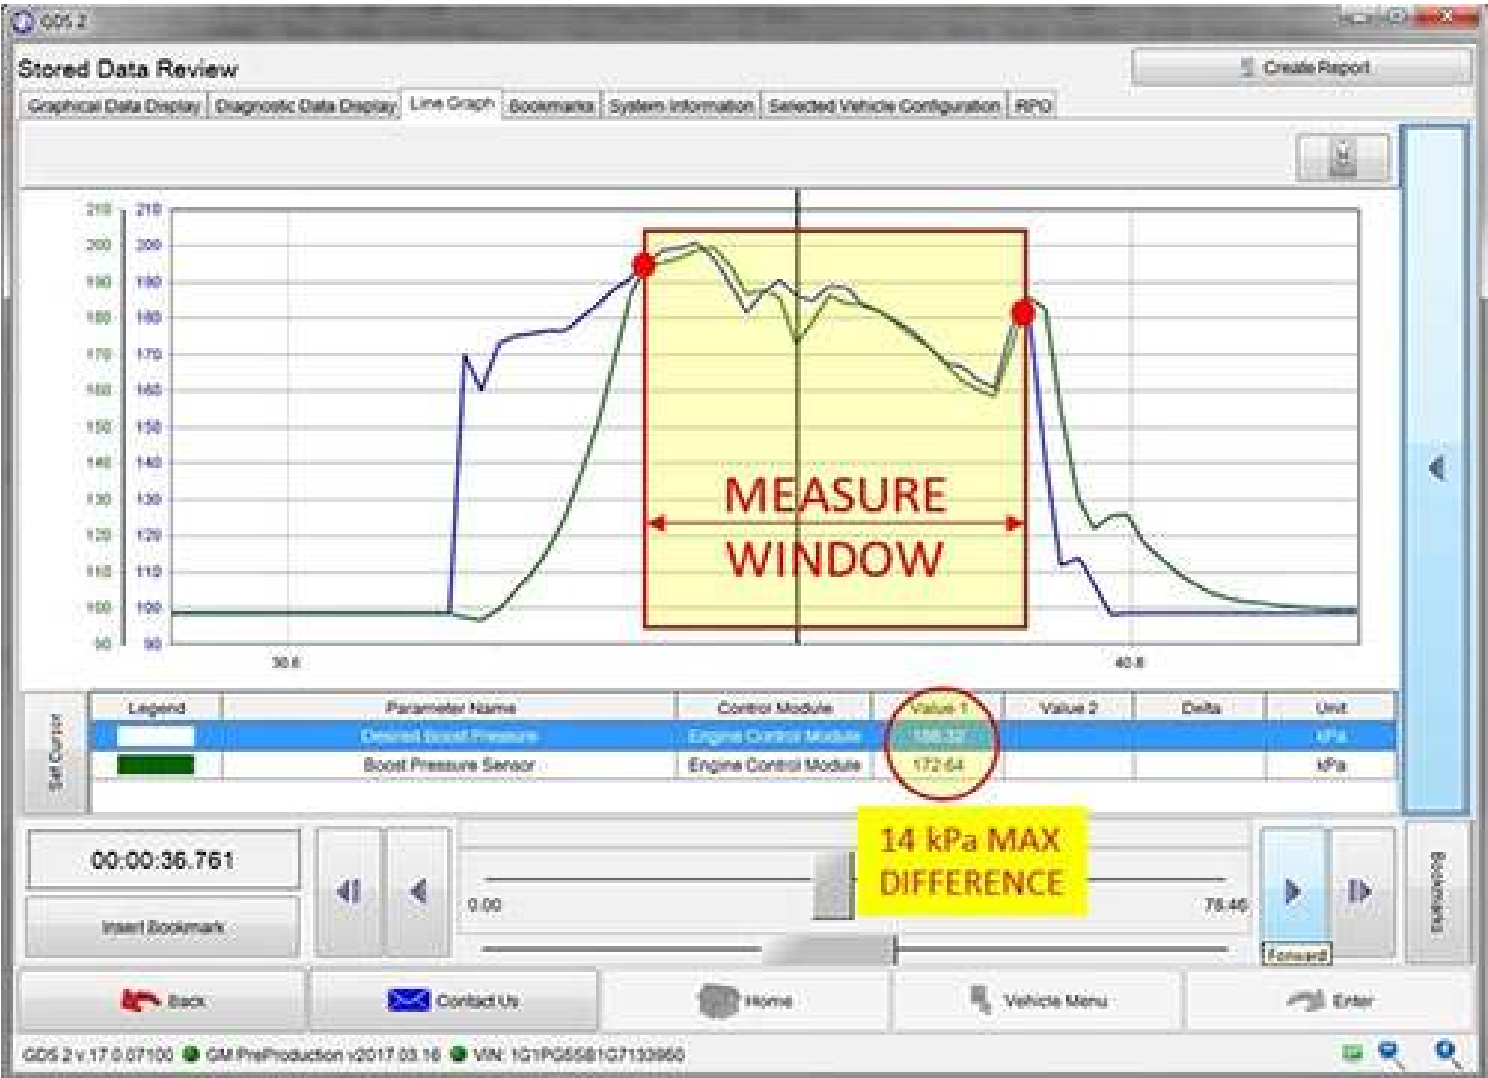
Example of normal turbocharger wastegate operation:  
In this example, notice that the measure window begins once the Boost Pressure Sensor reading (Green) meets the Desired Boost Pressure reading (Blue) and ends when the APP is released per the testing instructions.  
The Boost Pressure Sensor reading (Green) closely tracks the Desired Boost Pressure reading (Blue) indicating normal Turbocharger operation.
