Preliminary Information

PIT5535E Service Front Camera / Service Lane Departure Warning / Service Lane Keep Assist Message with DTC B1008 SYM4B / IntelliBeam Headlight / Windshield Wind Rush Noise

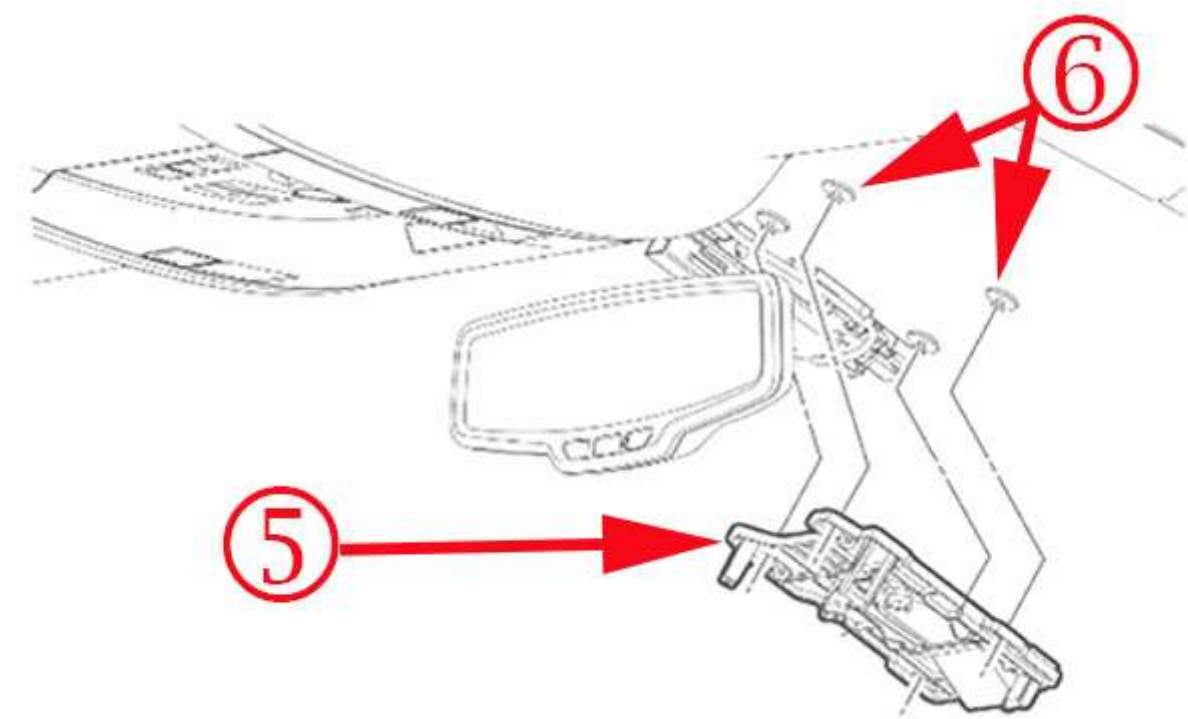
- Verify the front view camera module bracket (5) is fully seated down and secured on the windshield pins (6), shown below.

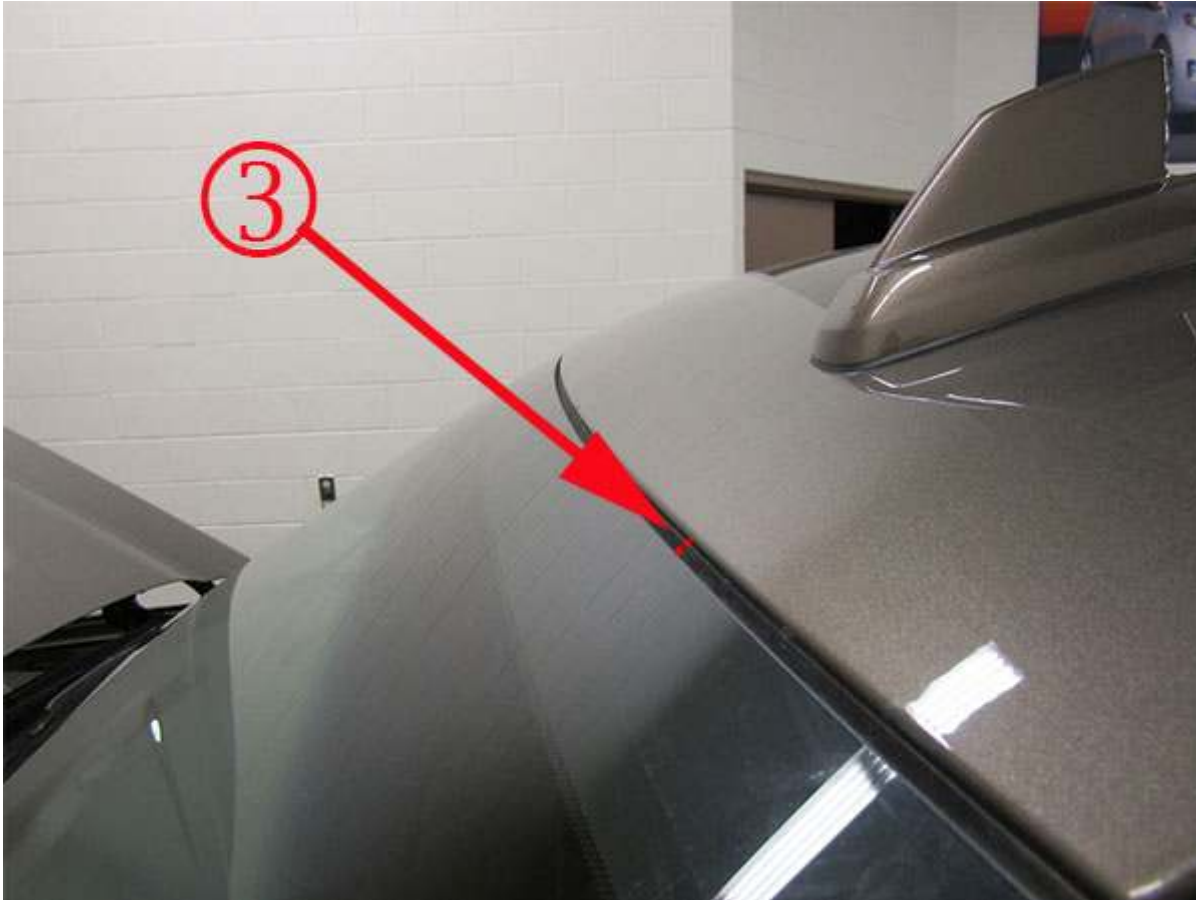
**Inspect the gap between the top of the windshield and roof sheet metal (3), shown below. This gap should be 3.6 mm (+/- 1 mm).**

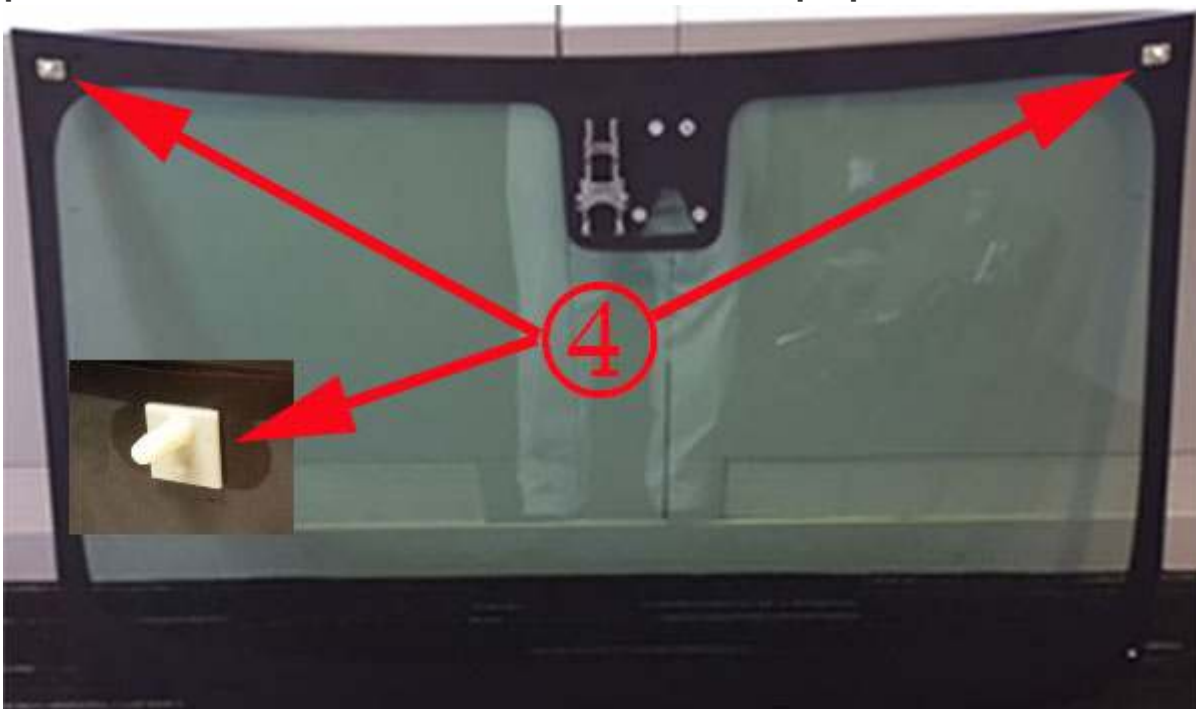
**Factory GM windshields use alignment/locating pins (4) in the upper corners of the windshield, which makes it much easier to properly align the windshield to the body opening, shown below. Most aftermarket windshields do not use these alignment/locating pins, which can make it more difficult to ensure a proper installation.**

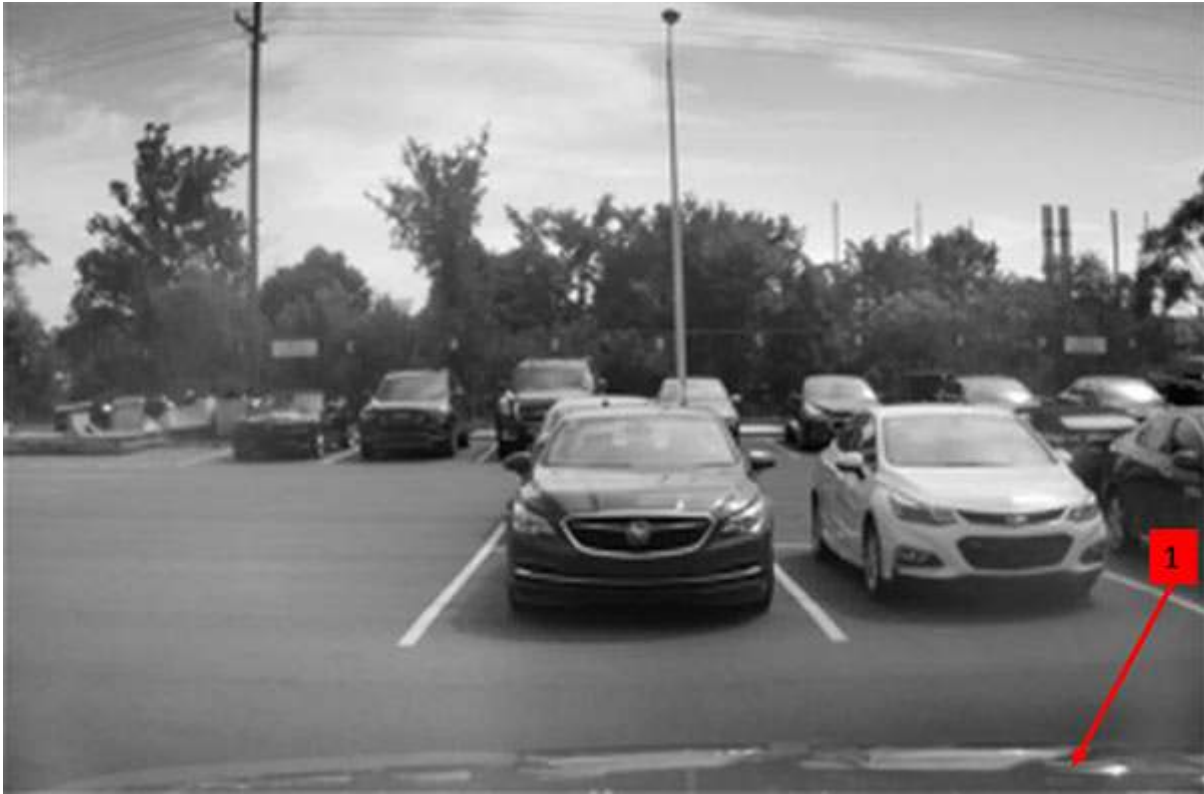
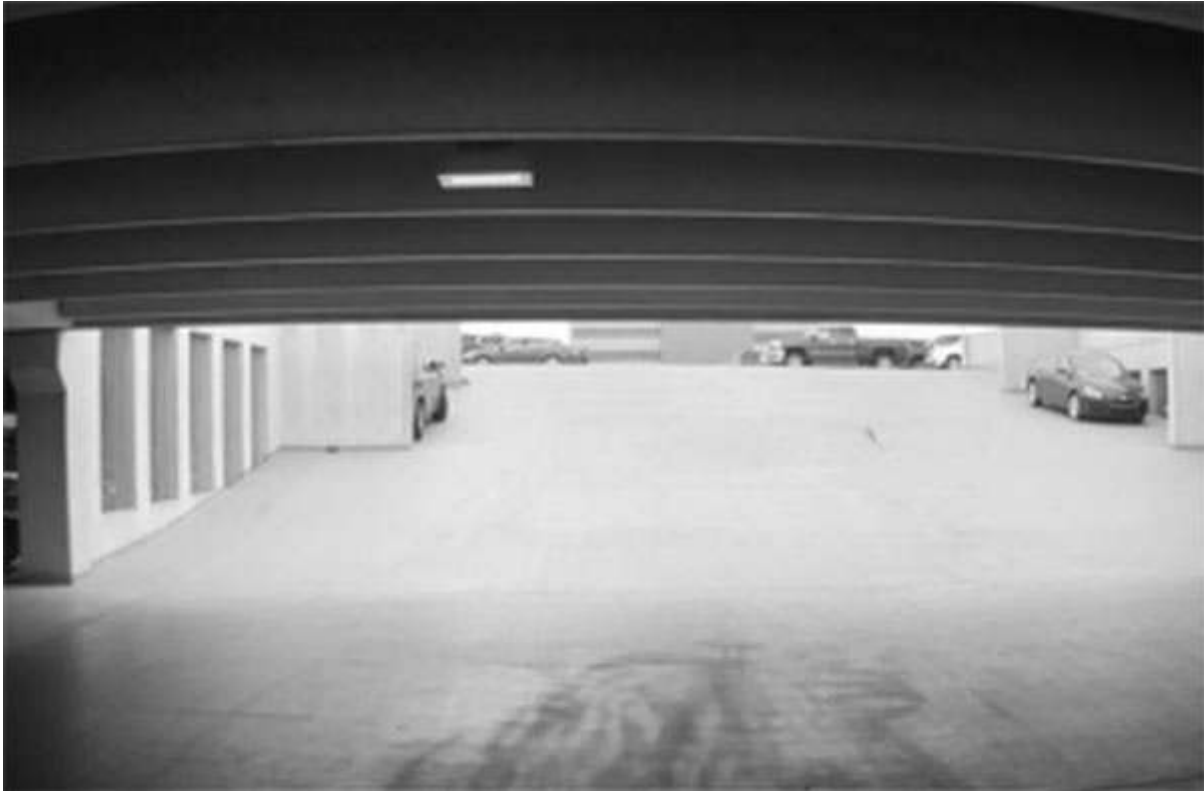
It has been found that some aftermarket windshields do not properly mount/position the front view camera. Shown below are some images, taken with engineering tools (see note below), of what the front view camera is actually seeing. The first image is taken from a truck with an aftermarket windshield. As shown below, the camera is seeing part of the hood (1). Because of this, the camera is not seeing movement in the area of the hood and can not complete the learn. The second image below is from a truck with a factory windshield and there is no hood seen by the front view camera.

**NOTE: If the windshield has to be removed/replaced for any of the above reasons, it is suggested that a factory GM windshield be installed.**
