Preliminary Information

PIT5288H RKE / Passive Entry And Start / No Audio / SWC / Touch Screen / Display Blank/ Rear Wiper And Rear Power Windows Inoperative / Dead Battery / Service Tire Pressure System / SES MIL DTC B3101 B144C C0710 C0544 P0106 P0107 P2122 P2123 P2127 P2128 P2138 U0028 U0029 U0077 U0126 U0151 U0415 U1548 U1549 U154A

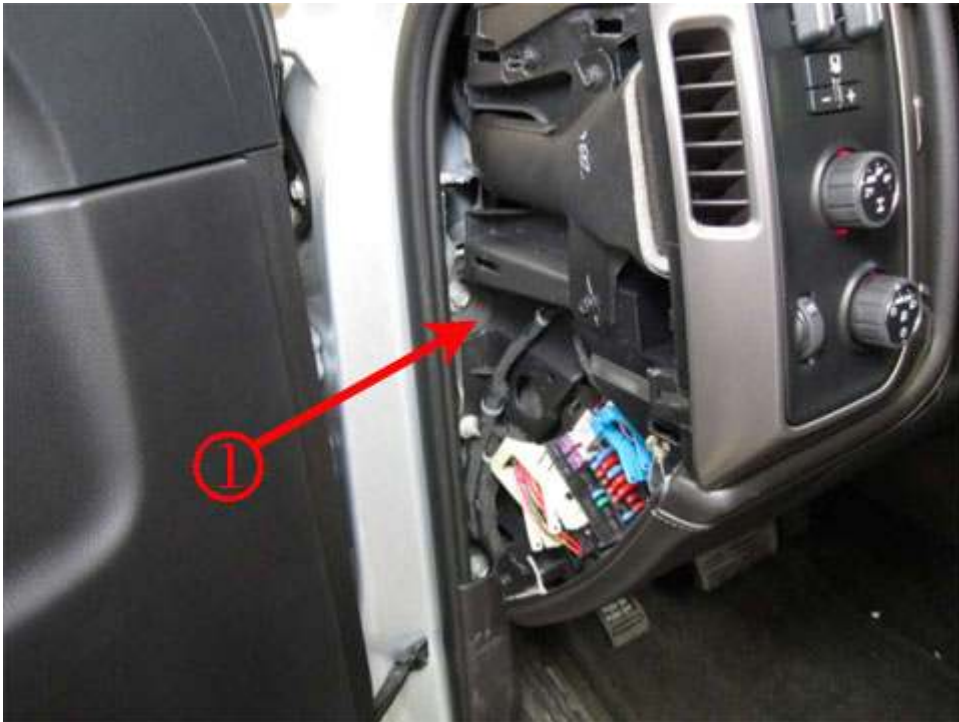
**These concerns could be caused by the dash harness being pinched between the left I/P dash mounting bracket (1) and the body. Shown below, is the left I/P mounting bracket (1) as seen when the I/P fuse block cover is removed from the end of the dash. This picture is for reference only and the wiring must be inspected from under the dash.**

To repair this concern, loosen the left I/P dash mounting bracket bolts and pull the harness free. Open the harness and repair any damaged wires as necessary.

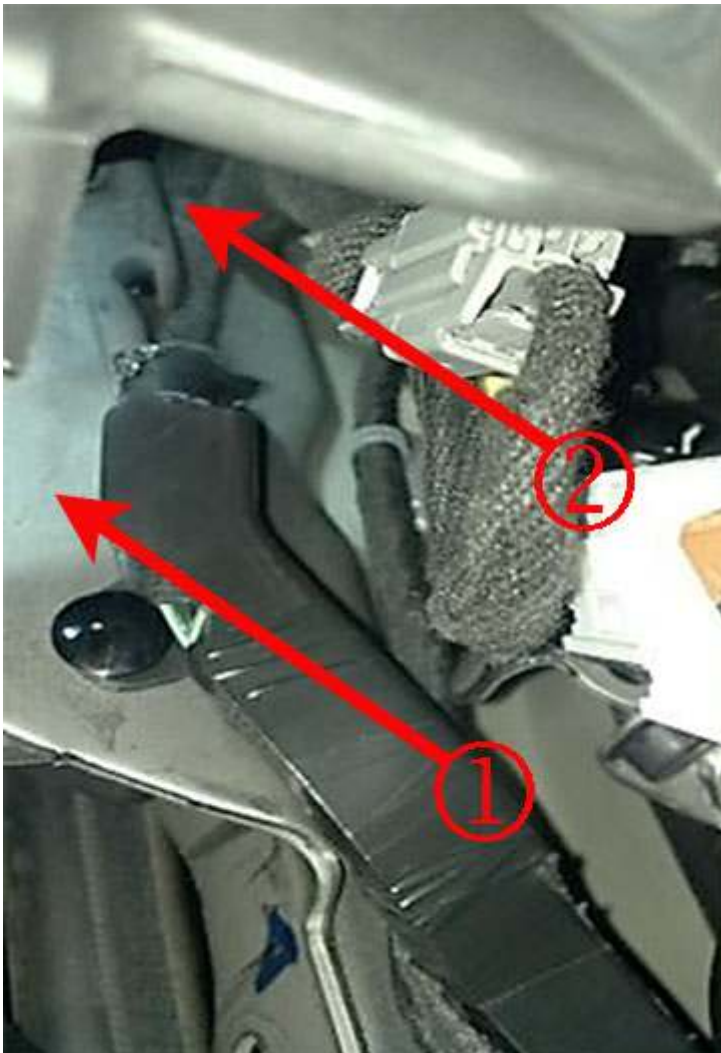
**As shown below, the wiring harness (2) is pinched at the upper portion of the I/P mounting bracket (1). In many cases, the complete harness may not be pinched and it can be difficult to see that the harness is damaged. When inspecting for a pinched harness, make sure the harness can be moved freely away from the bracket to body interface.**

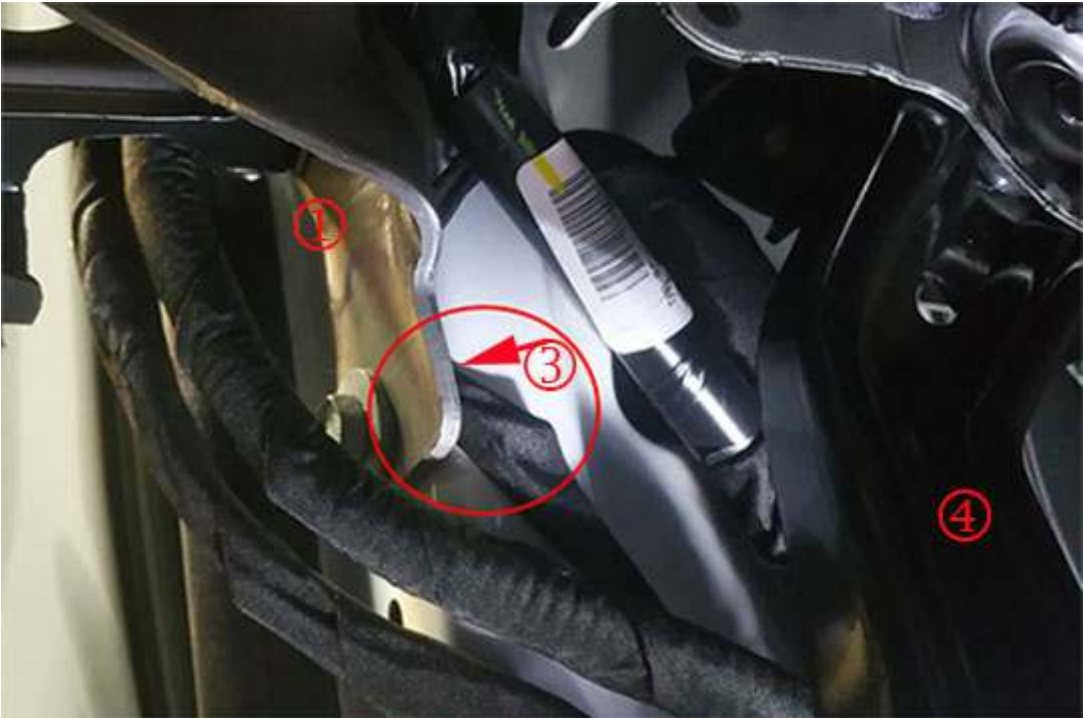
As shown below, the wiring harness (3) is pinched at the lower portion of the left I/P mounting bracket (1). For reference only, call out (4) is the parking brake pedal.
