# Preliminary Information

## PIP5686 Engine Air Leak from The Foul PCV Tube, Whistle Noise, P0171 and/or P0174

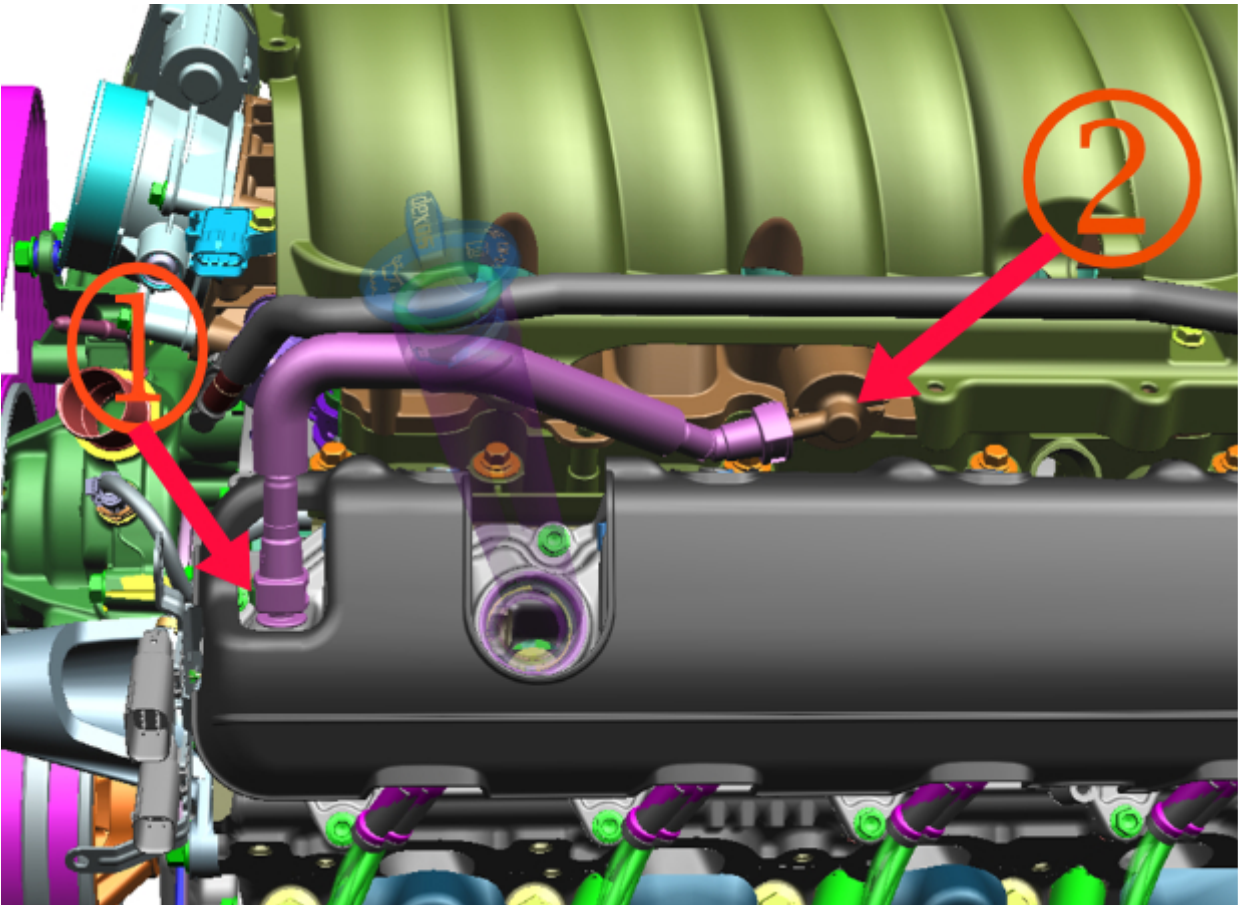
**PCV Tube Locations: Location 1- Connector to Rocker Cover, Location 2- Connector to Intake Manifold**

| Cause | This condition may be caused by an incorrectly installed foul air PCV tube or tube may be damaged. |

1. Check to see If tube is installed and seated correctly . If tube is installed correctly it will be necessary to smoke test and confirm there are no leaks. Proceed to the steps below .
  - a. If no smoke is detected, then tug on PCV tube ends (Location 1 or 2) to ensure the tube is seated. If tube was not fully seated, then properly secure connection by pressing tube in until it clicks, and the tube does not come off by pulling on it. Proceed to step 4.
  - b. If smoke is detected, at either at the cover or manifold (Location 1 or 2) Remove and reinstall the same PCV tube to ensure both latches click. Proceed to Step 2.
  - c. If the tube is cracked or other damage in any other location besides (1 or 2) then it will be necessary to remove and replace with a new tube. Proceed to step 4.

2. Repeat smoke test to verify condition is still present. If leak is still p resent at (Location 1 or 2) remove tube and inspect O -ring seals inside, look for damage or missing O-rings. Take images of findings. Replace with new tube if damage is found. Proceed to step 4.
3. Clear the ECU codes.
4. Start vehicle up, idle for 5 minutes in park, shut engine off, repeat (T otal needs to be 2 times)
5. Verify if code/s return:
  - If Yes - if condition is still present or DTC returns, then it will be necessary to follow SI diagnostics in the service manual for that DTC or condition.
  - If No - PCV tube was not correctly seated during assembly . Return vehicle to customer and document findings on repair order .
