# Preliminary Information

## PIP5661A 2019 2.0 LTG Engine Runs Rough with Malfunction Indicator Lamp (MIL) ON, Low Compression on Cylinder with Misfire, DTC P0300 Set

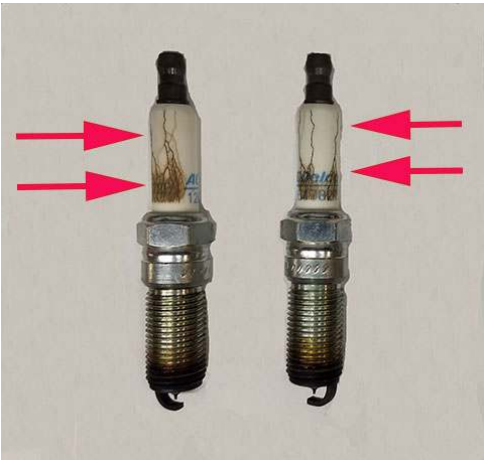
| Condition | Some customers may comment on a rough running engine with the Malfunction Indicator Lamp (MIL) ON. Upon inspection, a technician may find DTC P0300 misfire set and may find low compression in one or more cylinders. This condition may be caused by spark plug carbon tracking and/or a crack in a piston located between the piston compression rings. |
| Cause | Ignition coil and spark plugs with carbon tracking damage can lead to increased misfire events and ultimately damage the pistons and engine assembly. |

Visually inspect all the spark plugs for signs of carbon tracking on the portion of the spark plug being covered by the coil boot.

All four spark plugs and ignition coils must be replaced in any of the three scenarios to prevent future failures.

Important: Be sure to apply dielectric grease (19260901 USA / 19260902 Canada) to the spark plug boots as directed in SI for ignition coil replacement.

Apply a thin coating of dielectric grease (19260901 USA / 19260902 Canada) to the inside of the ignition coil rubber boot, up to a depth of 15 mm from the end of the boot.

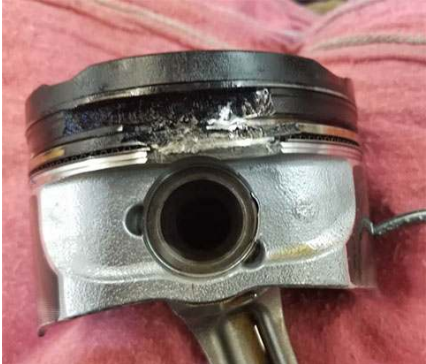
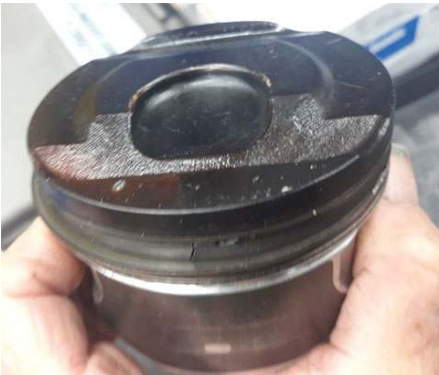
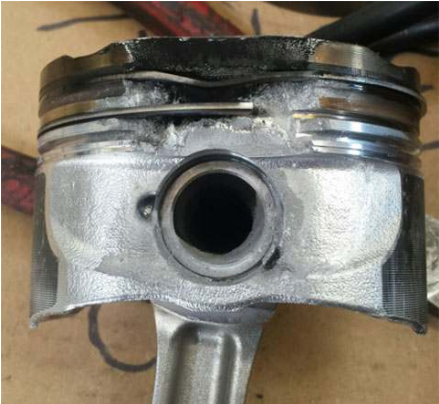
If the cylinder walls are not damaged, remove the pistons and inspect for a fractured piston between the top and second rings.

The pictures below are some examples of what might be found.

If cylinder walls are not damaged and one or more of the pistons are found fractured, replace all four spark plugs, all four ignition coils (apply dielectric grease 19260901 USA / 19260902 Canada to the spark plug boots), the fuel injector of the cylinder(s) that had damaged pistons, all four piston kits, all ring sets for all four pistons, all rod bearings, all four connecting rod assemblies and other components necessary when pistons are replaced.

**Note:** When installing pistons, make sure to use the tapered ring compressor J-43953 special tool. Use care when installing the piston assemblies into the cylinder so the rings are not damaged.
