# Service Update

## N192267870 Battery Saving Notification

Release Date: October 2019

Subject: N192267870 - Service Update  
Battery Saving Notification

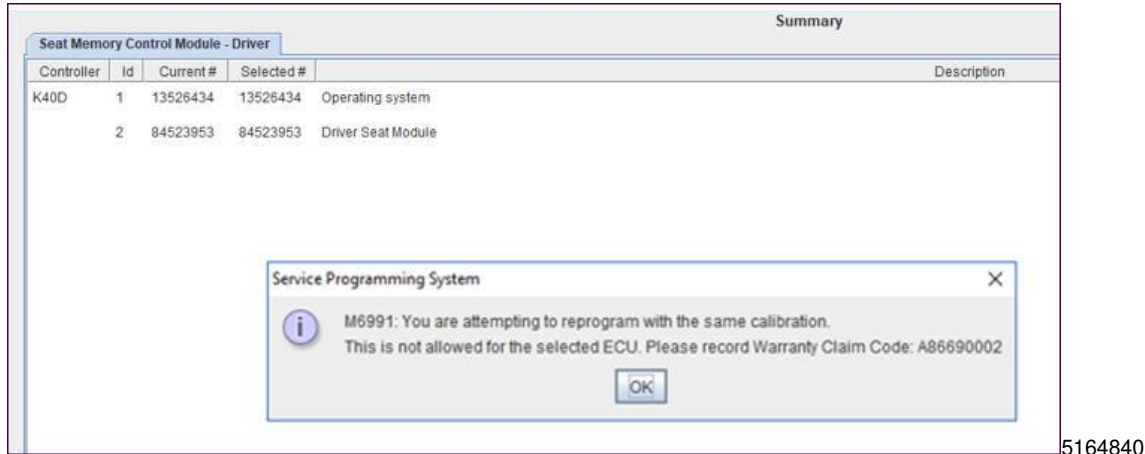
**Note:** If the Same Calibration/Software Warning is noted on the SPS Summary screen, record the warranty claim code (WCC) and select OK and follow screen instructions. After a successful programming event, the WCC is located in the Service Programming System dialogue box of the SPS Summary screen. No further action is required. Refer to the Warranty section of the bulletin.

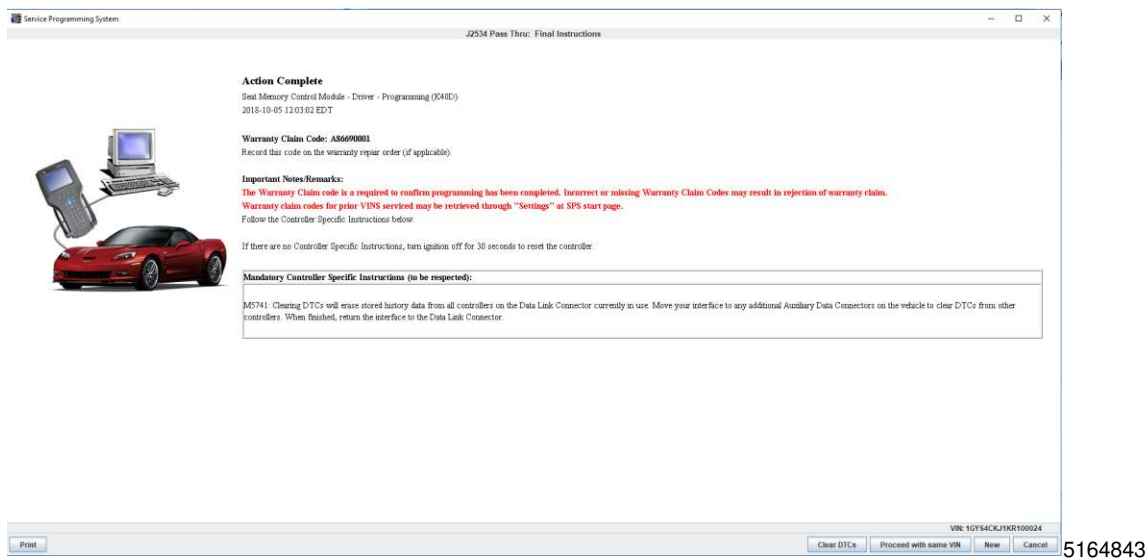
| <b>Condition</b> | Certain 2019 model year Chevrolet Silverado 1500 (new Model) and GMC Sierra 1500 (New Model) vehicles have a new feature that notifies customers via text or email of a low battery voltage. This feature will not function if the voltage becomes low and the vehicle is In Off Power Mode. A service engine soon (SES) light will illuminate upon starting or jump starting the vehicle and multiple U-Codes will be stored in the engine control module (ECM). The U-Code combinations will include two or more of the following codes: U0101, U0102, U0129, U0140, U18A2. |

1. Reprogram the Engine Control Module. Refer to *K20 Engine Control Module: Programming and Setup* in SI.

2. Record SPS Warranty Claim Code on job card for warranty transaction submission.
