# Technical Service Bulletin

**Subject:**

**POOR HEATER PERFORMANCE AND/OR DTC P011A:00 STORED**

**Bulletin No.:** 07-007/19

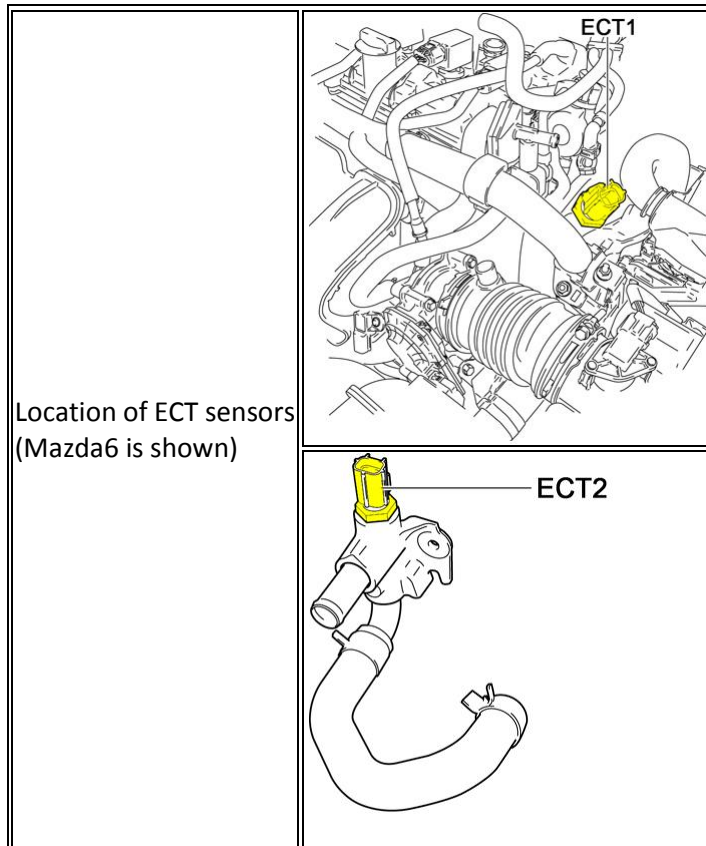
**NOTE A:** DTC P011A:00 (ECT sensor No.1/No.2 performance problem) is for 2013-2016 (US spec) / 2017 (Mexico spec) CX-5 and 2014-2016 Mazda6 only.

The purpose of having two ECT sensors is to mutually monitor their performances. If two temperature values detected by the sensors are different beyond the specified value, the DTC P011A:00 is set.

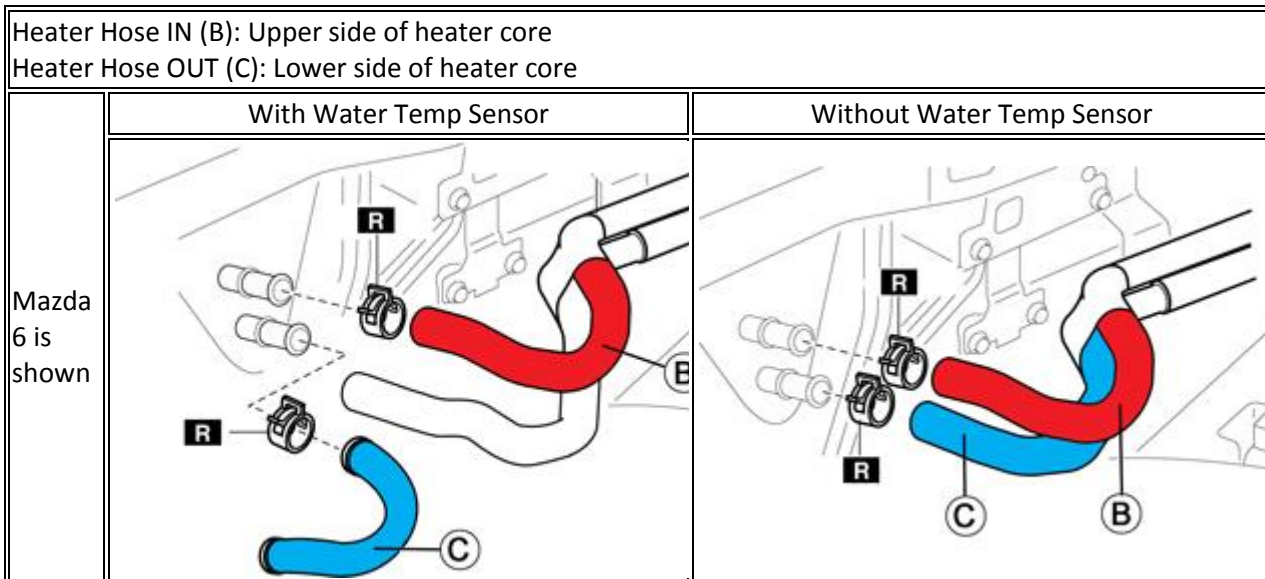
**NOTE C:** Inspect heater hose IN and OUT for temperature difference.

Using a thermal temperature gun or thermocouple, measure the heater hose IN and heater hose OUT temperature. If there is an obvious difference in temperature between both hoses, the heater core may be plugged.

**NOTE:** When doing this inspection, turn the HVAC blower fan OFF. If ON, the heater core radiates heat, so the temperature difference between IN and OUT hoses will generate heat even if the heater core is not plugged.

If the heater core was determined to be plugged by the diagnosis procedure, replace the heater core with a new one and replace the contaminated engine coolant twice.
