| <b>Subject:</b><br><br><b>ENGINE NO START (KEY NOT DETECTED)</b> | <b>M-Tips No.:</b> MT-004/19 |
| | <b>Last Issued:</b> 11/20/2019 |

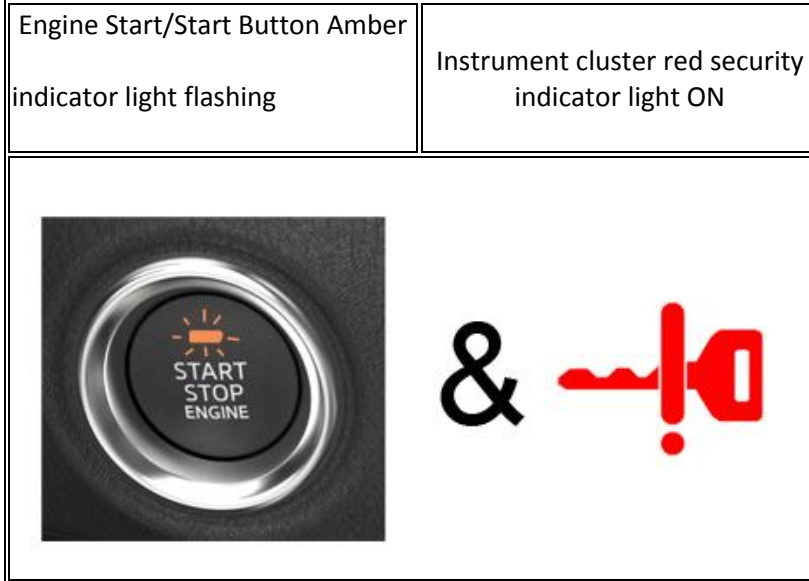
- Intermittent engine no start
- Instrument cluster red security indicator light ON
- Engine Start/Start Button Amber indicator light flashing
- Battery discharge
- Electrical relay buzzing noise
- **DTC B13D3:94 (Communication error with remote transmitter) stored.**

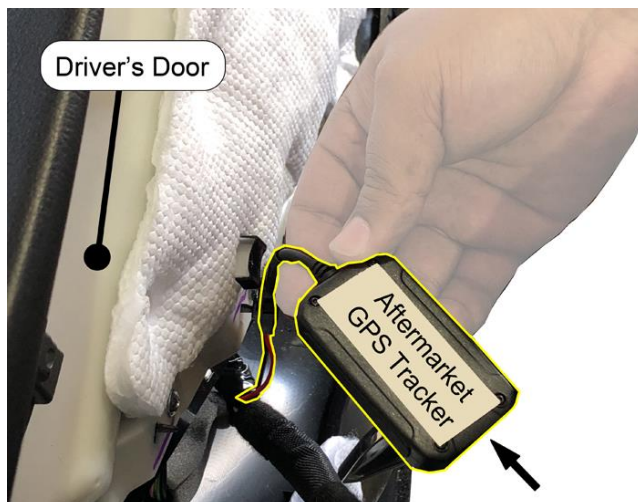
- A key in a purse near a cell phone. The cell phone radio waves may interrupt the immobilizer system.
- An aftermarket cell phone charger. The charger may produce electrical noise that interrupts the immobilizer system.
- An aftermarket GPS tracker. Some aftermarket devices that are wired to the vehicles's wiring harness may create unusual electrical symptoms.

1. Remove the key from the customers purse. Does the engine start?

- Yes - Advise customer that the key cannot be detected inside of purse. Possible out of range or an electrical device in the purse is causing immobilizer interruption.
- No - Check the key battery. Is the key battery dead?
  - Yes - Replace key battery.
  - No - Proceed to next step.

2. Remove the customers aftermarket device from the customers vehicle. Does the engine start?

- Yes - Advise customer that the aftermarket device is causing an electrical malfunction.
- No - Refer to Workshop Manual Immobilizer System diagnosis.
