**NUMBER:** 08-094-19

Video Routing Module (VRM) Enhancements For Rear Seat Entertainment System

This bulletin involves updating the VRM software level to 19.12.10.

2019 (RU) Chrysler Pacifica

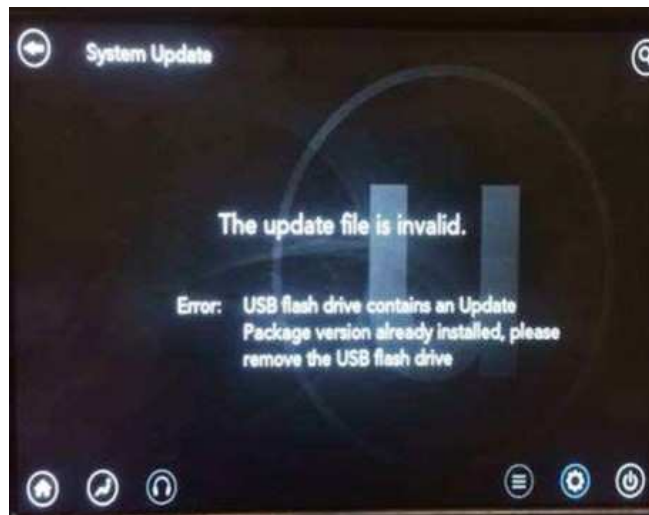
**NOTE: If the USB flash drive is left in the port after system reboot, there will be a pop-up on the rear seat back video screen that states "The update file is invalid" (Fig. 3) . This is not a concern as the system is already up to date.**

Fig. 3  
Rear Seatback Video Screen Error
