# Service Update

## 17096 Engine Stall During Aggressive Driving

Reference Number: N162069020

Release Date: March 2017

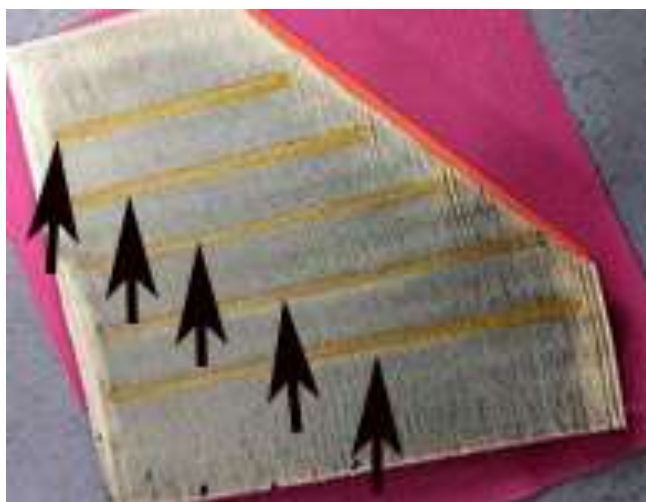
4733220

**Glue Beads Installed**

- If the glue **beads are installed**, install a new air cleaner filter element only.
- If the **glue beads are missing** install a new air cleaner filter element and a new air cleaner outlet duct assembly. Refer to *Air Cleaner Outlet Duct Replacement* in SI.

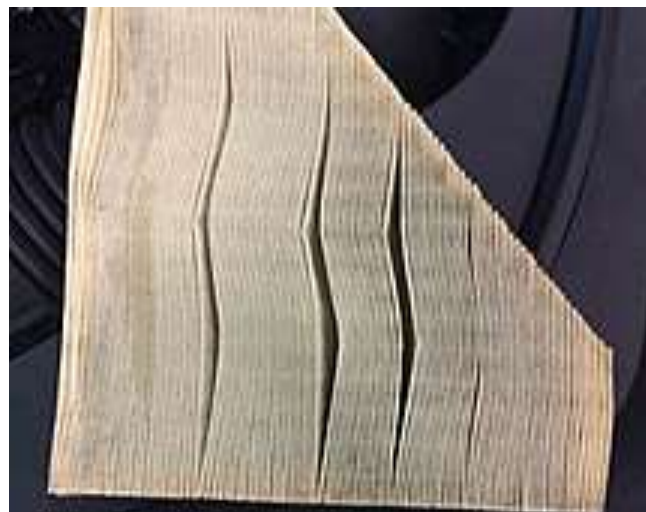
4733221

| <b>Condition</b> | Certain 2016-2017 model year Cadillac CTS-V vehicles, equipped with 6.2L engine (RPO LT4), may have a condition in which the engine air filter element does not have glue beads across the paper pleating. If this condition is present the pleats can fold over on themselves during high-RPM aggressive driving, and restrict the airflow, which may collapse the air duct and cause the engine to stall. Additionally, the air duct could be cut and a malfunction indicator lamp could illuminate with diagnostic trouble codes P0121-00, P2101-00 and P2119-00 stored. |

**Glue Beads Missing**
