# Service Bulletin

Bulletin No.: 17-NA-232

**Subject:** Power Liftgate Stops When Opening and/or Will Not Close from Open Position, DTC B153E or B396A Set

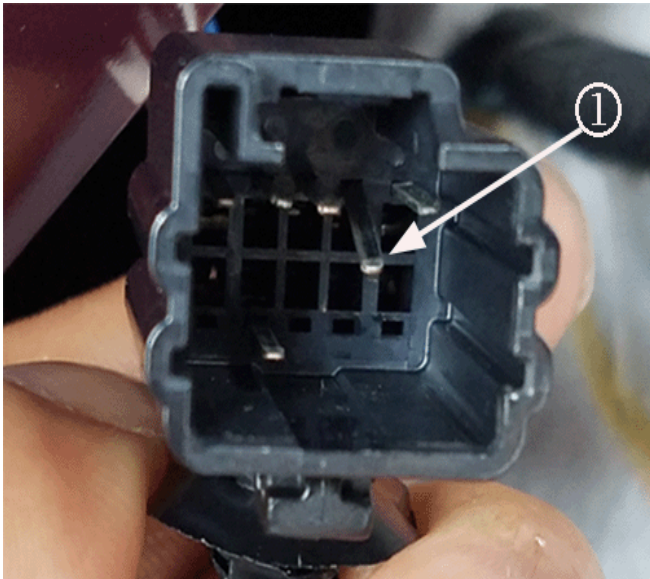
4833998

| | <p style="text-align: right;">4834001</p> <p><b>Note:</b> Examples of the bent pin condition are shown in the male terminal side (1) and mating side female terminal (2) connector graphics above.</p> <p>The cause of the condition may be that the male terminals in the body harness 10-way in-line connector to the liftgate power assist actuator may not be dimensionally stable and/or misaligned, causing intermittent electrical contact.</p> |

| <b>Correction</b> | <p><b>Important:</b> DO NOT replace the liftgate power assist actuator or the power liftgate ECU before first inspecting the connector as possible cause of the condition.</p> <p>Inspect the body harness to liftgate power assist actuator connector and repair as necessary following the Service Procedure below.</p> |
