# Technical Service Bulletin

## 90 Top view camera does not load - no communication

90 17 80 2047730/1 July 31, 2017.

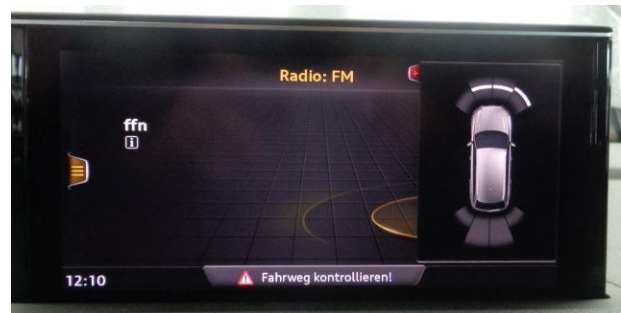
Customer may report that the Top view camera does not load. Only the visual parking aid overlays on the right half of the screen (Figure 1).

**Figure 1.** Camera image not displayed.

The following DTC is found in the data bus on board diagnostic interface, J533 (address word 0019):

- **DTC U104C00** (Rearview camera system control module, no communication)

Incorrect software.

1. Check DTC memory of the system via the diagnostic scan tool with Guided Fault Finding. DTC U104C00 will be stored in the data bus on board diagnostic interface, J533 (address word 0019).
2. Check the identification data of the peripheral camera control module, J928 (address word 006C). If the software part number and software version number show implausible values (Figure 2), replace the peripheral camera control module.
