# Technical Service Bulletin

## 93 Electric Drive Warning "System error" displayed on instrument cluster

93 17 05 2047162/1 March 29, 2017.

| Model(s) | Year | VIN Range | Vehicle-Specific Equipment |
|---|---|---|---|
| A3 | 2015 - 2016 | All | e-tron |

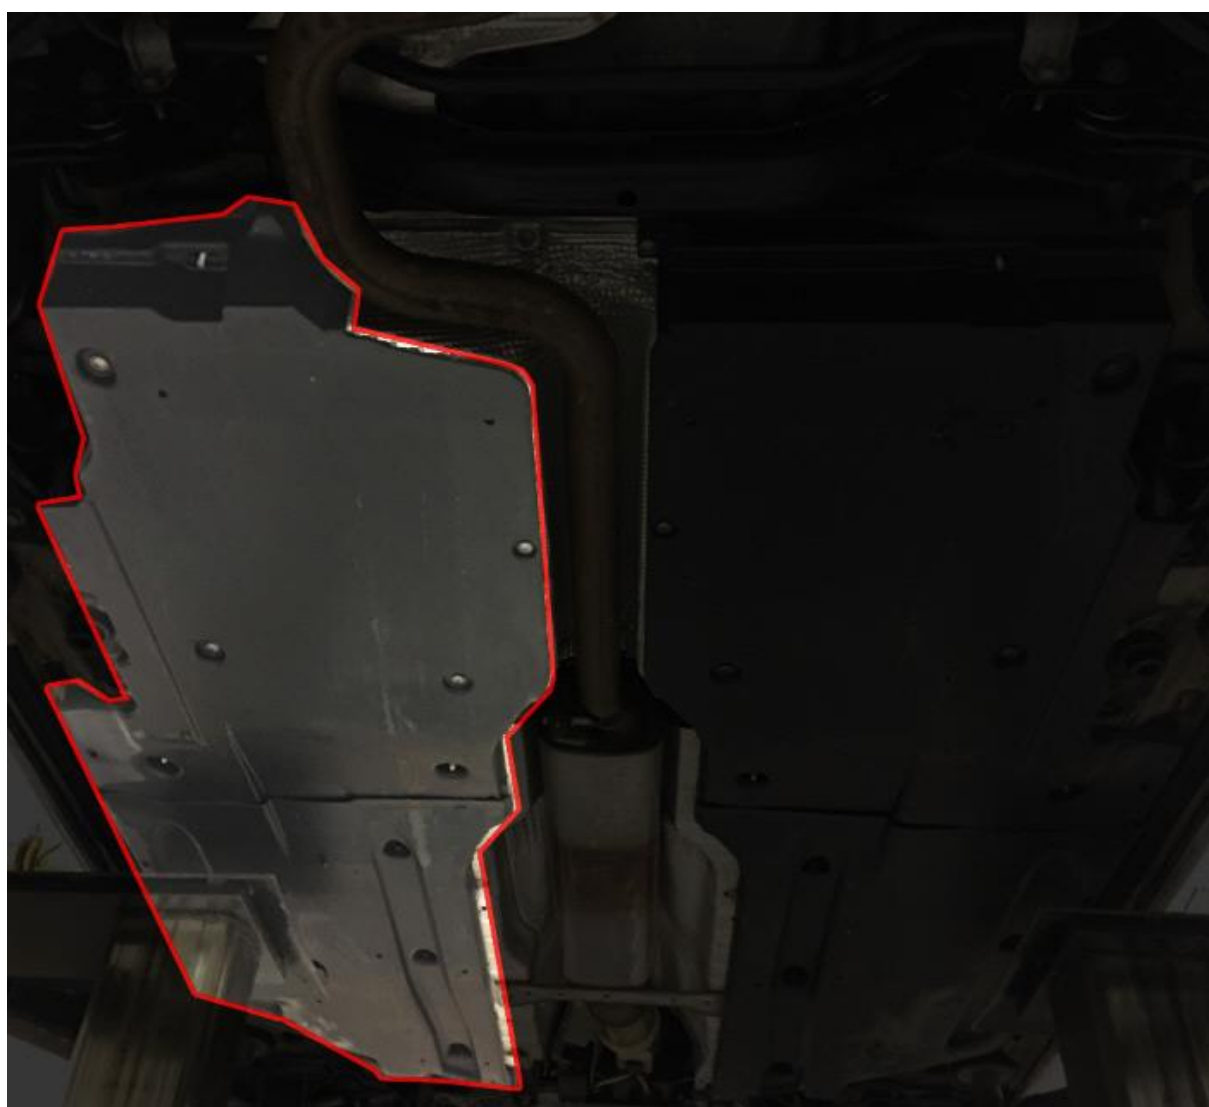
**Figure 1.** Left underbody trim panel.

3. De-energize the high-voltage system. See repair manual for instruction and required qualifications.
4. Remove the underbody trim panel from the left side of the vehicle (Figure 1).

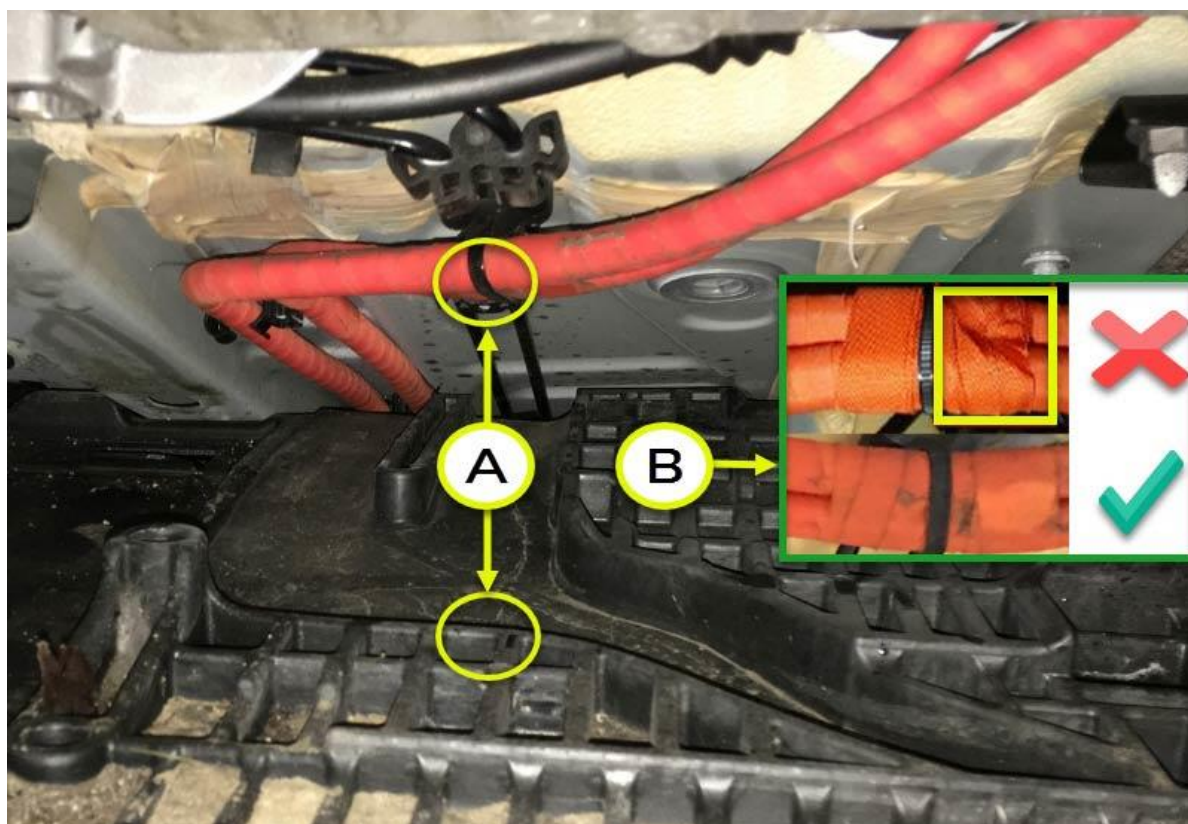
The wire harness for the high-voltage battery maybe pinched by the left underbody trim panel.

5. Inspect the high-voltage cable in the area (Figure 2-A).

- If the cable was not routed inside the underbody trim panel high-voltage cable channel, then damage can be caused to the cable by the underbody trim panel.
- If there is an indent on the high-voltage cable, proceed with the TSB, otherwise perform diagnostics of the DTC outside of this TSB.

**Figure 2.** Inspect high-voltage cable, in location A, for pinch damage as shown by B.

6. If pinch damage is present, replace the high-voltage cable from the high-voltage battery to the power-electronics.
7. When replacing the high-voltage cable in step 6, install additional retainer bracket (part number 1K0-611-853):
  - Ensure the spacer tabs of the additional retainer bracket (Figure 3-A) point towards the rear of the vehicle and the spacer tab presses up to the original retainer bracket.
  - Secure the high-voltage cable to the additional retainer bracket, not the original bracket.
