# Technical Service Bulletin

## 93 Electric Drive Warning "System error" displayed on instrument cluster

93 17 06 2047162/2 March 31, 2017. Supersedes Technical Service Bulletin Group 93 number 17-05 dated March 29, 2017 for reasons listed below.

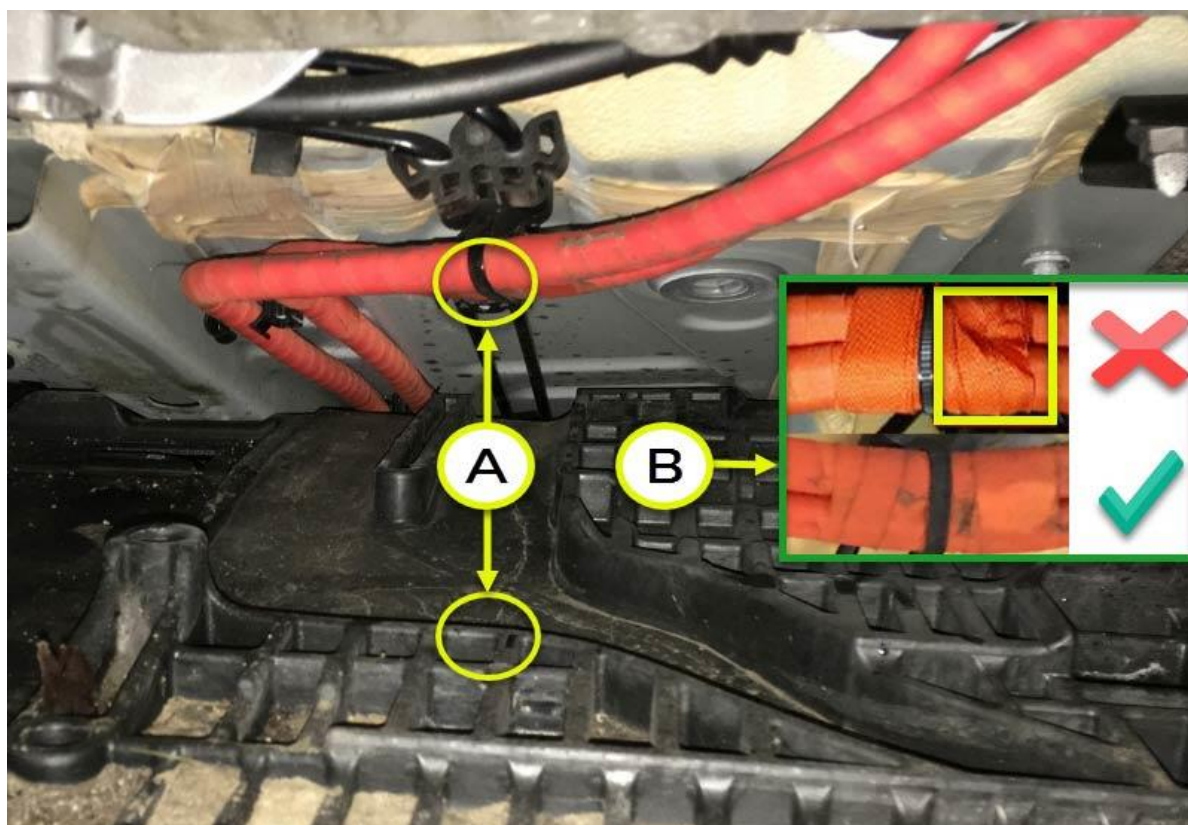
The wire harness for the high-voltage battery maybe pinched by the left underbody trim panel.

5. Inspect the high-voltage cable in the area (Figure 2-A).
  - If the cable was not routed inside the underbody trim panel high-voltage cable channel, then damage can be caused to the cable by the underbody trim panel.

- If there is an indent on the high-voltage cable, proceed with the TSB, otherwise perform diagnostics of the DTC outside of this TSB.

**Figure 2.** Inspect high-voltage cable, in location A, for pinch damage as shown by B.

6. If pinch damage is present, replace the high-voltage cable from the high-voltage battery to the power-electronics.
7. When replacing the high-voltage cable in step 6, install additional retainer bracket (part number 1K0-611-853):
  - Ensure the spacer tabs of the additional retainer bracket (Figure 3-A) point towards the rear of the vehicle and the spacer tab presses up to the original retainer bracket.
  - Secure the high-voltage cable to the additional retainer bracket, not the original bracket.

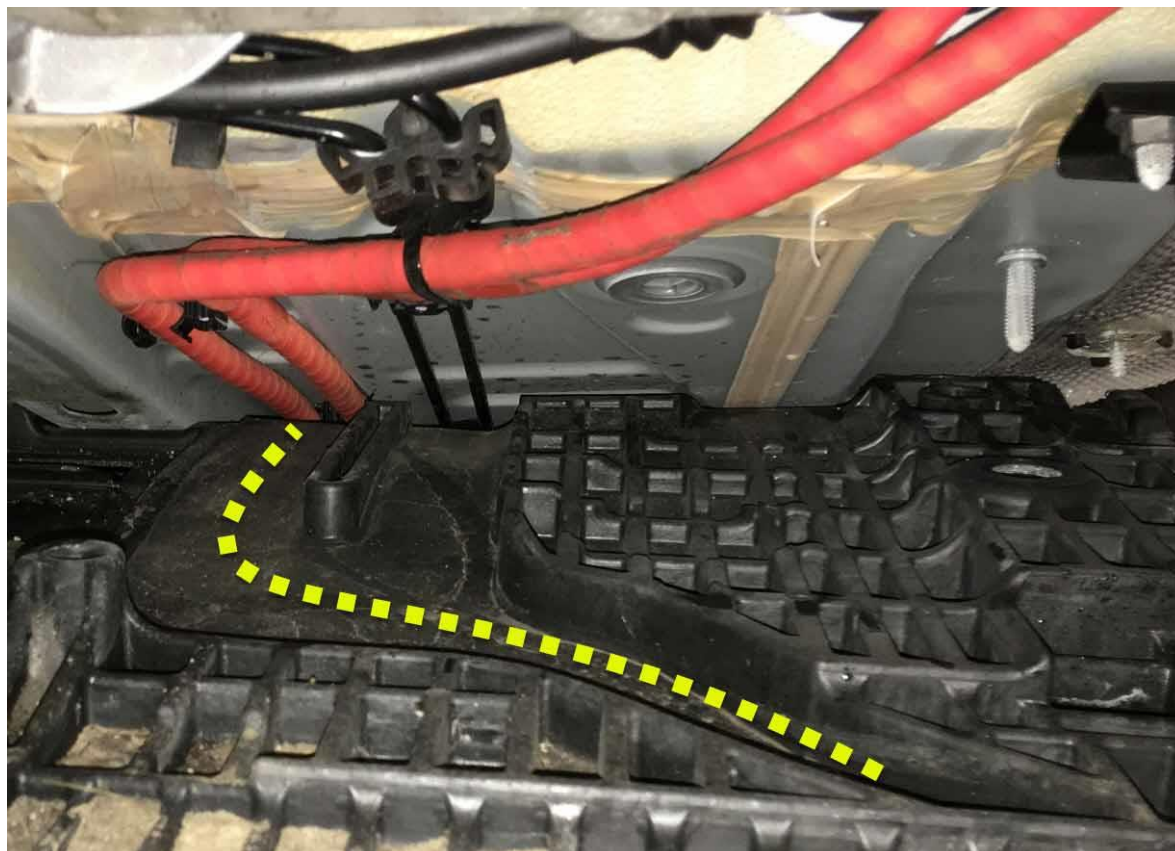
**Figure 4.** Underbody trim panel high-voltage cable channel. Routing path shown by dashed line. Pinch damage will occur if the high-voltage cable is not properly placed inside of the underbody trim panel.

8. When installing the underbody trim panel, ensure that the high-voltage cable fits inside the routing channel (see dashed line in Figure 4). Pinch damage will occur if the high-voltage cable is not properly placed inside of the underbody trim panel.
