# Technical Service Bulletin

**SCBS / SBS, LAS / LDWS, MASTER AND/OR HBC WARNING LIGHTS  
ON WITH DTC U3000:98 STORED DURING HOT WEATHER**

**Bulletin No.:** 15-006/17

**Last Issued:** 12/22/2017

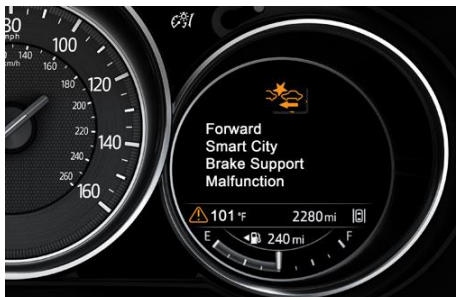
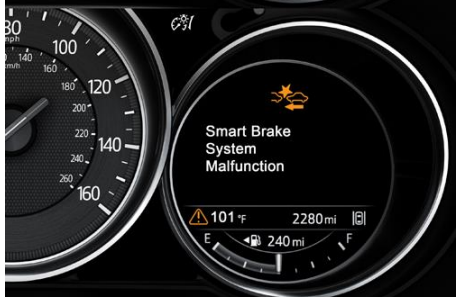
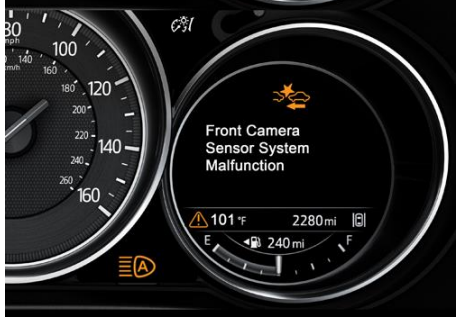
**Before FSC Reprogramming:**

This condition may be caused by FSC control logic that is too sensitive. When the FSC detects DTC U3000:98 during high temperature, it stops the internal communication and stores DTC U3000:04. DTC U3000:04 will not clear and SCBS/SBS, LAS/LDWS, and/or HBC functions will not resume until the ignition switch has been turned OFF even if the temperature of the FSC cools.

The warning lights/messages will be displayed until the FSC cools and the ignition is turned OFF, then back ON.

Customers having this concern should have their vehicle repaired using the following repair procedure.

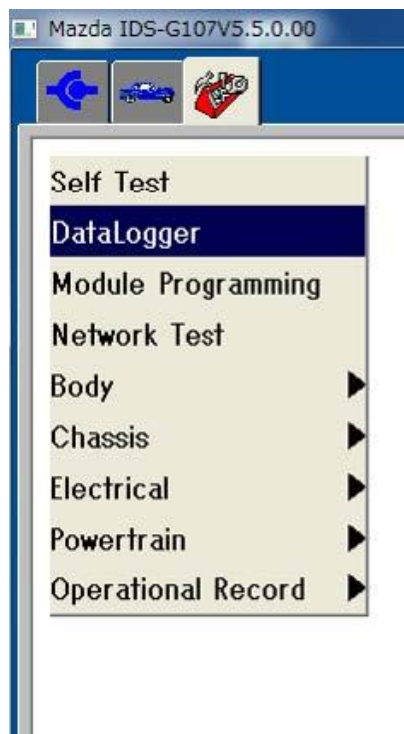
4. If the FSC seems to be hot (approx. 60 °C [140 F] or higher), cool it down by parking in the shade with the ignition OFF.

**NOTE:** If the FSC is hot, the FSC reprogramming process may fail. The FSC temperature can be monitored by the data logger function of the M-MDS.

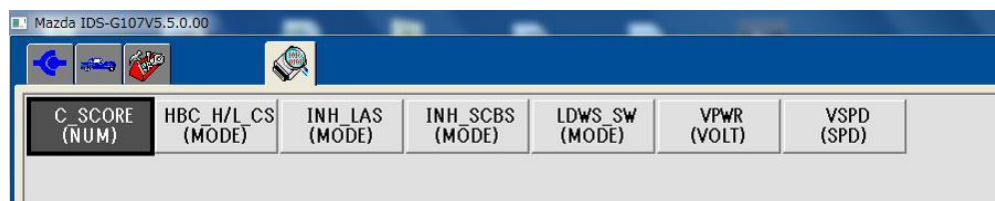
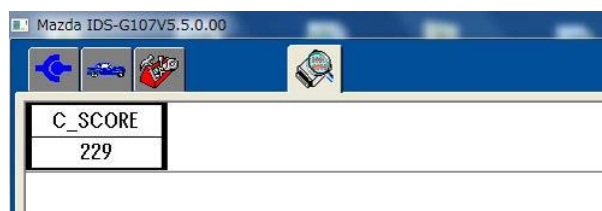
"C\_SCORE" has to be 174 or higher to perform the FSC reprogramming.

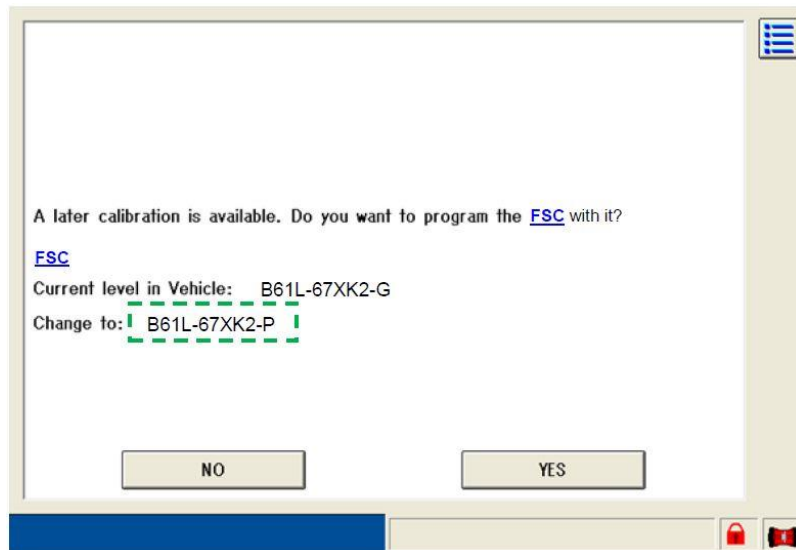
If the message “No later calibration is available on the system for this FSC” is displayed, the FSC is already at the latest calibration. “Current level in Vehicle” will show the new file name.

**NOTE:** The calibration level does not match to the part number level.

7. The following screen will be displayed:

Click “YES” and follow the M-MDS instructions to reprogram the FSC.

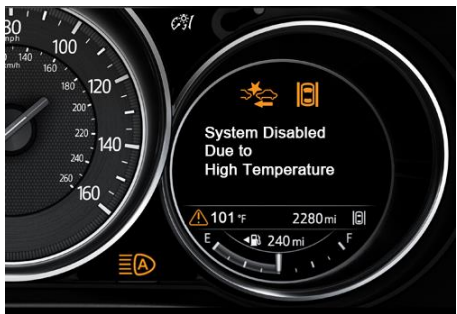
**After FSC Reprogramming:**

The warning lights/messages will be displayed until the FSC cools (No need to turn the ignition OFF).
