| | GROUP<br><b>ENG</b> | MODEL<br><b>2016-2017MY<br/>Optima (JF, JFa),<br/>Sorento (UMa)<br/>2017MY<br/>Sportage (QL)</b> |
| | NUMBER<br><b>175 (Rev 2, 2/2/2018)</b> | DATE<br><b>August 2017</b> |
| <b>TECHNICAL SERVICE BULLETIN</b> | | |
| <b>SUBJECT: SERVICE ACTION: E-CVVT COVER INSPECTION<br/>AND MOTOR PLUG REPLACEMENT (SA305)</b> | | |

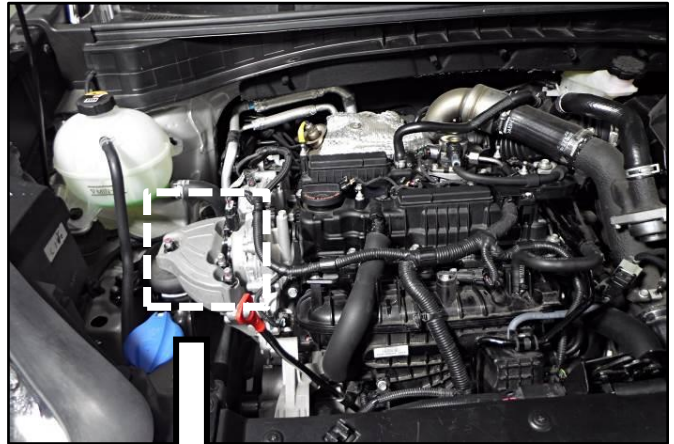
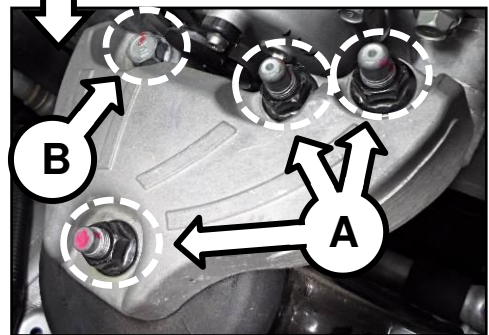
2. Loosen three (3) engine mounting support bracket retaining nuts (A) and one (1) retaining bolt (B).

**Tightening torque:**  
65.1 – 79.6 lb.ft (88.3 – 107.9 N.m)

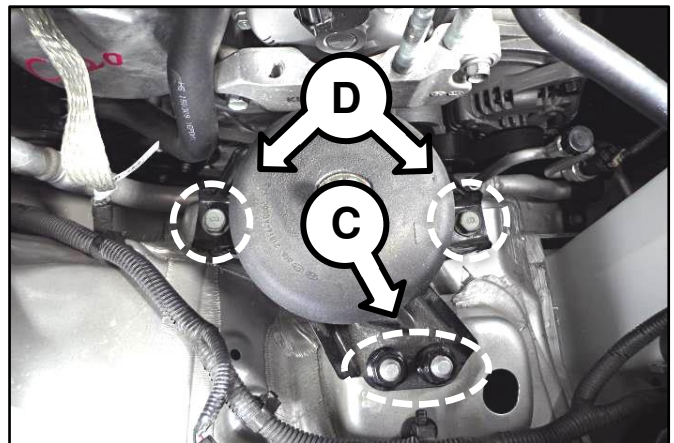
3. Loosen two (2) engine mounting bracket retaining nuts (C) and two (2) retaining bolts (D).

**Tightening torque:**  
47.0 – 61.5 lb.ft (63.7 – 83.3 N.m)

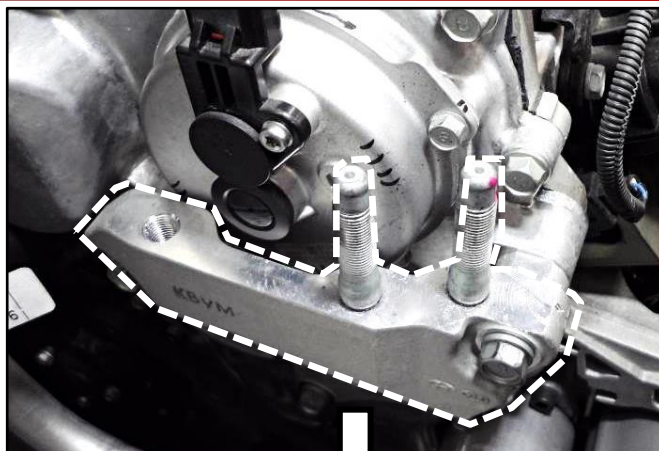
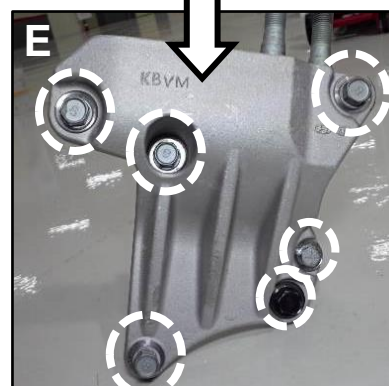
4. Loosen six (6) engine support bracket retaining bolts (E).

(A): 28.9 – 32.5 lb.ft (39.2 – 44.1 N.m)

(B): 14.5 – 18.1 lb.ft (19.6 – 24.5 N.m)

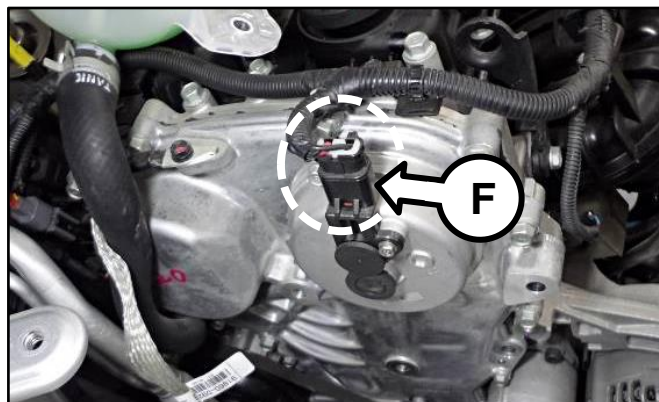
5. Disconnect the E-CVVT cover connector (F).

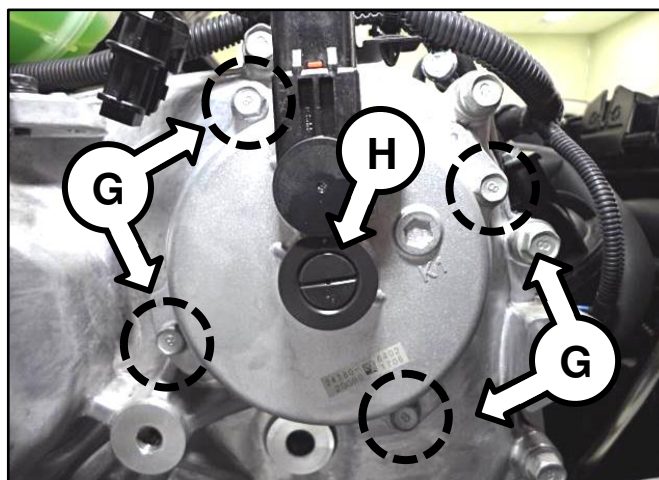
6. Loosen and remove the four (4) E-CVVT cover retaining bolts (G) and then remove the E-CVVT cover. Remove the cover plug (H) using a non-marring trim removal tool (this cover plug will be reused).

7.2 – 8.7 lb.ft (9.8 – 11.8 N.m)

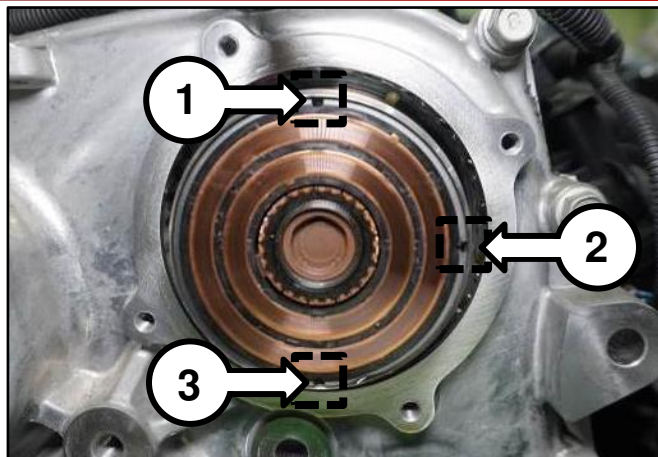
7. Rotate the E-CVVT assembly by hand until the three holes are aligned as shown.

- Hole 1 at the top (12 o'clock)
- Hole 2 at 45 degrees of Hole 1
- Hole 3 at 90 degrees Hole 1

Place a clean shop towel at the bottom of Hole 3. Then using brake cleaner with a straw attachment, insert the straw into Hole 1 and carefully spray for approximately thirty (30) seconds.

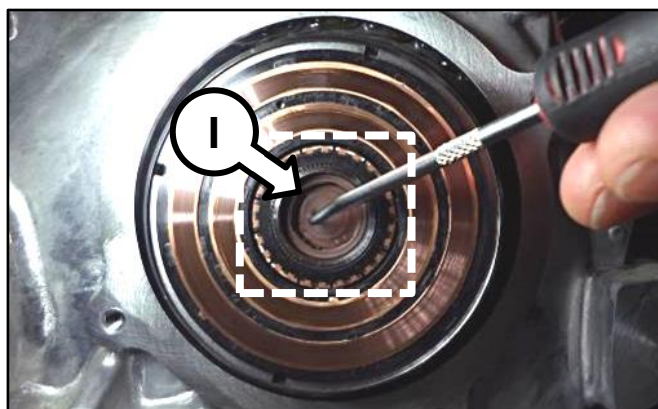
8. Remove the motor plug (I) by carefully breaking the center with a straight pick.

Wipe off any oil leakage when removing the motor plug.  
Cover the motor shaft inlet with a clean shop towel.

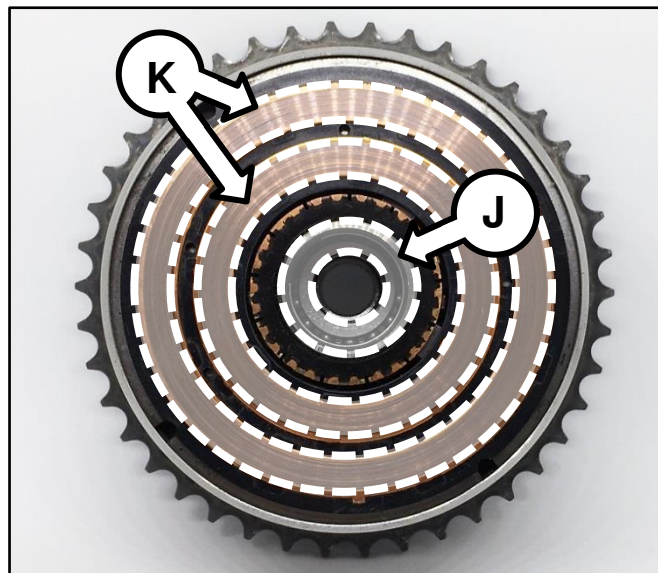
9. Using brake cleaner, spray directly on the motor plug assembly seat (J) inside the motor shaft and clean. Spray brake cleaner on a shop towel to wipe and clean the commutators (K).

Remove any residual oil or fluid in the motor shaft to prevent plug from becoming displaced.

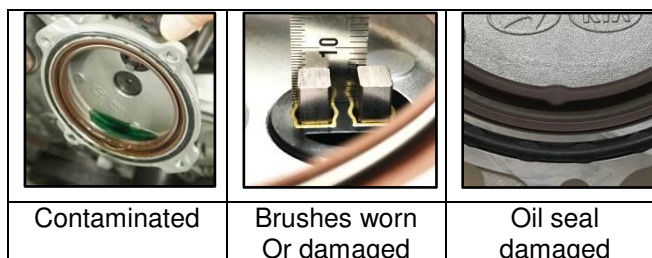
10. Inspect the E-CVVT cover.
- If there is no sign of oil leakage, contamination, and/or damage, replace only the cover O-ring.
  - If there is an oil leak, contamination, and/or damage, replace the cover.

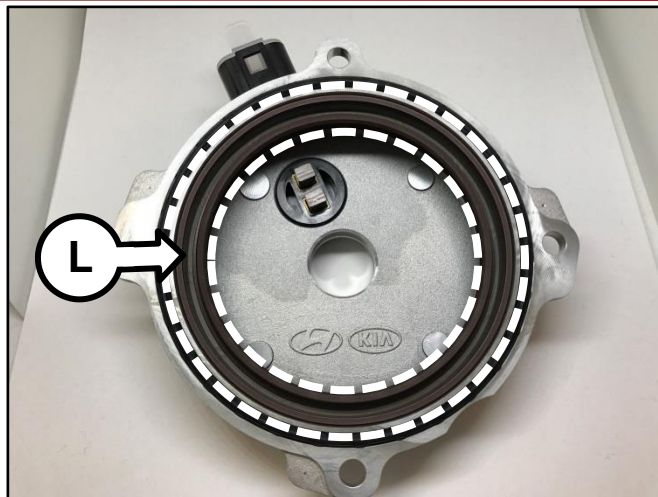
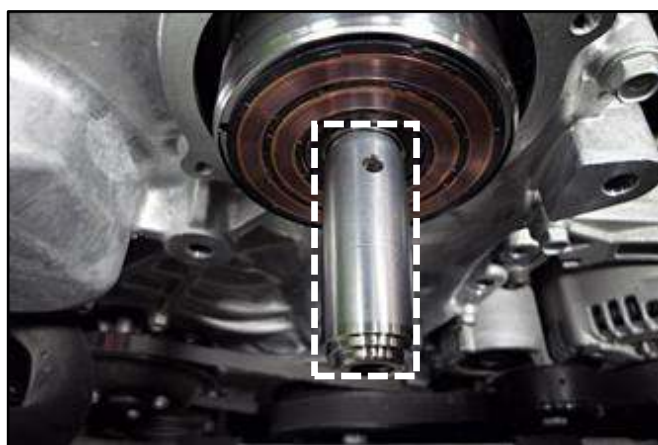
11. Apply oil to the oil seal lip (L) of the E-CVVT cover and install the SST "B" to the E-CVVT motor as shown.

When installing the cover, correctly insert the end of the SST to the motor shaft as shown below. Ensure that the SST hole faces towards the motor shaft.

Use caution not to fold the oil seal when installing the cover.

**SST INSERTED  
INCORRECTLY**

**SST INSERTED  
CORRECTLY**

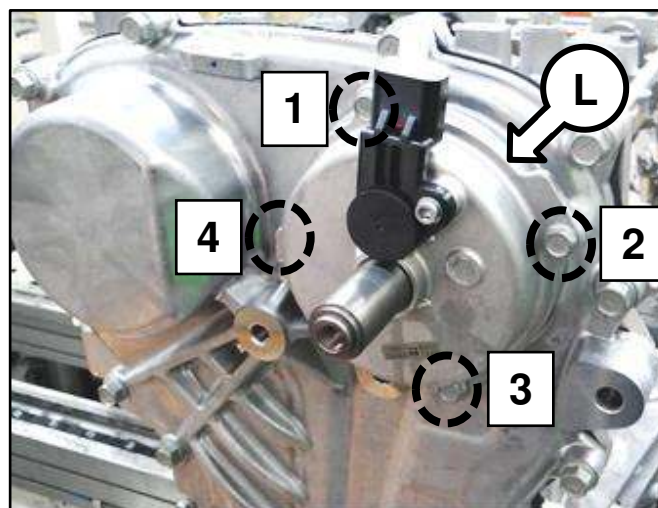
12. Install the E-CVVT cover (L) and perform initial tightening sequence of the E-CVVT cover to the specified torque in the sequence below.

**Tightening torque:**  
8.4 – 16.8 lb.in (1.0 – 2.0 N.m)

Tighten the retaining bolts in this sequence: 1 → 3 → 4 → 2

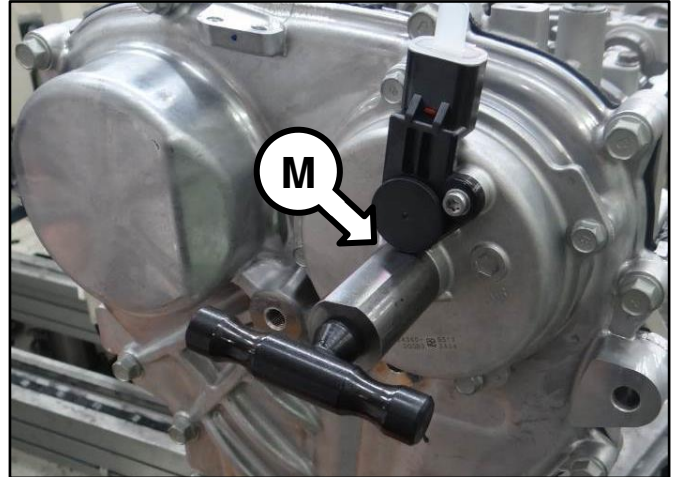
13. Install the new motor plug (M) by using the SST "A" of Required Tools.

Insert the plug onto the SST and then insert the SST into the E-CVVT cover opening.

Do not apply impurities (oil, cleaners) on the motor plug.

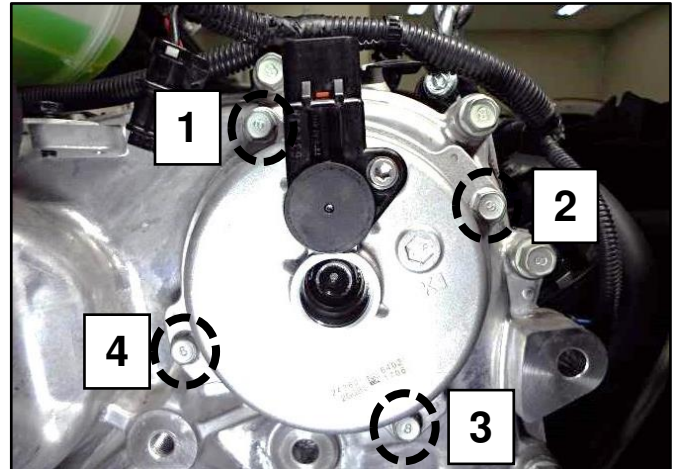
14. Remove the SST and perform final tightening sequence of the E-CVVT cover retaining bolts to the specified torque in the sequence below. Reinstall the cover plug (H) removed in step 6.

7.2 – 8.7 lb.ft (9.8 – 11.8 N.m)

Tighten the retaining bolts in this sequence: 1 → 3 → 4 → 2
