MODEL  
2017MY  
Multiple Models  
2016-2017MY  
Optima (JF)

NUMBER  
072A (Rev 2, 2/12/2018)

## TECHNICAL SERVICE BULLETIN

SUBJECT: SERVICE ACTION: INHIBITOR SWITCH  
REPLACEMENT (SA317A)

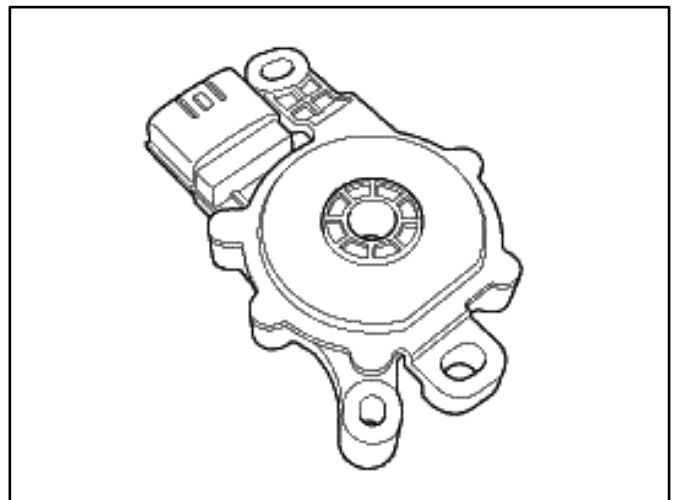
- Malfunction Indicator Lamp (MIL) ON with DTC P0705 - Transmission Range Sensor (TRS) Circuit Malfunction (active or history)
- CAN-related DTCs (For both Hybrids: CAN DTC C2243)
- Intermittent no crank/no start
- Erratic or harsh shifting
- EPB and Hold lights illuminated intermittently
- "Key OFF" indicated after placing the selector lever into the 'P' position and depressing the Start/Stop button

1. Replace the inhibitor switch by referring to the “Automatic Transaxle System → Automatic Transaxle Control System → Inhibitor Switch → Repair procedures” chapter of the applicable Shop Manual on KGIS.
