## Advanced Technical Information

Cayenne (92A)

### Additional Coolant Pump Fault (POC4700) Causes MIL

Vehicle Type: **Cayenne PHEV (92A)**

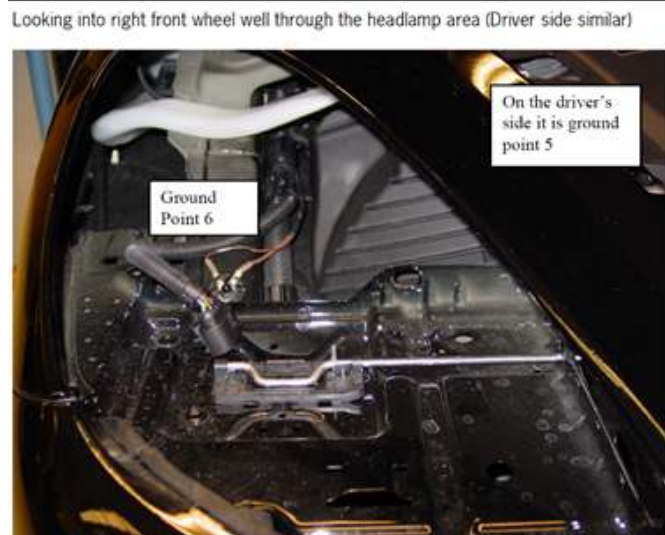
Figure 1 – Ground Pin 6B

- a) Corrosion on Ground Pin 6B (See figures 1 and 2.)
- b) Corrosion on the connector to the secondary low temperature coolant pump.
- c) A bad ground or otherwise unsound wiring.

The service recommendation is to check the ground, connector, and wiring for corrosion and circuit continuity. Repair the ground, connector, or wiring as needed. Sometimes, the ground bolt is painted and not adequately conductive. In this case, clean the ground bolt and eyelet using a wire brush and sandpaper.

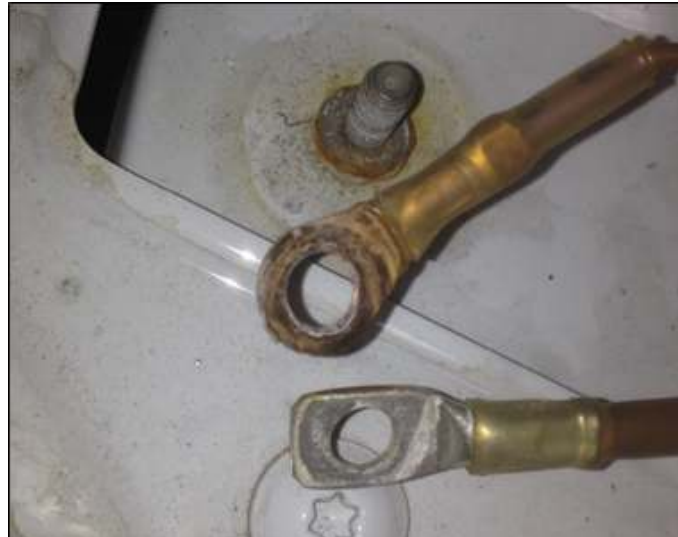
Figure 2 – Example of corrosion on ground point
