## SERVICE BULLETIN

BR18-002

February 14, 2018

### 2017 ARMADA; DTC C1116 AND VDC WARNING LAMP ON

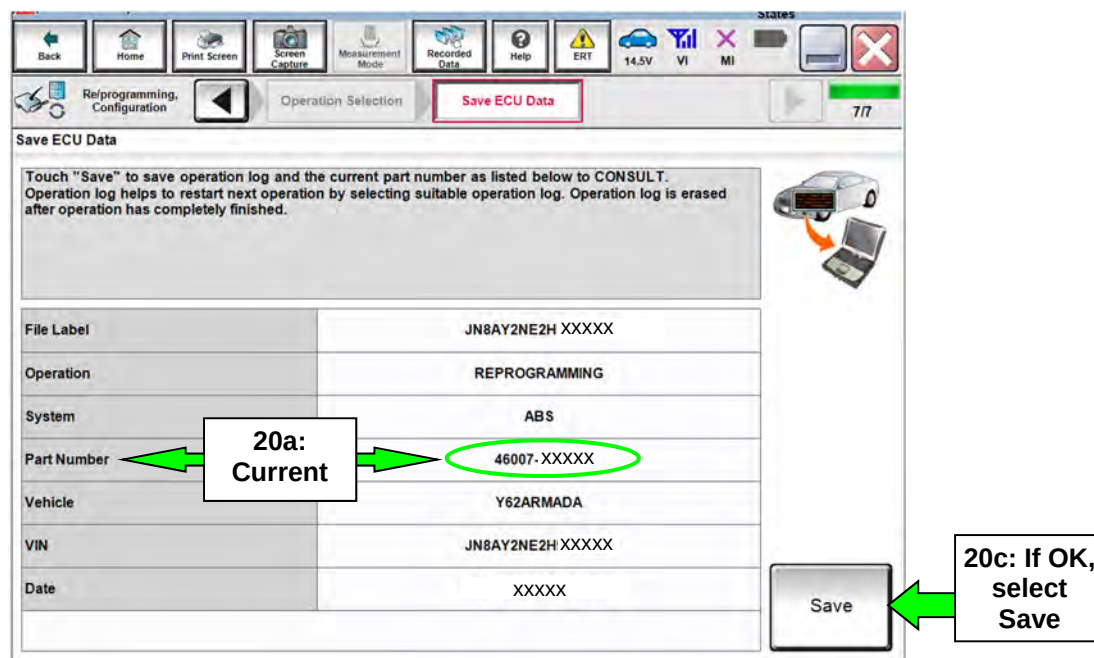
Figure 9

20. When you get to the screen shown in Figure 9, confirm reprogramming applies as follows:

- a. Find the ABS Part Number and write it on the repair order.

**NOTE:** This is the current ABS Control Unit Part Number.

- b. Compare the P/N you wrote down to the numbers in the **Current Part Number** column of **Table A** below:
  - If there is a match, this bulletin applies. Continue with the reprogramming procedure on the next page.
  - If there is not a match, this bulletin does not apply. Close C-III plus and check ASIST for further diagnostic and repair information.
- c. If there is a part number match as specified below, select **Save** and then continue with the reprogramming procedure on the next page.
