# Window Freezing, Losing Initialization

**Service Category** Vehicle Exterior

**Section** Window/Glass

| YEAR(S) | MODEL(S) | ADDITIONAL INFORMATION |
|---|---|---|
| 2013 | FR-S | |

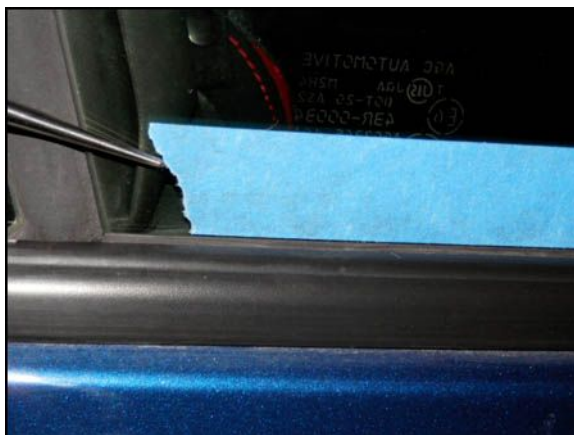
Figure 3. Example of Tape Applied to Front of Outer Door Weatherstrip

- Apply tape horizontally to about 1 inch (15 mm) from the rear edge of the passenger and driver side windows and about 1 inch (15 mm) from the front outer Door Weatherstrip, as shown.
- Apply the tape parallel to the outer Door Weatherstrip as shown in Figures 2 – 6.

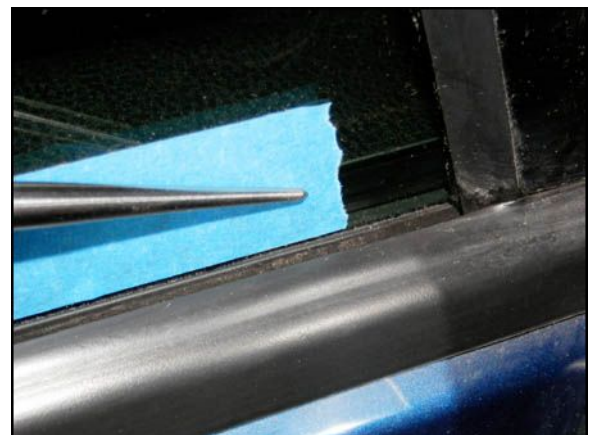
Figure 4. Example of Tape Applied to Rear of Outer Door Weatherstrip

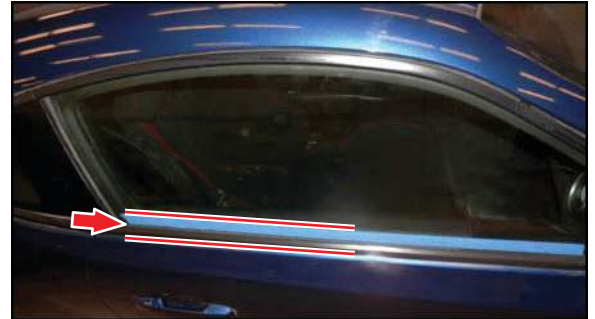
**Figure 5. No Gap Between Tape and Outer Door Weatherstrip**

- There should be no gap between the outer Door Weatherstrip and tape.
- If the window was not properly aligned prior to this repair, the procedure will not be successful.

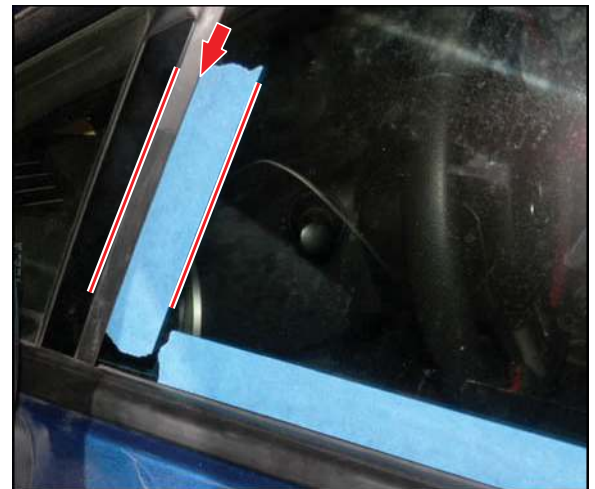
**Figure 6. No Gap Between Tape and Outer Door Weatherstrip**

- D. Apply a strip of 3M™ ScotchBlue™ Painter's Tape (or equivalent) vertically on the glass, parallel and adjacent to the front weatherstrip. There should be no gap between the weatherstrip and tape.

The tape should extend within 2 inches (or closer) to the top and bottom of the glass. This will aid in aligning the window during installation.

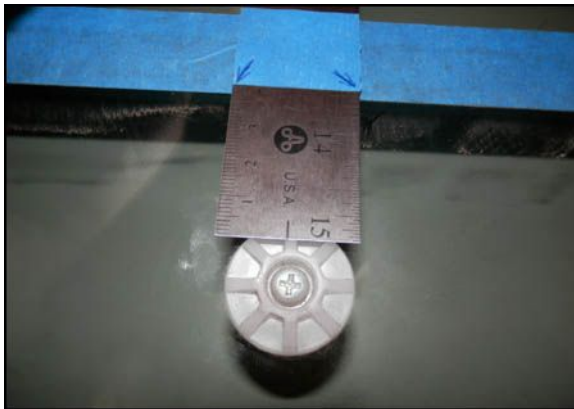
Figure 9. Edge of Ruler Against Flat Side of Glass Lifter

4. Using a ruler as a guide, install the NEW Glass Lifters. Ensure the flat edge at the top of the Glass Lifter is facing the top of the glass and is parallel to the masking tape on the glass as shown below.

- Be sure the flat edge on the Glass Lifter is parallel to the tape applied in earlier steps. If necessary, loosen and realign the Glass Lifter to ensure it is parallel to the tape.
- If new nuts are not available to install the window to the regulator, use Toyota Genuine Adhesive 1344, Three Bond 1344, Loctite® 242, or equivalent, to reinstall the nuts.

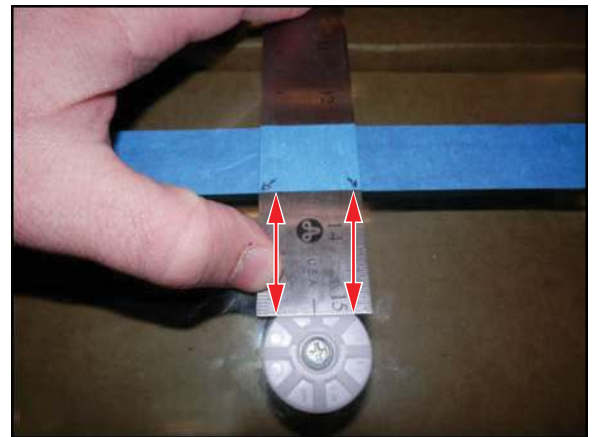
Figure 10. Edge of Ruler Parallel to Tape

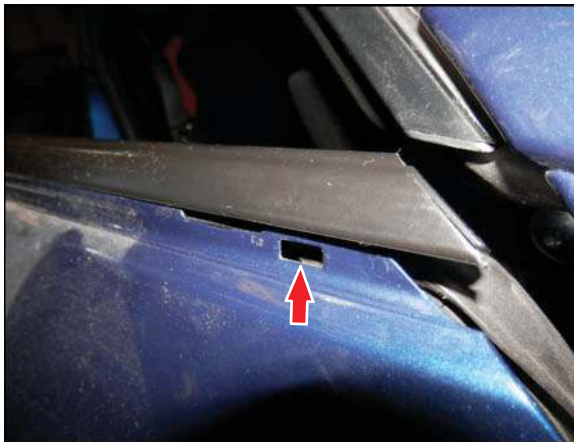
**Figure 11. Hole for Clip in Outer Door Weatherstrip at Front of Door**

1. Ensure the bolt holding the outer Door Weatherstrip is removed.
2. Disengage the clip holding the weatherstrip.
  - A. At the front of the door is a hole where the clip is engaged. Use a plastic pry tool to gently pry out and up on the weatherstrip in this location at the front of the door. This will allow the clip in the weatherstrip to disengage.
  - B. After disengaging the clip, lift up on the outer Door Weatherstrip starting where the bolt is.
