# ABS Brake Noise with DTC C1431

## Applicability

| YEAR(S) | MODEL(S) | ADDITIONAL INFORMATION |
|---|---|---|
| 2012 – 2013 | Camry | |

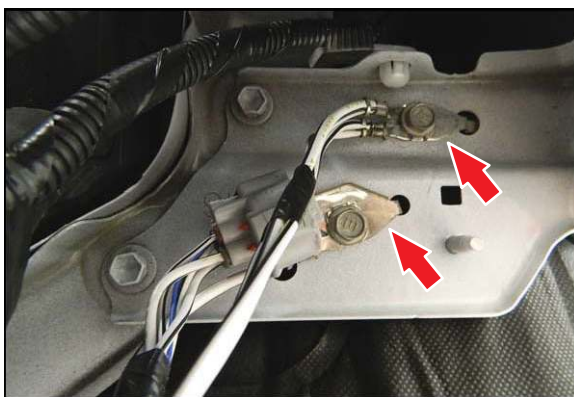
Figure 1.

- [2012](#) / [2013](#) Camry:  
*Brake – Brake Control/ Dynamic Control Systems – “Vehicle Stability Control System: C1430, C1431; Brake Pedal Load Sensing Switch OFF Stuck Malfunction”*
2. If the brake pedal load sensing switch is judged OK, check the resistance at connector A40 Pin 1 to body ground. Is the resistance always below 1 ohm?
    - **YES** – Continue diagnosis using the Repair Manual.
    - **NO** – Proceed to step 3.
  3. With the battery connected, perform voltage drop test from the two left fender bracket ground wire eyelet tabs to body ground (see Figure 1).

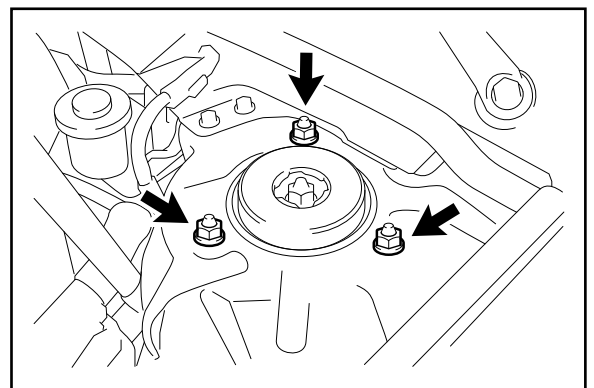
Figure 2.

- A. Use a left front strut tower mounting bolt as a good body ground (see Figure 2).

- B. To perform voltage drop test, connect the negative lead of the DVOM to the strut tower bolt, and the positive lead to the ground wire eyelet tab.

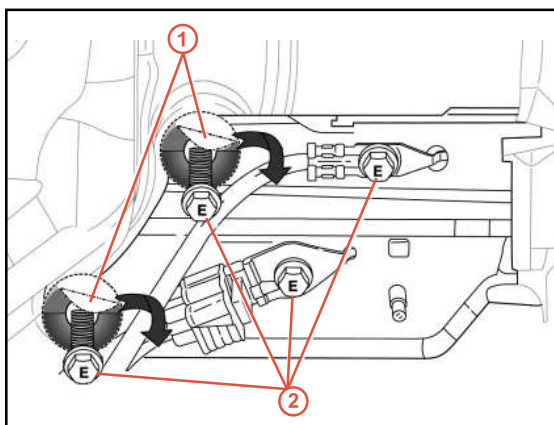
Figure 3.

4. Is voltage drop from each ground location less than 0.2 volts?
  - **YES** – Continue diagnosis using the applicable Repair Manual.
  - **NO** – A voltage drop of 0.2 volts or more from either of the ground locations may indicate poor continuity in the ground circuit. Proceed to step 5.
5. With the battery disconnected, remove the left hand fender bracket from the apron for inspection.
6. Inspect the grounds on the left hand fender bracket. Confirm the following:
  - Ground bolts are “E” bolts (see Figures 3 and 5).
  - Apron bolts should be “E” bolts if left hand fender bracket has been replaced (see Figures 3 and 5).
  - The area around the bracket to apron mounting bolt holes (see Figure 4) is free of paint.
  - The area around the apron mounting bolt holes do not show masking tape or painted masking tape (see Figures 3 and 4).

| 1 | Confirm Green Masking Tape Is Removed |
| 2 | Confirm “E” Bolts Are Installed |

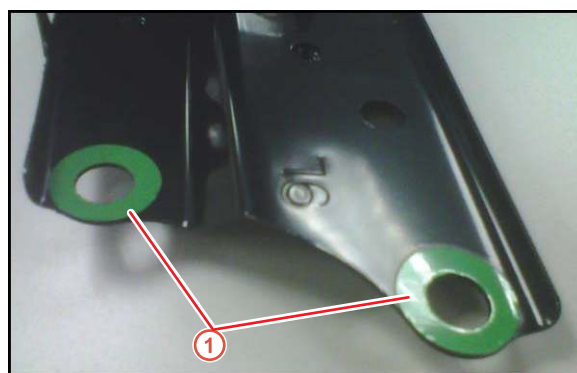
Figure 4.

| 1 | Masking Tape — REMOVE After Painting, NO Paint in This Area |

- **NO** — Replace the left hand fender bracket.
- **YES** — Remove the tape or paint and continue to step 8.

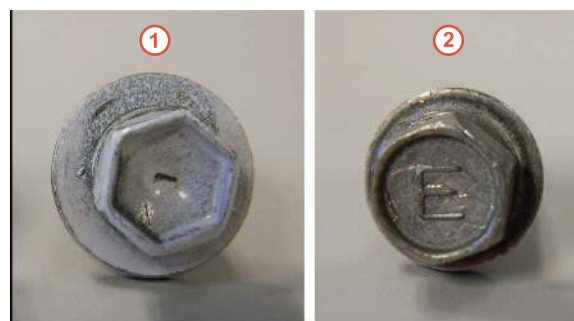
Figure 5.

- It is important that the bracket to apron mounting bolts/washers are free of paint on the front portion of the bracket.
- The new part number bracket comes with instructions that should be followed carefully when replacing.
- The new bracket also comes with green tape around the apron mounting bolts to protect it during the painting phase (see Figures 3 and 4). This green masking tape MUST be removed in order for the bracket to be properly installed on the vehicle.
- The new bracket includes new apron "E" mounting bolts. It is important that the new "E" bolts are used and are torqued properly. See Figure 5 on how to identify new bolts.

| 1 | Old Bolt: DO NOT USE or Reuse These Bolts |
| 2 | NEW "E" Bolt |

Torque: Ground Bolts:  
6.9 – 9.8 N\*m (70 – 100 kgf\*cm,  
5.1 – 7.2 ft\*lb)

Torque: Bracket to Apron Bolts:  
3.9 – 8.8 N\*m (40 – 90 kgf\*cm,  
2.8 – 6.5 ft\*lb)
