# Air Injection System MIL "ON"

## Air Injection System MIL "ON"

Some 2005 – 2009 model year 4Runner, 2006 – 2007 model year Land Cruiser, 2005 – 2007 model year Sequoia, and 2005 – 2006 model year Tundra vehicles equipped with the 2UZ-FE (4.7 L) engine may exhibit a MIL "ON" condition for the following Diagnostic Trouble Codes (DTCs):

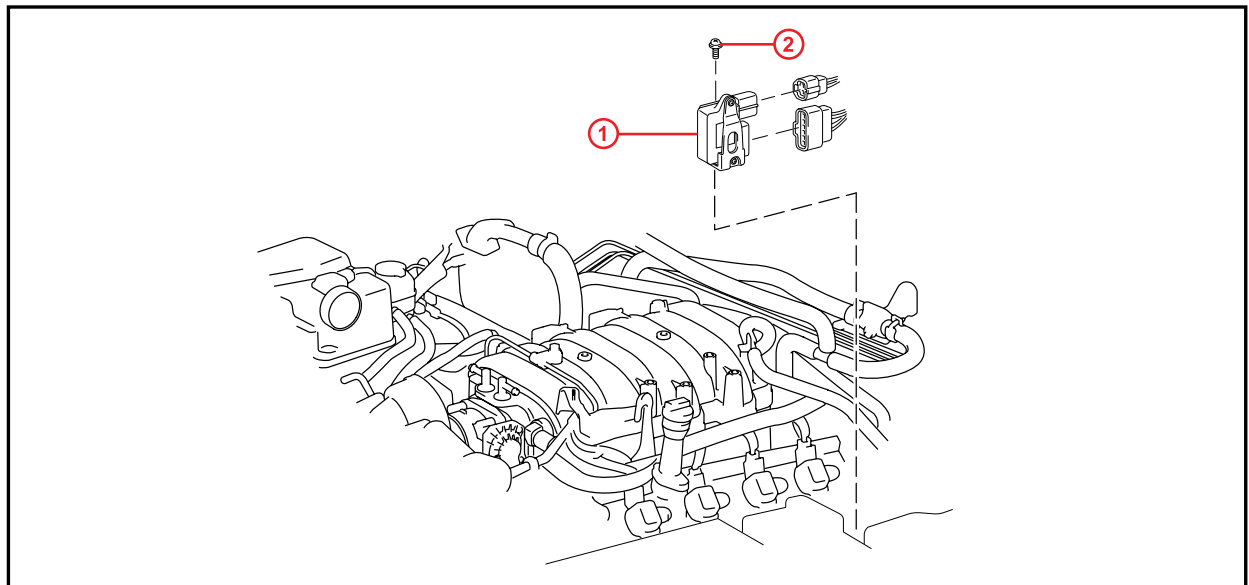
Figure 1.

1 Air Injection Control Driver

- If MIL illuminates, or a DTC is detected, proceed to step 6.
  - If MIL does not illuminate, or a DTC is not detected, proceed to step 8.
6. Using Techstream, check for DTCs. If P0418 and/or P2445 are present, replace the Air Injection Control Driver.

2 Specified Torque: 7.5 N\*m (76 kgf\*cm, 66 in\*lb)
