# Front Exhaust Pipe Catalyst Rattle Noise and/or MIL "ON" DTC P0420

| YEAR(S) | MODEL(S) | ADDITIONAL INFORMATION |
|---|---|---|
| 2010 | Tacoma | VDS(s): NX4CN, NX4GN, PX4EN, TX4CN, TX4GN, UX4EN |

Some 2010 model year Tacoma vehicles equipped with the 2TR-FE engine may exhibit a front exhaust pipe catalyst rattle noise and/or MIL "ON" condition with DTC P0420 (Catalyst System Efficiency Below Threshold) stored in the Engine Control Module (ECM) (SAE Term: Powertrain Control Module/PCM). Refer to the repair procedure to address this condition.

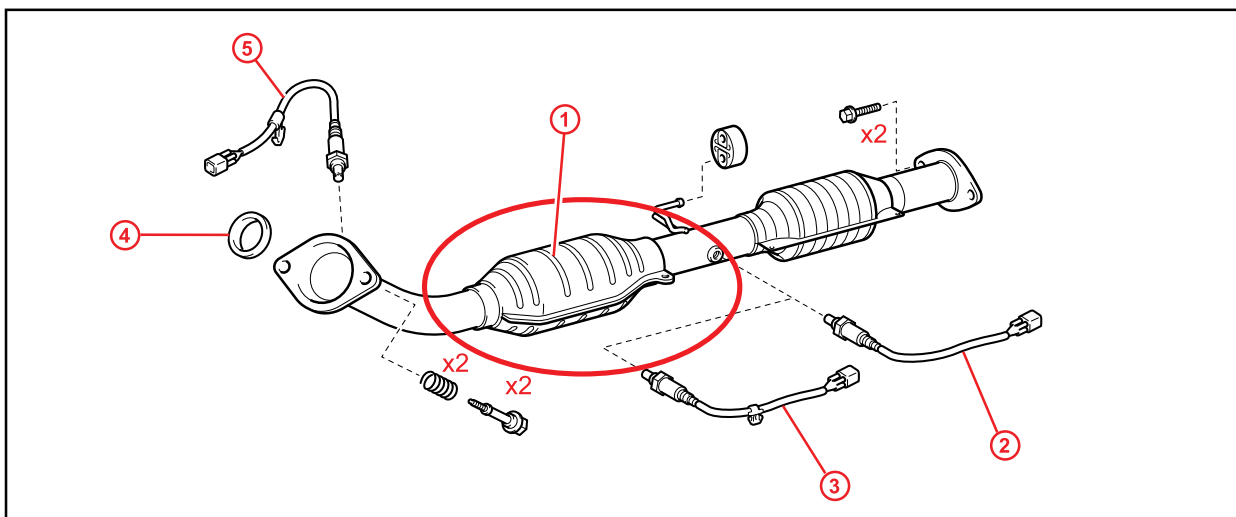
Figure 1. 2TR-FE Front Exhaust Pipe Components

3. Increase the engine speed and listen to the catalytic converter section on the front exhaust pipe assembly for a rattle noise.

4. Did the noise appear to be the loudest at the catalytic converter section of the front exhaust pipe assembly?
  - **YES** — Continue to step 5.
  - **NO** — This bulletin does NOT apply. Continue diagnosis using the applicable Repair Manual.
5. Replace the front exhaust pipe assembly.
