# MIL "ON" P023400 - Turbocharger/Supercharger "A" Overboost Condition

| YEAR(S) | MODEL(S) | ADDITIONAL INFORMATION |
|---|---|---|
| 2015 - 2016 | NX200T | |

Some 2015 – 2016 model year NX 200t vehicles equipped with 8AR-FTS engines may exhibit a MIL "ON" condition Diagnostic Trouble Code (DTC) P023400 (Turbocharger/Supercharger "A" Overboost Condition). The Engine Control Module/ECM (SAE Term: Powertrain Control Module/PCM) logic has been modified to reduce the possibility of this condition occurring. Follow the Repair Procedure in this bulletin to address this condition.

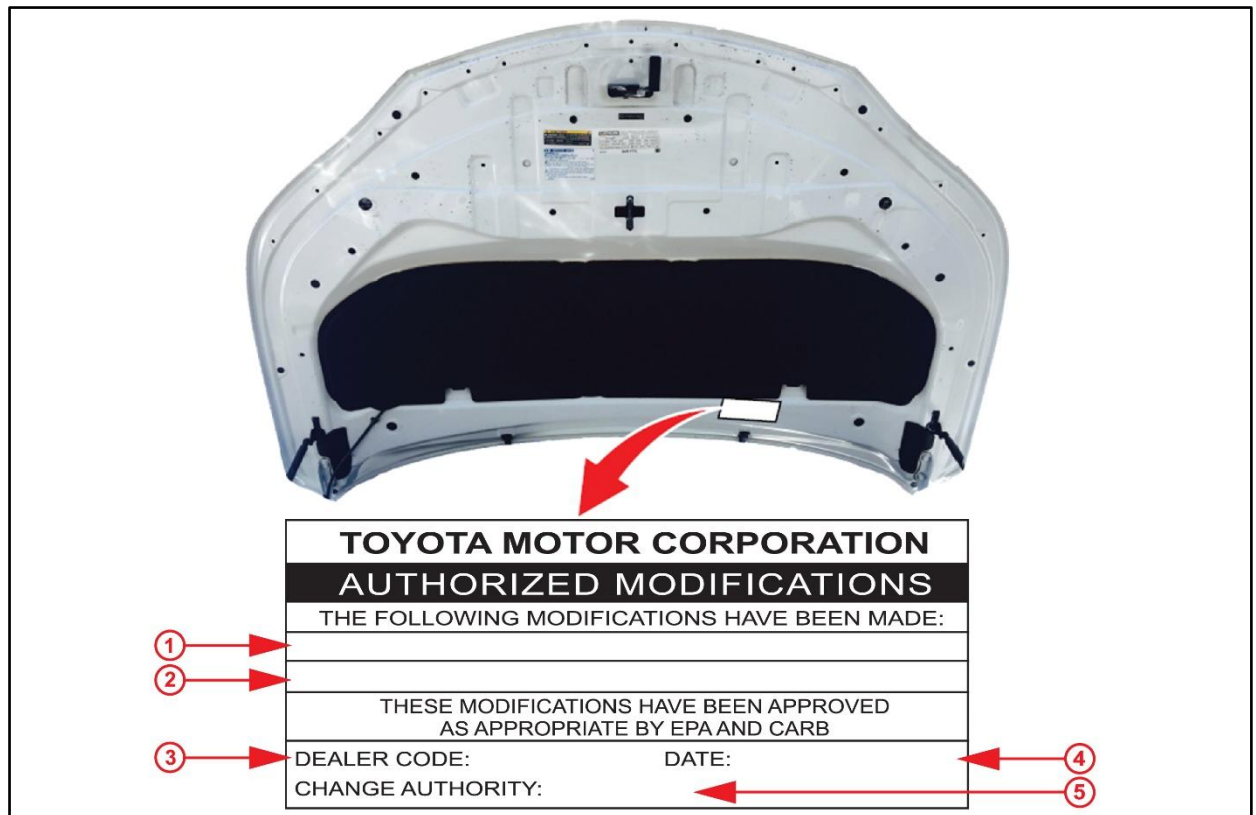
**Figure 1. Location of Authorized Modifications Label on 2015 – 2016 NX 200t**

1. Confirm the condition.  
Using Techstream, perform a Health Check. Was DTC P023400 retrieved?
  - **YES** – Go to step 2.
  - **NO** – This bulletin does NOT apply. Continue diagnosis using the applicable Repair Manual.
2. Check for the Authorized Modifications Label affixed to the vehicle in the location shown below. Confirm if the ECM (PCM) calibration has been updated.  
Is the calibration ID listed NOT the latest ECM (PCM) calibration?
  - **YES** – Go to step 3.
  - **NO** – This bulletin does NOT apply. Continue diagnosis using the applicable Repair Manual.

4. Install the Authorized Modifications Label.
  - A. Using a permanent marker, enter the following information on the label:
    - ECM part number [*Refer to the **Parts Information** section for the **NEW PART NUMBER***]
    - Calibration ID(s) [*Refer to the **Calibration Information** section for the **NEW CALIBRATION ID***]
    - Dealer Code
    - Repair Date
    - Change Authority [**This bulletin number**]
  - B. Affix the Authorized Modifications Label to the vehicle at the location shown in Figure 1.  
The Authorized Modifications Label is available through the MDC, P/N 00451-00001-LBL.
5. Test drive the vehicle to confirm the DTC does NOT reset.
