| | GROUP<br><b>ENG</b> | MODEL<br><b>2016-2017MY<br/> Optima (JF, JFa),<br/> Sorento (UMa)<br/> 2017MY<br/> Sportage (QL)</b> |
| | NUMBER<br><b>175 (Rev 3, 03/20/2018)</b> | DATE<br><b>August 2017</b> |
| <b>TECHNICAL SERVICE BULLETIN</b> | | |
| <b>SUBJECT: SERVICE ACTION: E-CVVT COVER INSPECTION<br/> AND MOTOR PLUG REPLACEMENT (SA305)</b> | | |

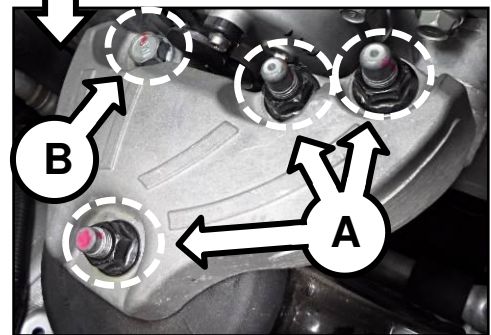
2. Loosen three (3) engine mounting support bracket retaining nuts (A) and one (1) retaining bolt (B).

**Tightening torque:**  
65.1 – 79.6 lb.ft (88.3 – 107.9 N.m)

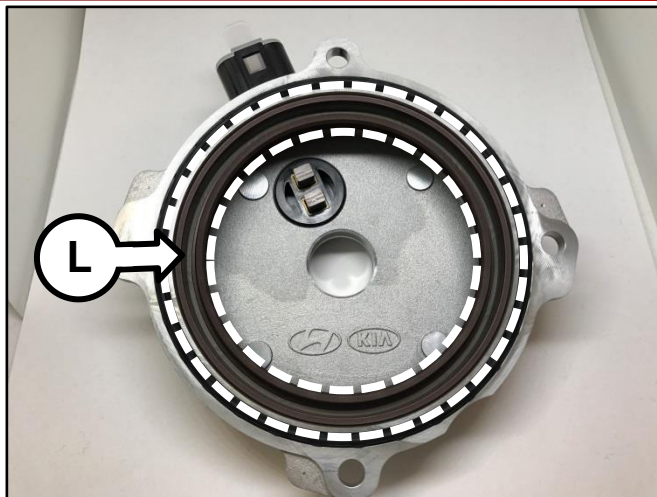
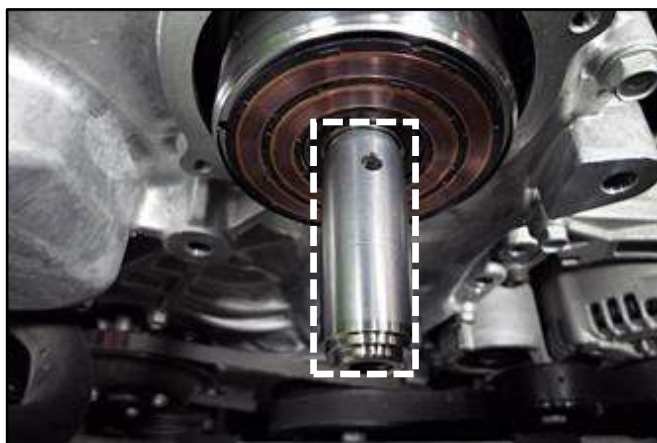
11. Apply oil to the oil seal lip (L) of the E-CVVT cover and install the SST "B" to the E-CVVT motor as shown.

When installing the cover, correctly insert the end of the SST to the motor shaft as shown below. Ensure that the SST hole faces towards the motor shaft.

**SST INSERTED  
INCORRECTLY**

**SST INSERTED  
CORRECTLY**

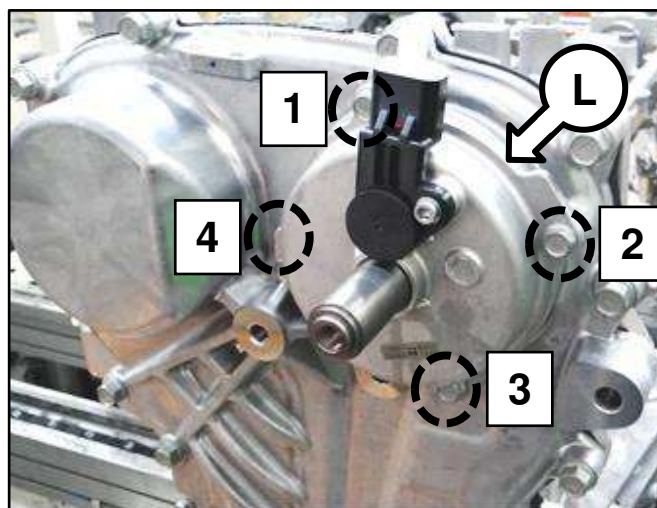
12. Install the E-CVVT cover (L) and perform initial tightening sequence of the E-CVVT cover to the specified torque in the sequence below.

**Tightening torque:**  
8.4 – 16.8 lb.in (1.0 – 2.0 N.m)

Tighten the retaining bolts in this sequence: 1 → 3 → 4 → 2

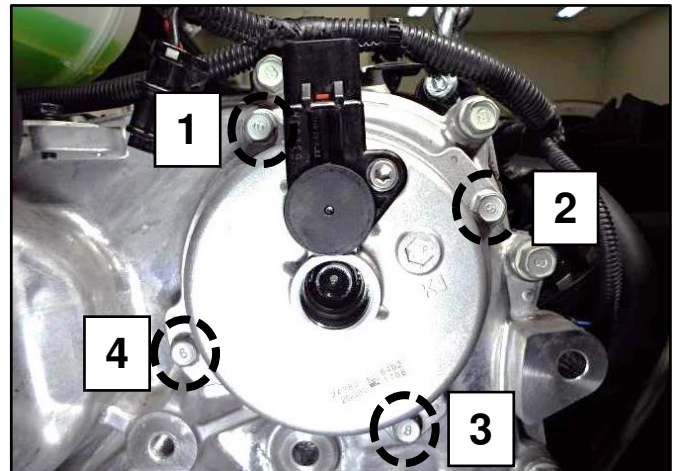
14. Remove the SST and perform final tightening sequence of the E-CVVT cover retaining bolts to the specified torque in the sequence below. Reinstall the cover plug (H) removed in step 6.

7.2 – 8.7 lb.ft (9.8 – 11.8 N.m)

Tighten the retaining bolts in this sequence: 1 → 3 → 4 → 2
