## SERVICE BULLETIN

| EC18-008 | NTB18-026 | March 22, 2018 |

### 2017-2018 PATHFINDER; MIL ON WITH DTC P219F

**APPLIED VEHICLES:** 2017-2018 Pathfinder (R52)

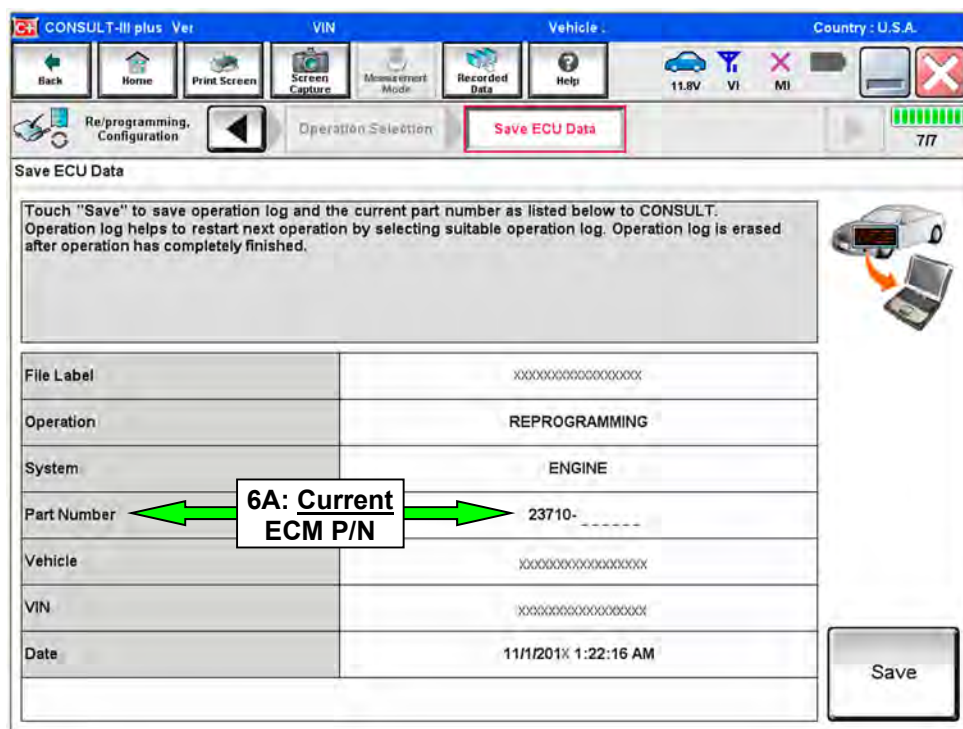
Figure 2

6. When you get to the screen shown in Figure 2, confirm this bulletin applies as follows:

A. Find the ECM **Part Number** and write it on the repair order.

B. Compare the P/N you wrote down to the numbers in the **CURRENT ECM PART NUMBER** column in **Table A** below.

- If there is a match, this bulletin applies. Continue with the reprogramming procedure.
- If there is not a match, this bulletin does not apply. Close C-III plus and refer to ASIST for further diagnostic information.

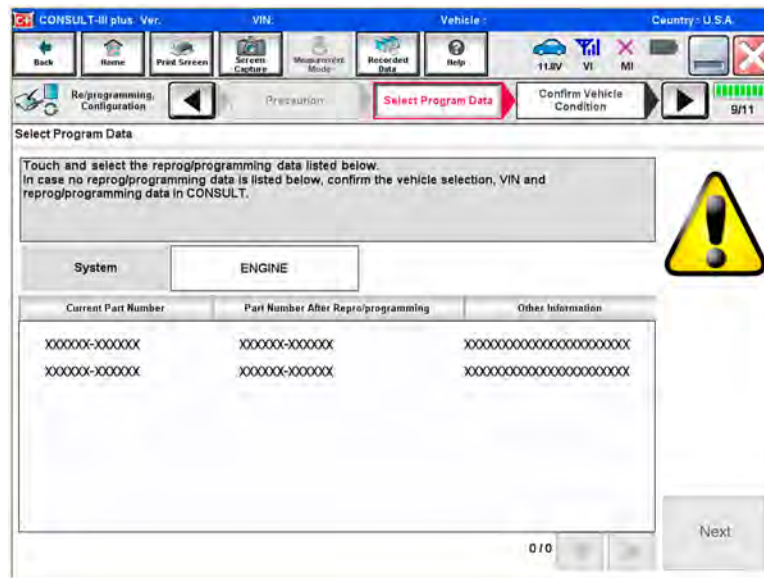
- In some cases, more than one new P/N for reprogramming is available.
  - In this case, the screen in Figure 3 displays.
  - Select and use the reprogramming option that **does not** have the message “Caution! Use ONLY with NTBXX-XXX”.
- If you get this screen and it is blank (no reprogramming listed), it means there is no reprogramming available for this vehicle. Close C-III plus and refer back to ASIST for further diagnosis.

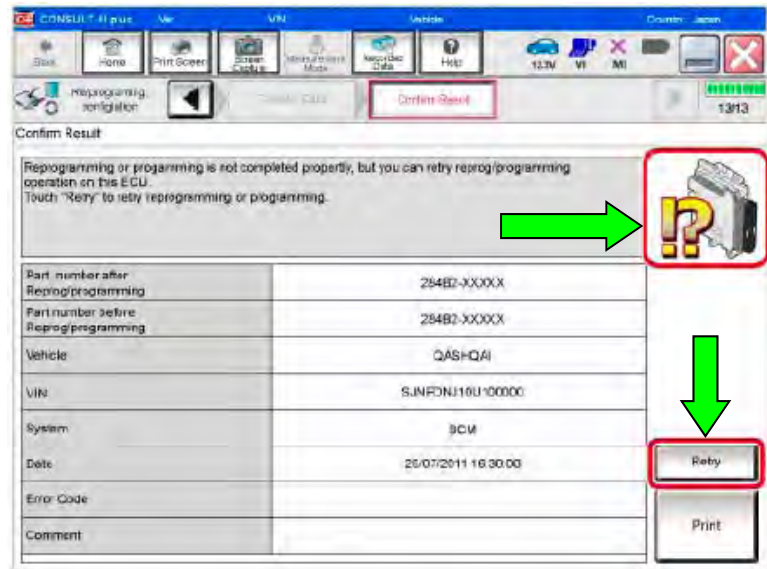
Figure 6

If reprogramming does not complete and the “!?” icon displays as shown in Figure 6:

- Check battery voltage (12.0–15.5 V).
- Ignition is ON, engine OFF.
- External Bluetooth® devices are OFF.
- All electrical loads are OFF.
- **Select retry and follow the on screen instructions.**
- “Retry” may not go through on first attempt and can be selected more than once.

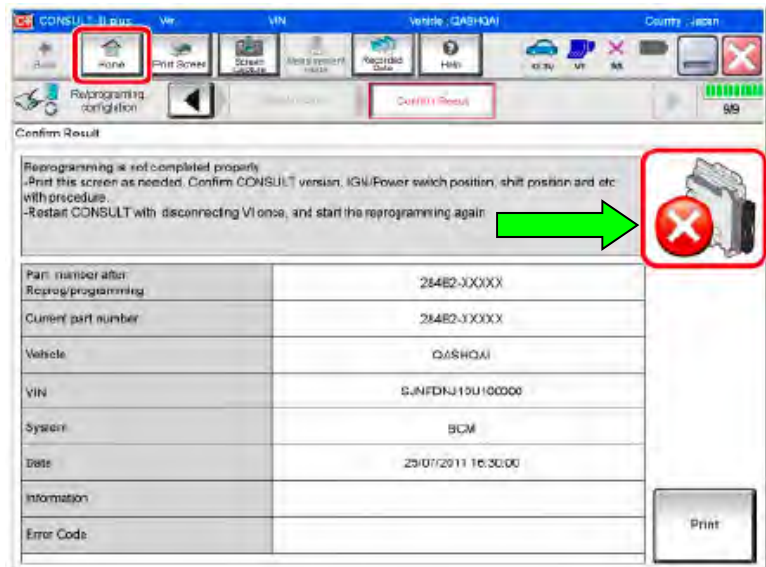
Figure 7

If reprogramming does not complete and the “X” icon displays as shown in Figure 7:

- Check battery voltage (12.0 – 15.5 V).
- CONSULT A/C adapter is plugged in.
- Ignition is ON, engine OFF.
- Transmission is in Park.
- All C-III plus / VI cables are securely connected.
- All C-III plus updates are installed.
- **Select Home, and restart the reprogram procedure from the beginning.**
