# Technical Service Bulletin

## 97 No start (DTC P068A00)

97 18 60 2036764/4 February 1, 2018. Supersedes Technical Service Bulletin Group 97 number 14-43 dated April 14, 2014 for reasons listed below.

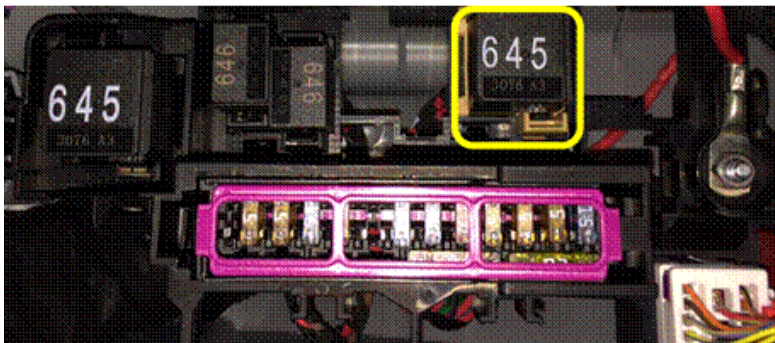
**Figure 6.** J271 relay (outlined).

7. The J271 relay is now accessible (Figure 6).

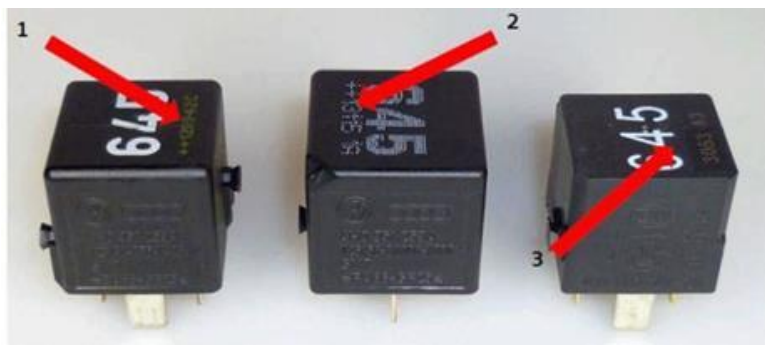
**Figure 7.** Relay manufacture data: Tyco Electronics relay with a yellow label (1), Tyco Electronics relay with a white label (2), Hella relay with a white label (3).

8. Check the relay manufacture build information on the relay. This information is printed under "645" on the relay:
  - If the relay is from Tyco Electronics and has a yellow label (Figure 7, 1), replace the relay and proceed to step 10.
  - If the relay is from Tyco Electronics and has a white label (Figure 7, 2) or from Hella and has a white label (Figure 7, 3), do not replace the relay. Proceed to step 9.

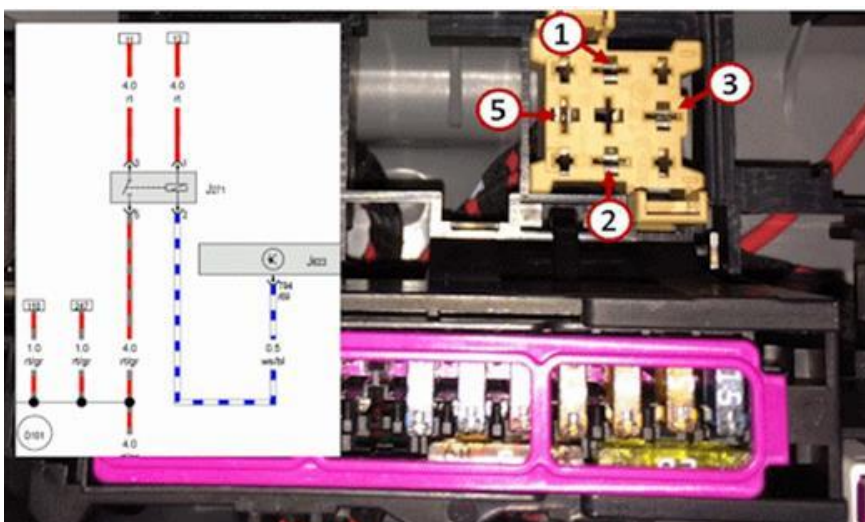
**Figure 8.** J271 relay pins. Terminal 1: 30 power from SA2, Terminal 2: switched ground from J623, Terminal 3: 30 power from SA2, and Terminal 5: switched power from J271.

9. Check the J271 relay according to the instructions in Elsa at: *Engine >> Generic Scan Tool >> ST Generic Scan Tool >> Diagnosis and Testing >> Diagnostic Procedures >> Engine Component Power Supply Relay, Checking.*
10. Check for battery voltage on J271 relay harness terminals 1 (85 power) and 3 (30 power) (Figure 8 and Figure 9).

If no voltage is found, do not proceed with this bulletin. Continue with diagnosis.

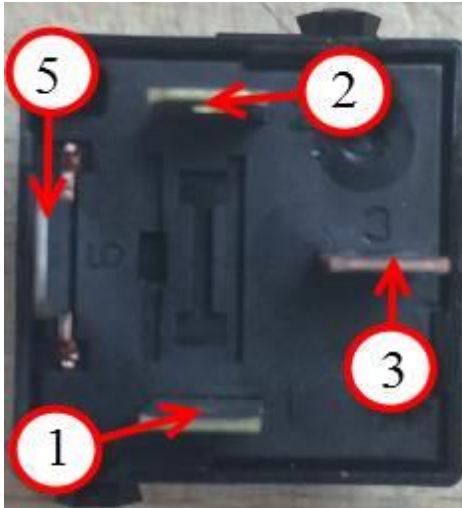
**Figure 9.** Relay terminal locations. Terminal 1: 85 Terminal 2: 86  
Terminal 3: 30 Terminal 5: 87

11. With the ECM disconnected, check the wiring from J271 relay terminal 2 to the ECM:
  - If voltage and wiring are good, replace the J271 relay.
  - If voltage and wiring are not good, do not proceed with this bulletin. Continue with diagnosis.
