# MIL "ON" DTC P2440/P2442

**Service Category** Engine/Hybrid System

**Section** Engine Control

**Market** USA

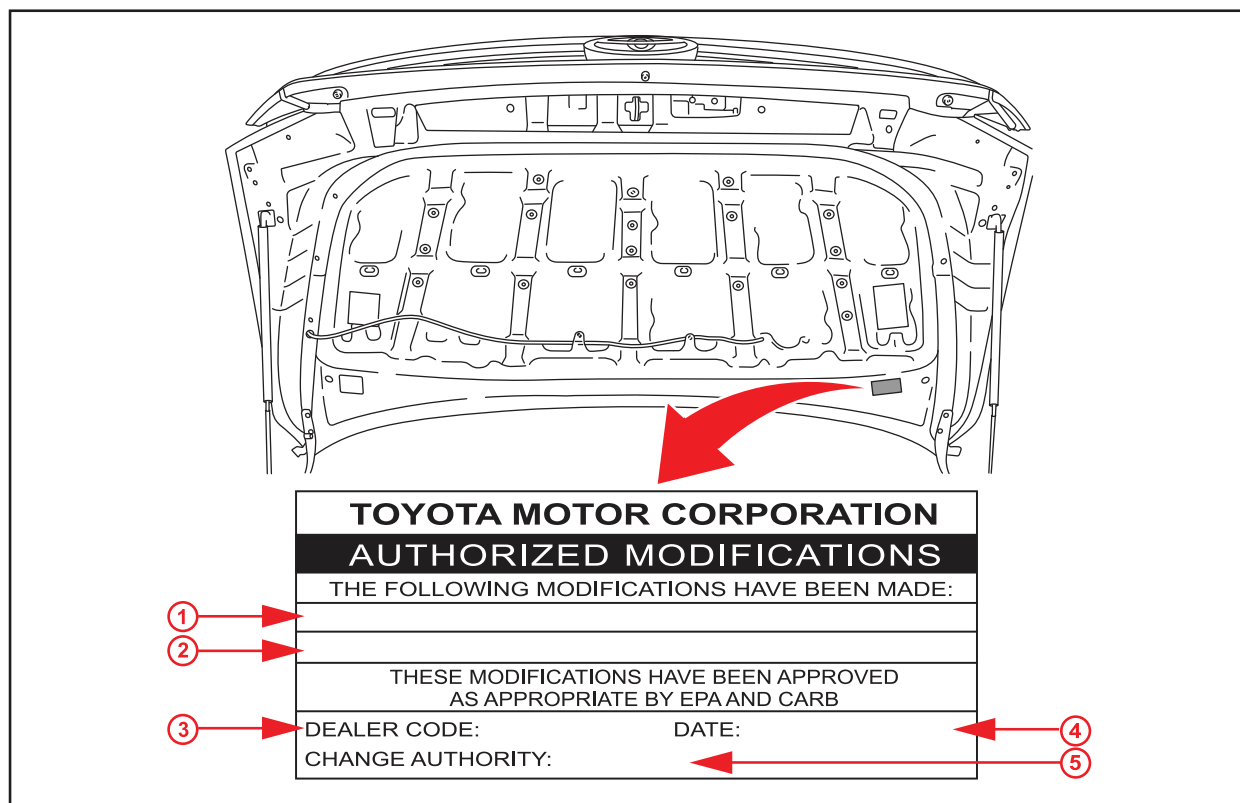
**Figure 1. Location of Authorized Modifications Label on 2012 – 2013 Sequoia and Tundra**

1. Confirm the condition matches the Introduction.
2. Check for the Authorized Modifications Label affixed to the vehicle in the location shown in Figure 1. Confirm if the ECM (PCM) calibration has been updated. If the calibration ID listed is NOT the latest ECM (PCM) calibration — go to step 3.

4. Install the Authorized Modifications Label.

A. Using a permanent marker, enter the following information on the label:

- ECM part number [Refer to the **Parts Information** section for the **CURRENT PART NUMBER**]
- Calibration ID(s) [Refer to the **Calibration Identification Chart** for the **NEW CALIBRATION ID**]
- Dealer Code
- Repair Date
- Change Authority [**This SB number**]

B. Affix the Authorized Modifications Label to the vehicle at the location shown in Figure 1. The Authorized Modifications Label is available through the MDC, P/N 00451-00001-LBL.
