# MIL "ON" DTC P0017 or P0019

**Service Category** Engine/Hybrid System

**Section** Engine Control

| YEAR(S) | MODEL(S) | ADDITIONAL INFORMATION |
|---|---|---|
| 2013 | FR-S | |

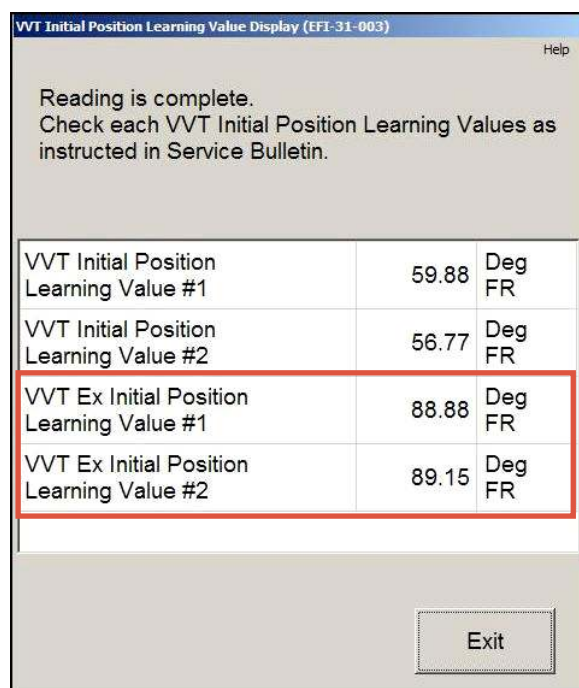
**Figure 1.**

1. Confirm DTC P0017 or P0019 is set.
2. Using the Techstream Utility "VVT Initial Position Learning Value Display", confirm the VVT Ex Initial Position Learning Value #1 and #2 are within the range.

| | RANGE (IN DEGREES) | |
|---|---|---|
| VVT Ex Initial Position Learning Value | 85.0 | 95.0 |

- **YES** — Proceed to step 4 (Reprogram the ECM).
- **NO** — Proceed to step 5 (Replace the ECM).

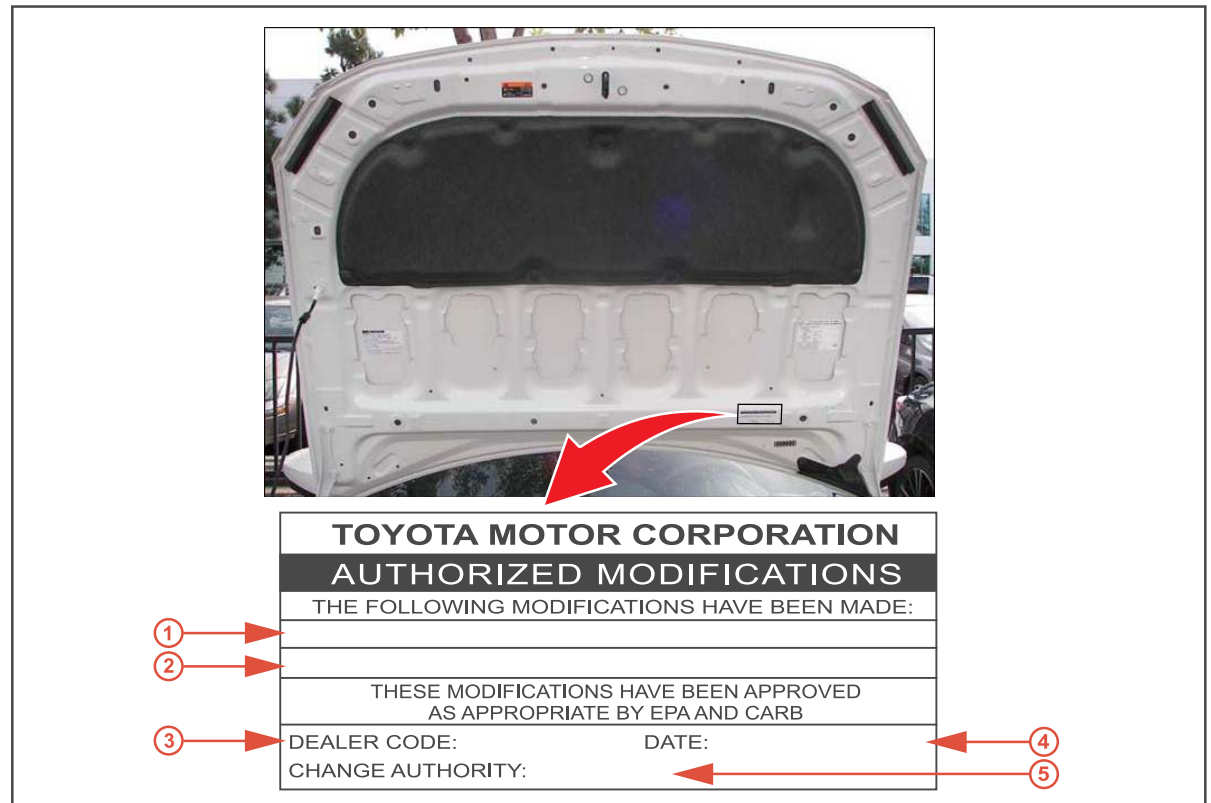
**Figure 2. Location of Authorized Modifications Label on 2013 FR-S**

- A. Check for the Authorized Modifications Label affixed to the vehicle in the location shown in Figure 2. Confirm if the ECM (PCM) calibration has been updated. If the calibration ID listed is NOT the latest ECM (PCM) calibration — go to step 4.B.

##### (2) Affix the Authorized Modifications Label to the vehicle at the location shown in Figure 2. The Authorized Modifications Label is available through the MDC, P/N 00451-00001-LBL.
