# MIL "ON" DTC P1235

**Service Category** Engine/Hybrid System

**Section** Engine Control

## Applicability

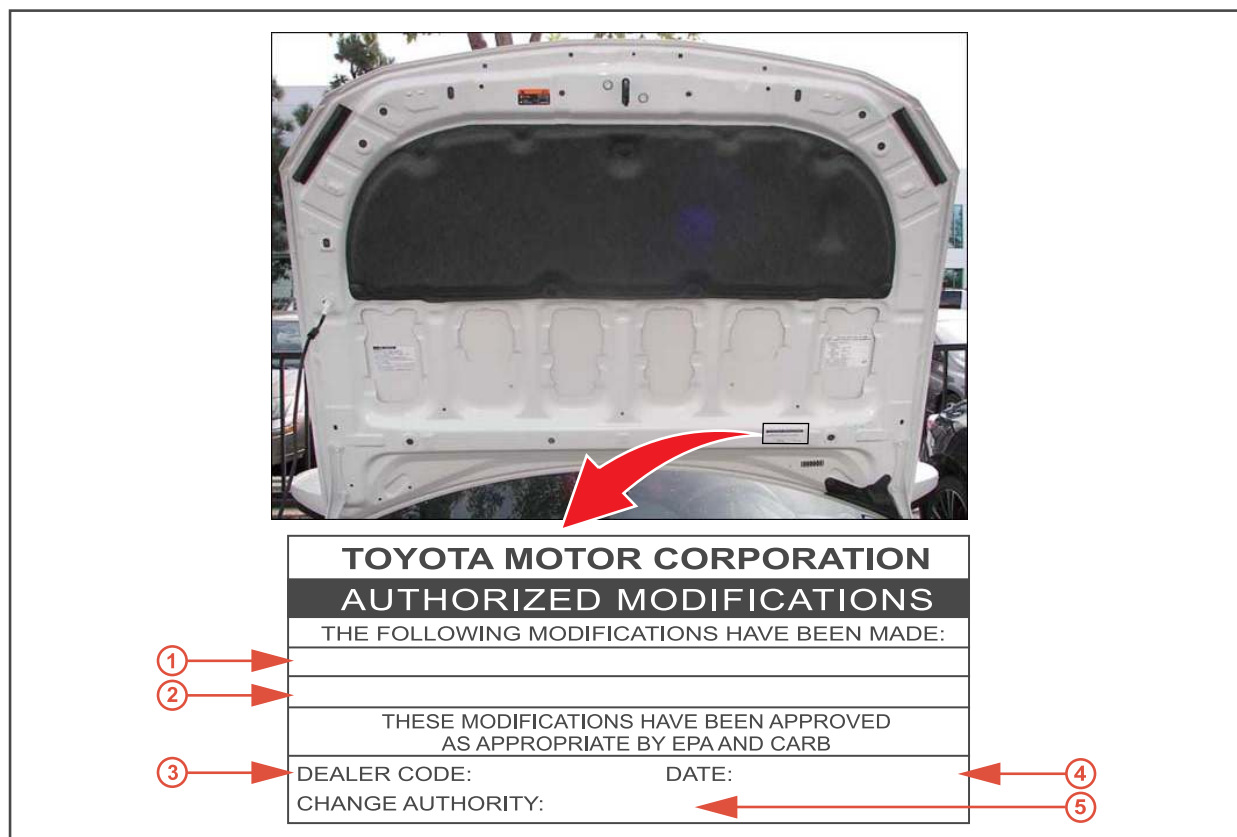
**Figure 1. Location of Authorized Modifications Label on 2013 FR-S**

1. Confirm DTC P1235 is set.
2. Check for the Authorized Modifications Label affixed to the vehicle in the location shown in Figure 1. Confirm if the ECM (PCM) calibration has been updated. If the calibration ID listed is NOT the latest ECM (PCM) calibration — go to step 3.

4. Install the Authorized Modifications Label.
  - A. Using a permanent marker, enter the following information on the label:
    - ECM part number [Refer to the **Parts Information** section for the **CURRENT PART NUMBER**]
    - Calibration ID(s) [Refer to the **Calibration Identification Chart** for the **NEW CALIBRATION ID**]
    - Dealer Code
    - Repair Date
    - Change Authority [**This bulletin number**]
  - B. Affix the Authorized Modifications Label to the vehicle at the location shown in Figure 1. The Authorized Modifications Label is available through the MDC, P/N 00451-00001-LBL.
5. Start the engine and warm it up to normal operating temperature and test drive to confirm proper vehicle operation.
