# MIL "ON" DTC P2610

## Applicability

| YEAR(S) | MODEL(S) | ADDITIONAL INFORMATION |
|---|---|---|
| 2014 - 2015 | IS250 | |

Some 2014 – 2015 model year IS 250 vehicles may exhibit a MIL “ON” condition with Diagnostic Trouble Code (DTC) P2610 present, indicating an ECM/PCM engine OFF Timer Performance condition. The Engine Control Module (ECM) logic has been modified to reduce the possibility of this condition. Please follow the Repair Procedure below to address this condition.

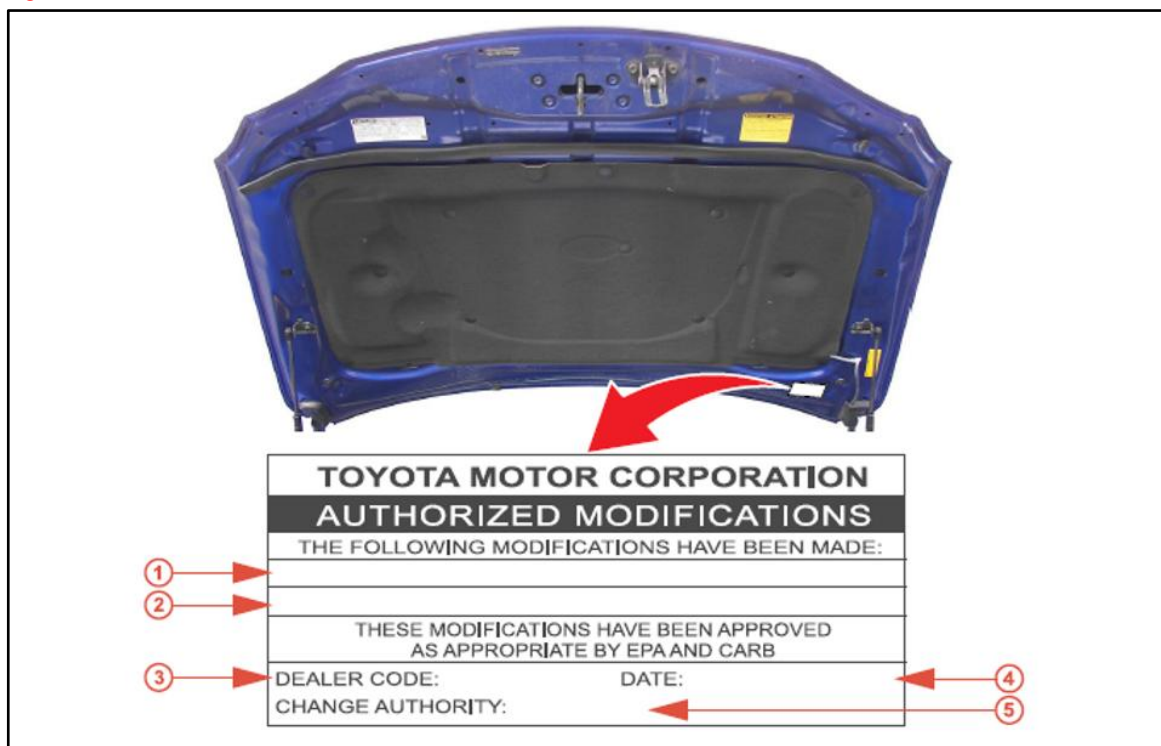
**Figure 1: Location of Authorized Modifications Label on 2014-2015 IS 250**

2. Check for the Authorized Modifications Label affixed to the vehicles in the location shown below. Confirm if the ECM (PCM) calibration has been updated.

4. Install the Authorized Modifications Label.
  - A. Using a permanent marker, enter the following information on the label:
    - ECM part number [Refer to the **Parts Information** section for the **NEW PART NUMBER**]
    - Calibration ID(s) [Refer to the **Calibration Information** section for the **NEW CALIBRATION ID**]
    - Dealer Code
    - Repair Date
    - Change Authority [**This bulletin number**]
5. Affix the Authorized Modifications Label to the vehicle at the location shown in Figure 1. The Authorized Modifications Label is available through the MDC, P/N 00451-00001-LBL.
6. Test drive the vehicle to confirm proper vehicle operation.
