# MIL "ON" DTC P2440/P2442

## Applicability

| YEAR(S) | MODEL(S) | ADDITIONAL INFORMATION |
|---|---|---|
| 2014 - 2016 | GX460 | |

## Introduction

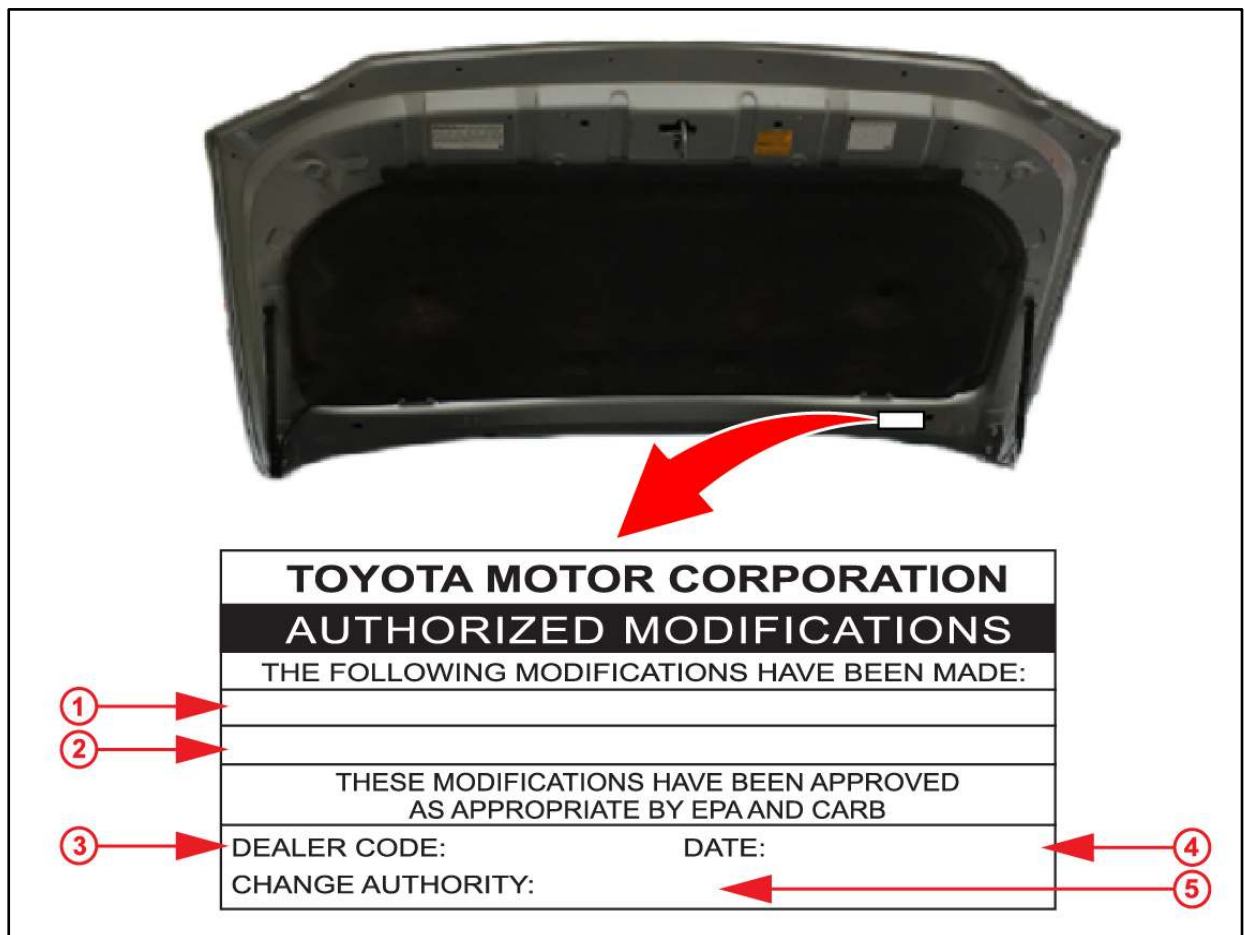
**Figure 1. Location of Authorized Modification Label for 2014 – 2016 GX 460**

2. Check for the Authorized Modification Label affixed to the vehicle in the location shown below. Confirm the ECM (PCM) calibration has been updated.

4. Install the Authorized Modifications Label.
  - A. Using a permanent marker, enter the following information on the label:
    - ECM part number [*Refer to the **Parts Information** section for the **NEW PART NUMBER***]
    - Calibration ID(s) [*Refer to the **Calibration Information** section for the **NEW CALIBRATION ID***]
    - Dealer Code
    - Repair Date
    - Change Authority [**This bulletin number**]
  - B. Affix the Authorized Modifications Label to the vehicle at the location shown in Figure 1. The Authorized Modifications Label is available through the MDC, P/N 00451-00001-LBL.
5. Test drive the vehicle to confirm proper vehicle operation.
