# Technical Service Bulletin

**LED HEADLIGHT WARNING LIGHT FLASHES WITH DTC C0061:54**

**Bulletin No.:** 09-012/18

2018 CX-3 vehicle equipped with LED headlight auto leveling system

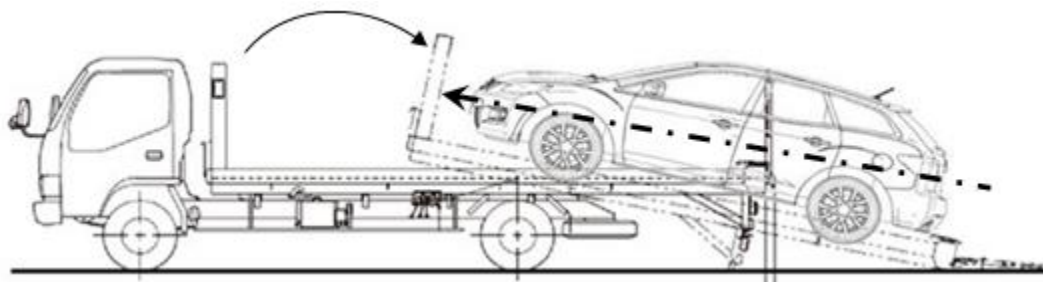
**2. Unloading Vehicle:** After sliding the carrier outward to unload the vehicle from the trailer, the ignition is turned **ON** while the vehicle is inclined.

If **both** of the above conditions (1 and 2) occur, the LED headlight auto leveling system determines that the vehicle angle was changed from level to inclined during the initialization. This interrupts the initialization and causes the LED headlight warning light to flash and DTC C0061:54 to be stored.
