## SERVICE BULLETIN

| EC18-005 | NTB18-020 | March 6, 2018 |

### 2018 FRONTIER; MIL ON WITH DTC P00D2 AND/OR P00D4

**APPLIED VEHICLES:** 2018 Frontier (D40)  
**APPLIED ENGINE:** VQ40DE

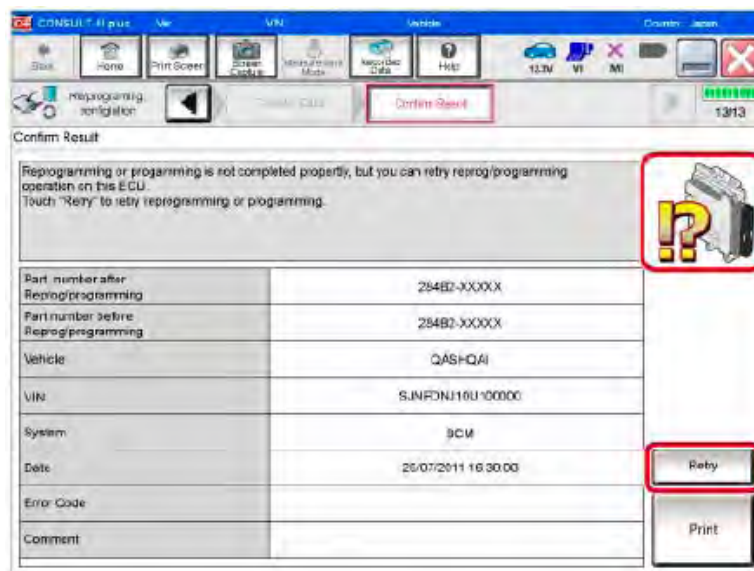
Figure 6

If reprogramming does not complete and the “!” icon displays as shown in Figure 6:

- Check battery voltage (12.0–15.5 V).
- Ignition is ON, engine OFF.
- External Bluetooth® devices are OFF.
- All electrical loads are OFF.
- **Select retry and follow the on screen instructions.**
- “Retry” may not go through on first attempt and can be selected more than once.

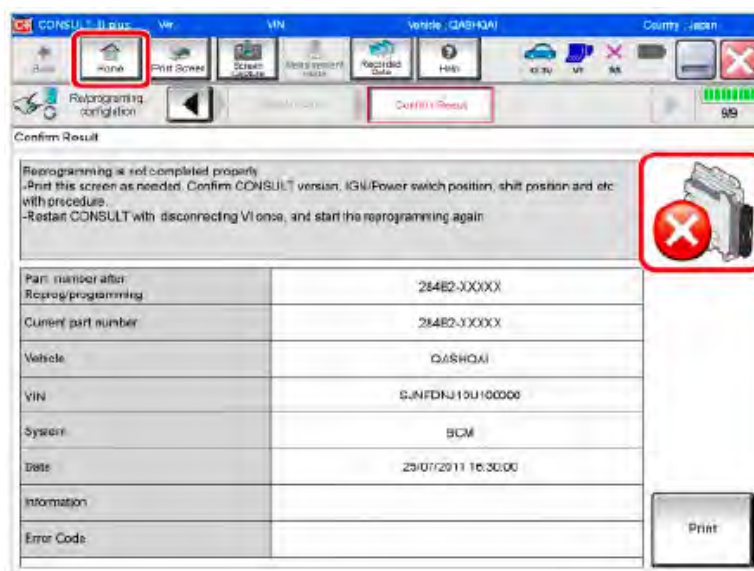
Figure 7

If reprogramming does not complete and the “X” icon displays as shown in Figure 7:

- Check battery voltage (12.0 – 15.5 V).
- CONSULT A/C adapter is plugged in.
- Ignition is ON, engine OFF.
- Transmission is in Park.
- All C-III plus / VI cables are securely connected.
- All C-III plus updates are installed.
- **Select Home, and restart the reprogram procedure from the beginning.**
