## Coolant / Vacuum / Temperature fault codes - Check Engine Light with DTCs P003313, P0299FA, P0299FB, P226100, P261F71, P012800, and P012809

| Topic number | LI07.09-N-063338 |
| Validity | OM651 |

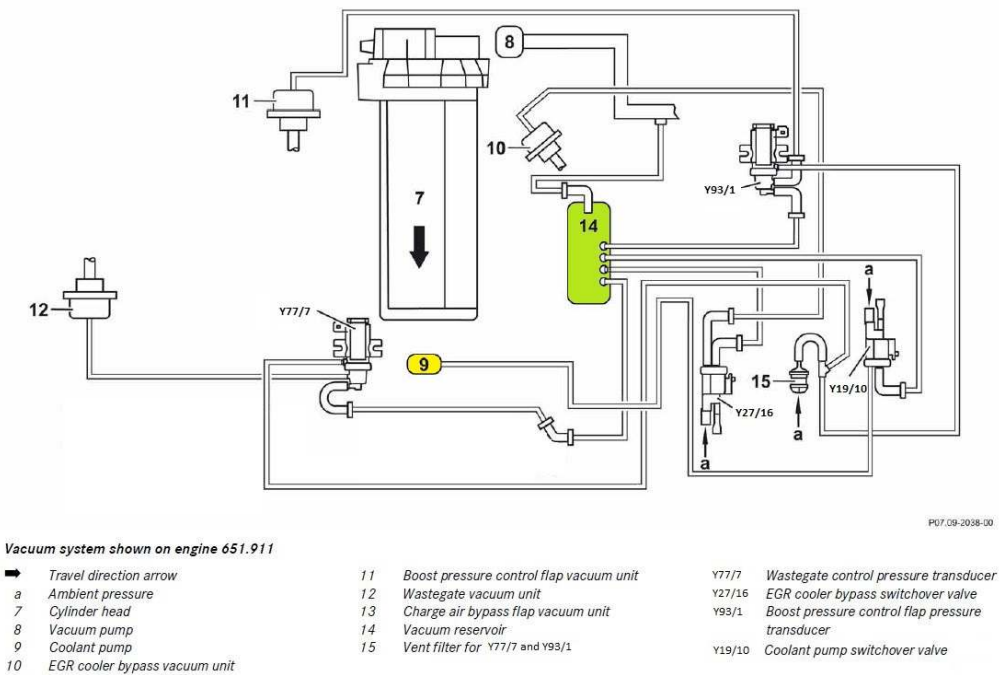
Sprinter OM651 vaccum  
diagram.jpg:

| Attachments | |
|---|---|
| Sprinter OM651 vaccum diagram.jpg | Vacuum diagram |

1- Inspect the vacuum system for loose connections or cracked hoses (See Vacuum Diagram)

-Yellow color -> part #9 --> connection point behind the coolant pump bracket

-Green color --> part #14 --> vacuum reservoir

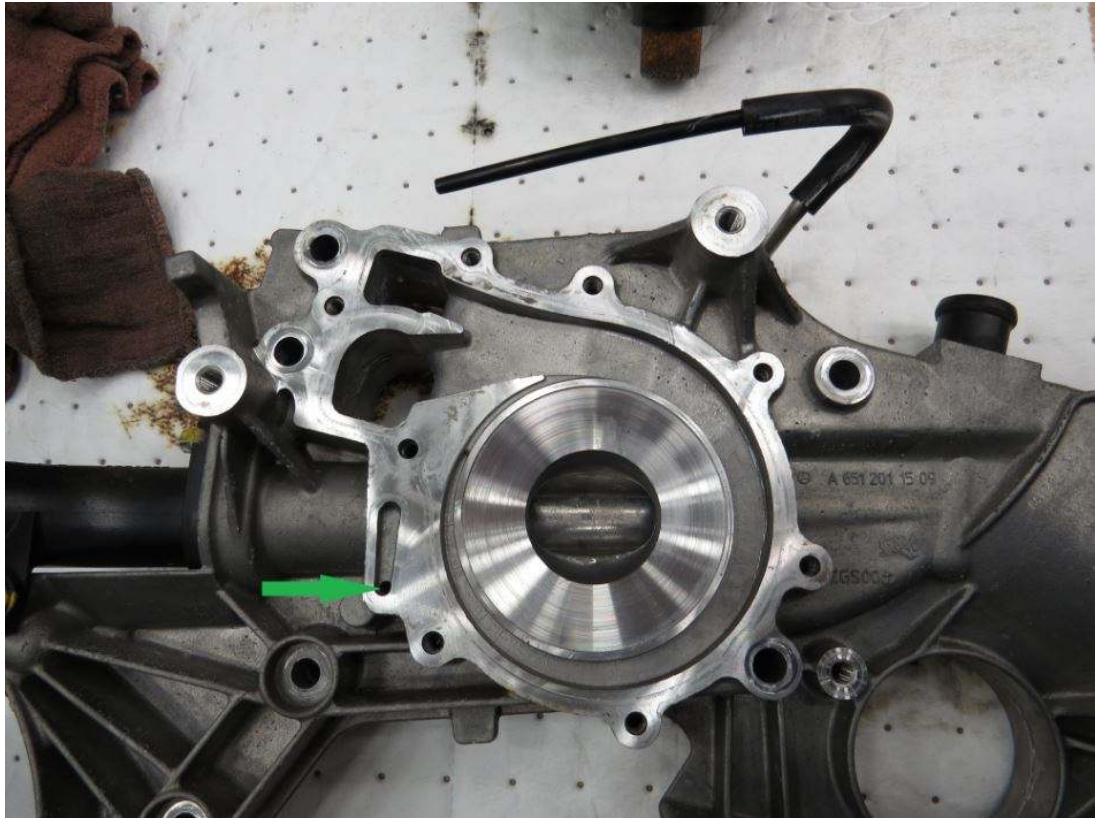
Mounting Plate.JPG:

| Attachments | |
|---|---|
| Mounting Plate.JPG | Mounting plate |

-Water pump mounting plate

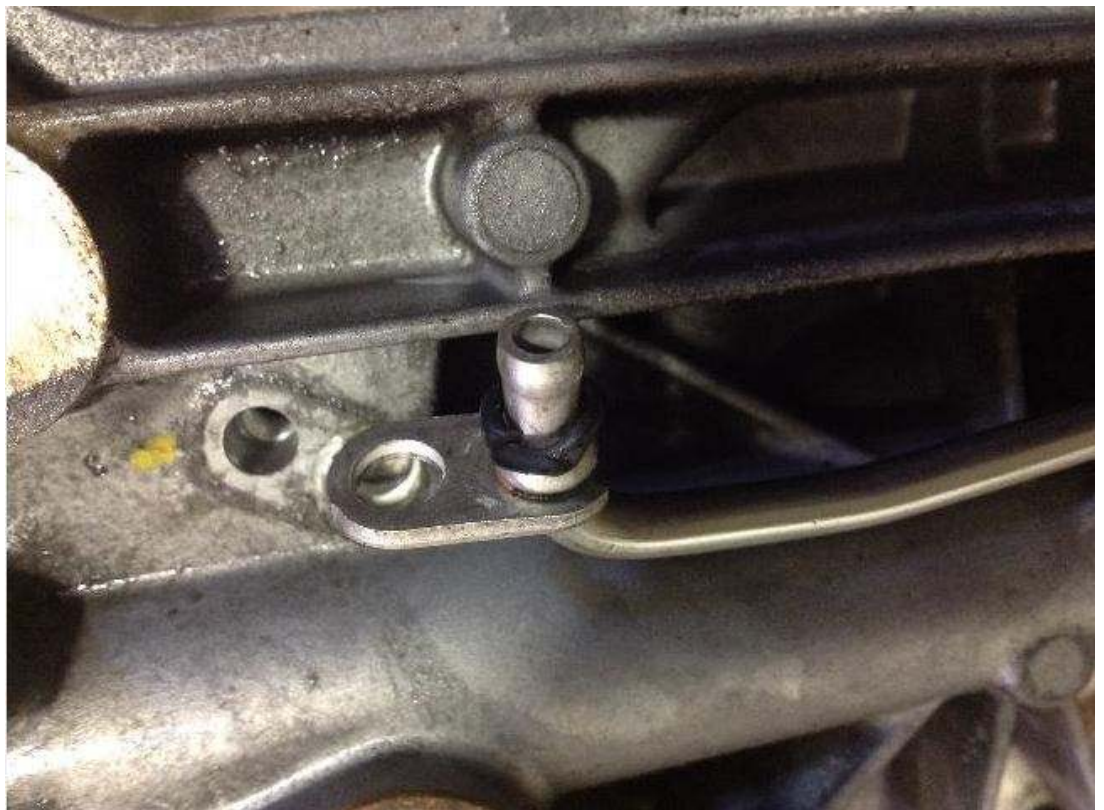
Vacuum connection on mounting plate.JPG:

| Attachments | |
|---|---|
| Vacuum connection on mounting plate.JPG | Vacuum connection on mounting plate |

-Vacuum connection on water pump mounting plate

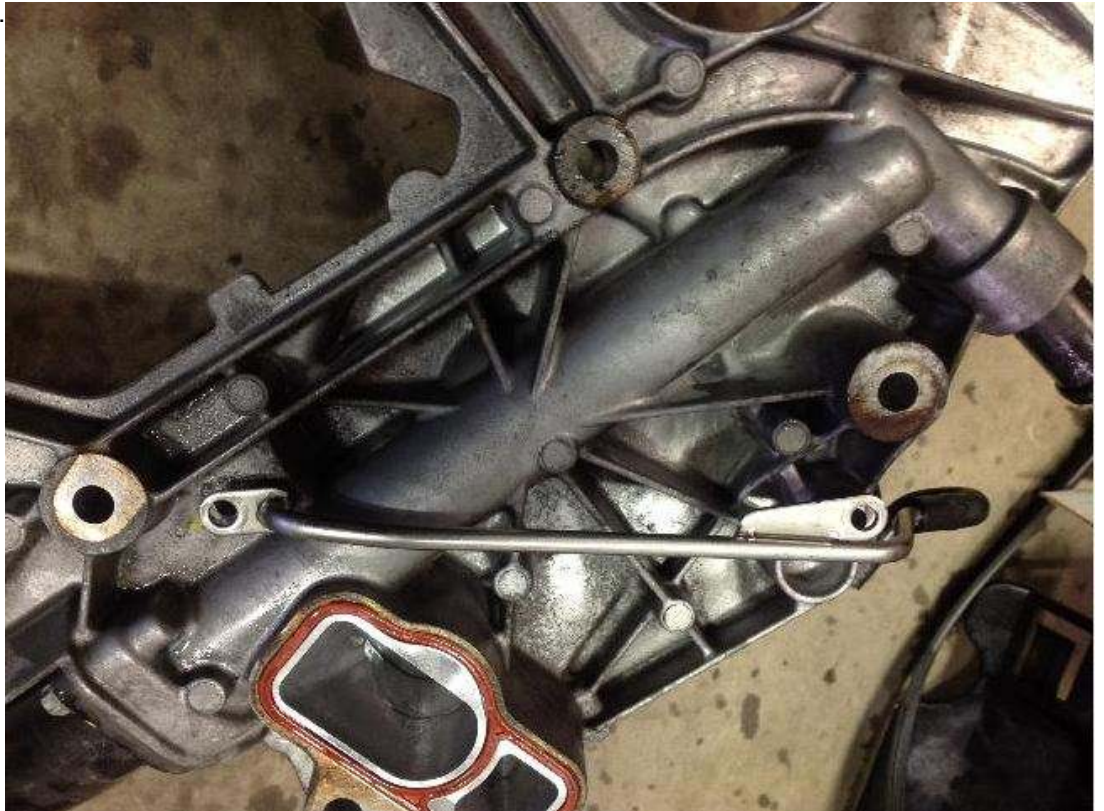
Water pump vacuum line.  
JPG:

| Attachments | |
|---|---|
| Water pump vacuum line.JPG | Water pump vacuum line. Green points to vacuum port |

-Water pump vacuum line

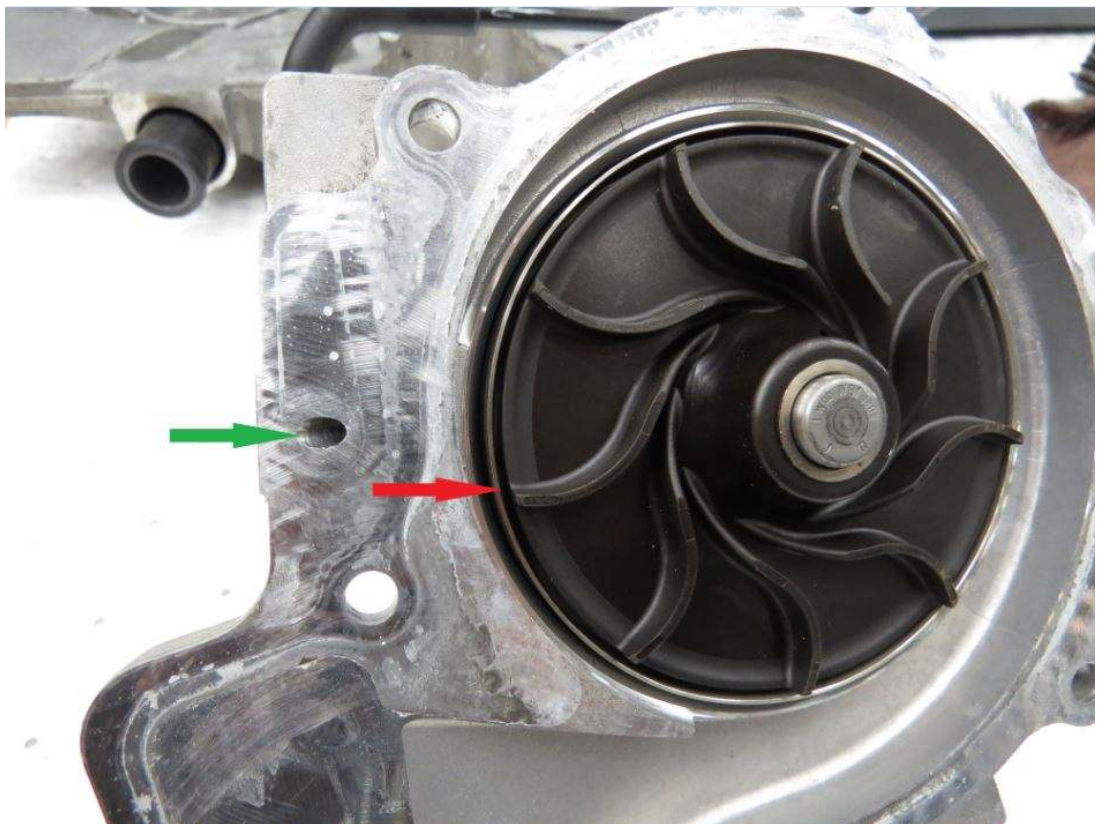
Water Pump.JPG:

| Attachments | |
|---|---|
| Water Pump.JPG | Water Pump. Green points to vacuum ports. Red points to shield |

-Water pump

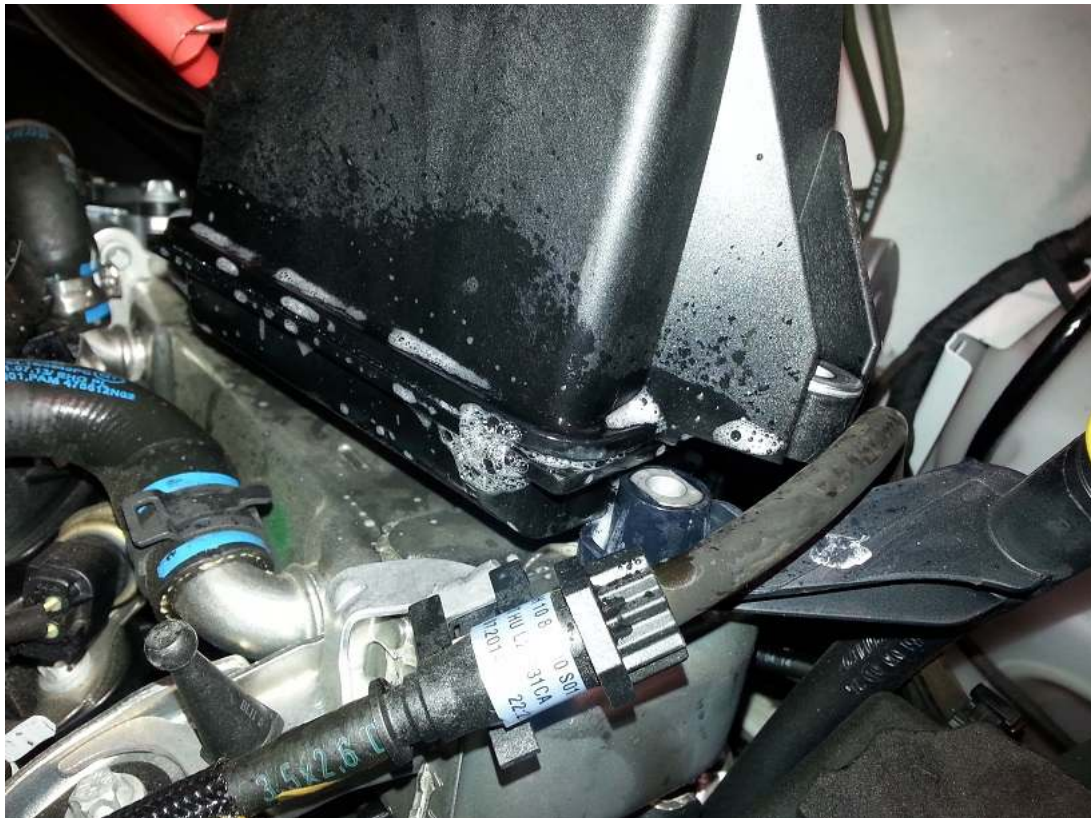
Leaking vaccum manifold.jpg:

| Leaking vaccum manifold.jpg | Leaking vacuum manifold |

-Vacuum manifold / Vacuum reservoir

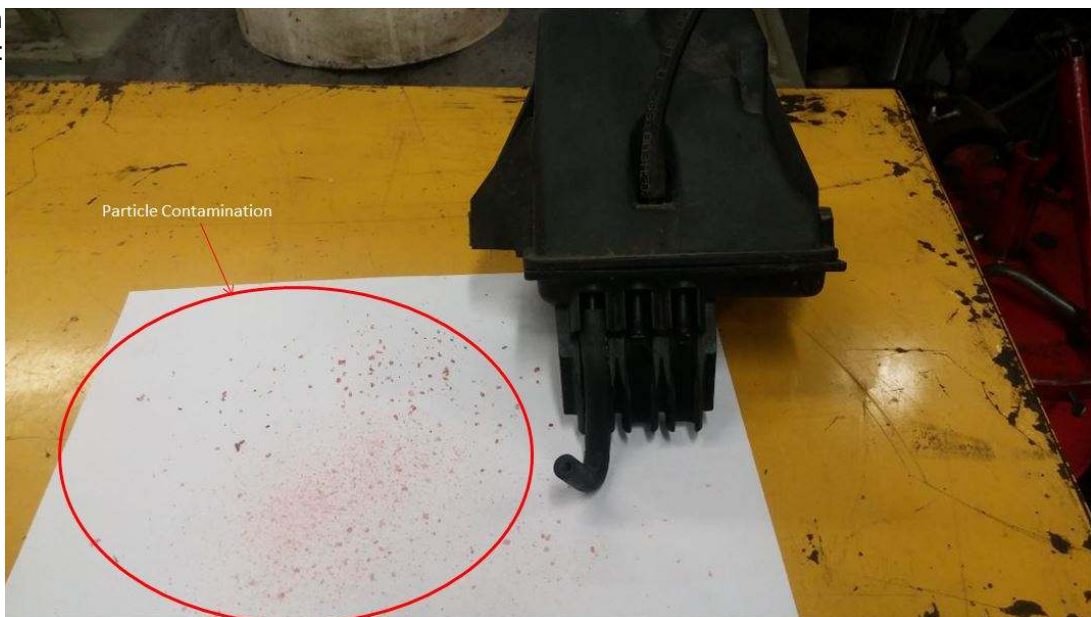
Particulate contamination of vacuum reservoir.JPG:

| Particulate contamination of vacuum reservoir.JPG | Particulate contamination from vacuum reservoir |

3- Remove vacuum hoses from vacuum reservoir and look for the following

- Particulate matter

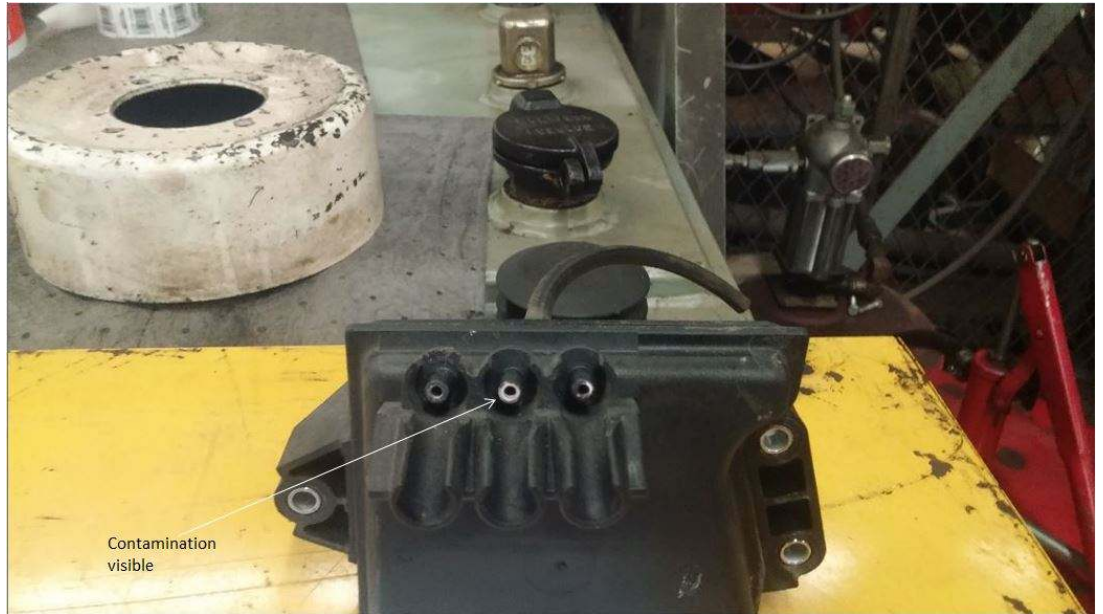
Vacuum reservoir contaminated output ports.jpg:

| Vacuum reservoir contaminated output ports.jpg | Vacuum reservoir contaminated output ports |

- Contamination of the inside of the vacuum connection

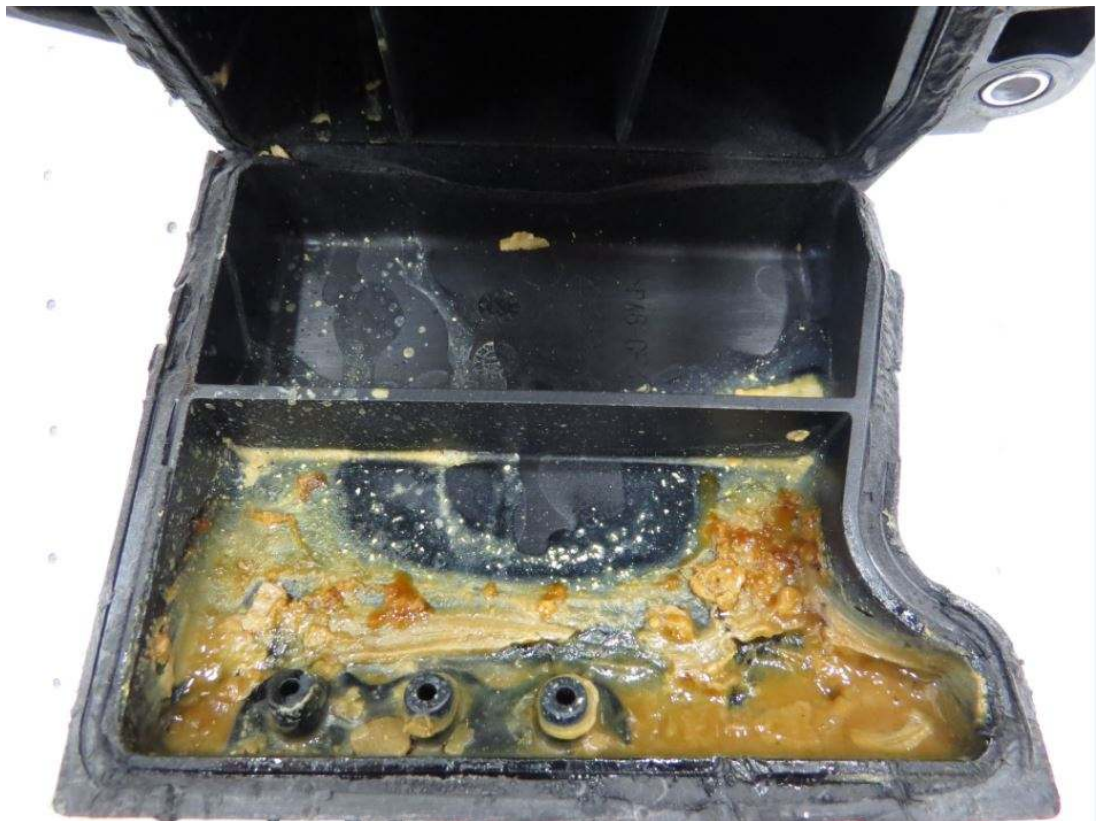
Vacuum Reservoir 1 bottom.JPG:

| Vacuum Reservoir 1 bottom.JPG | Vacuum reservoir 1 bottom |

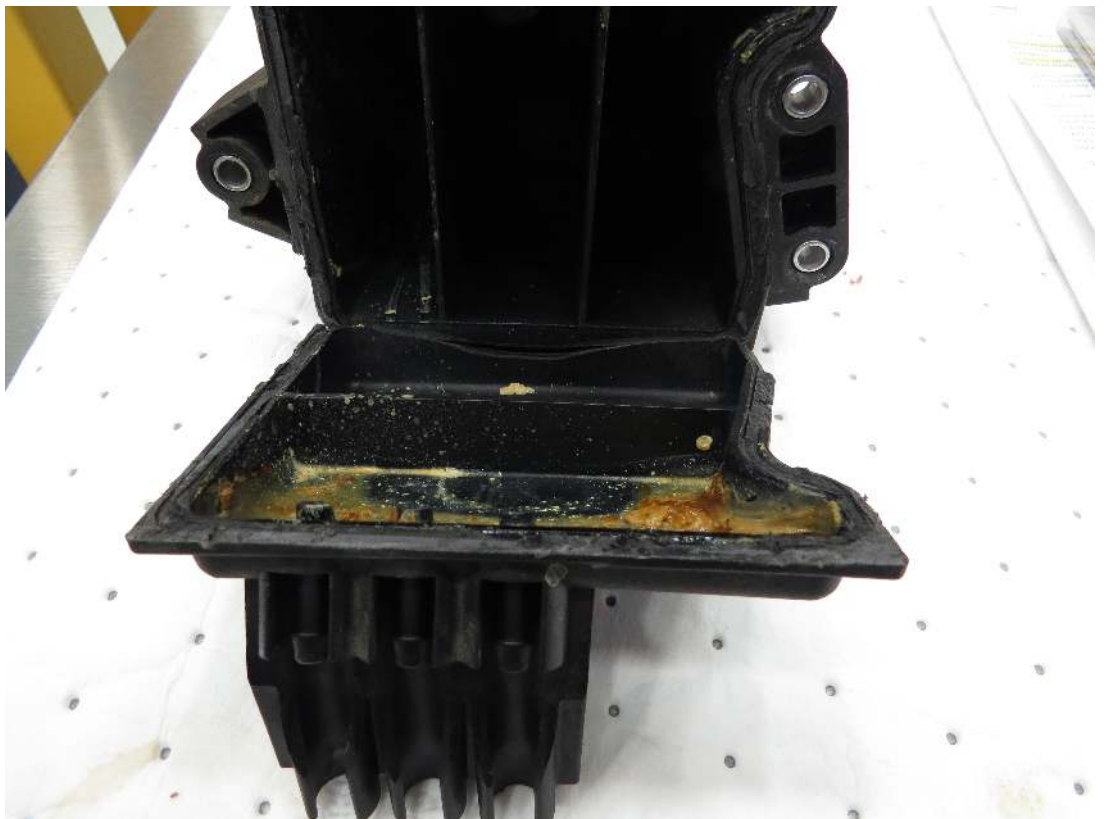
Vacuum reservoir 1 angle.  
JPG:

| Vacuum reservoir 1 angle.JPG | Vacuum reservoir 1 angled |

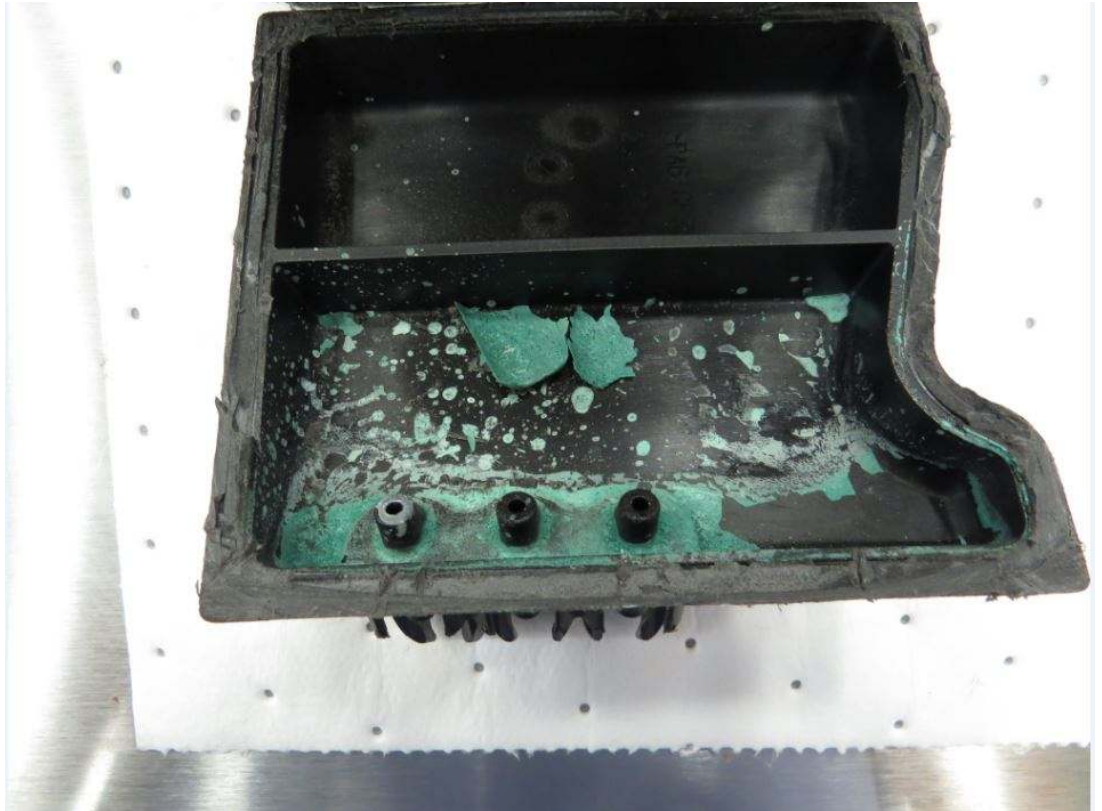
Vacuum Reservoir 2 bottom.JPG:

| Vacuum Reservoir 2 bottom.JPG | Vacuum reservoir 2 bottom |

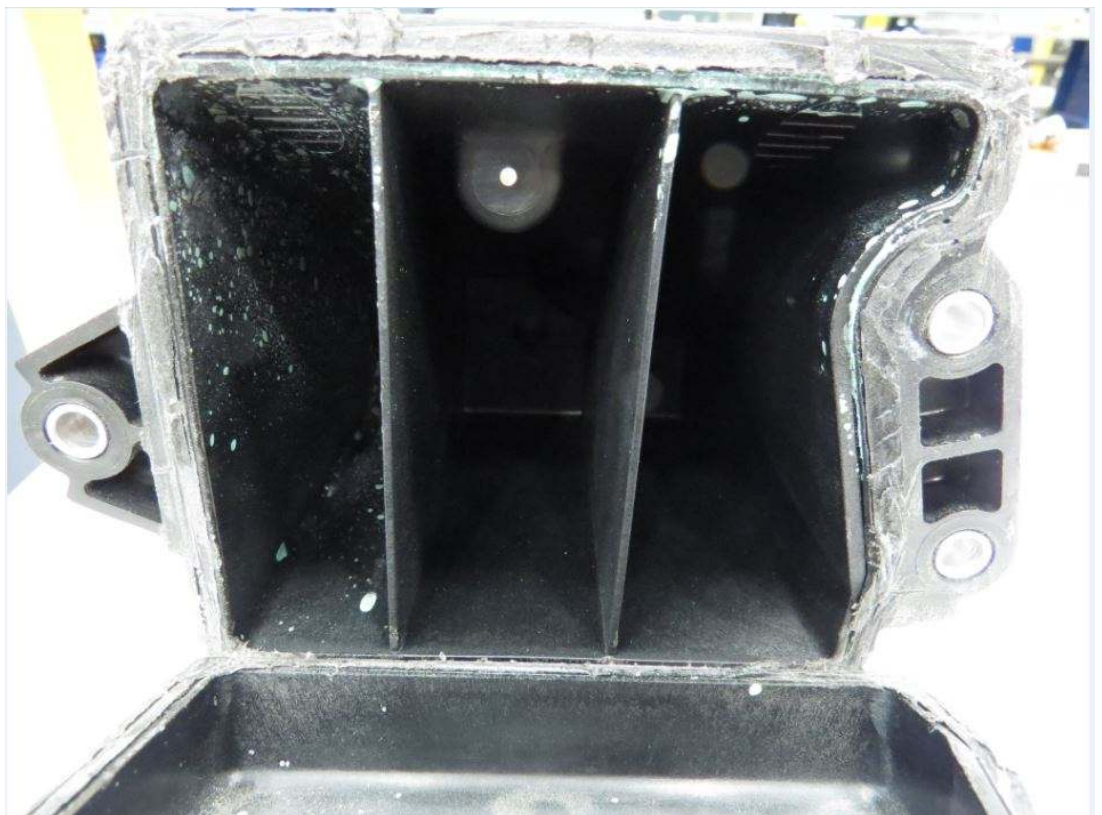
Vacuum reservoir 2 top.  
JPG:

| Vacuum reservoir 2 top.JPG | Vacuum reservoir 2 top |

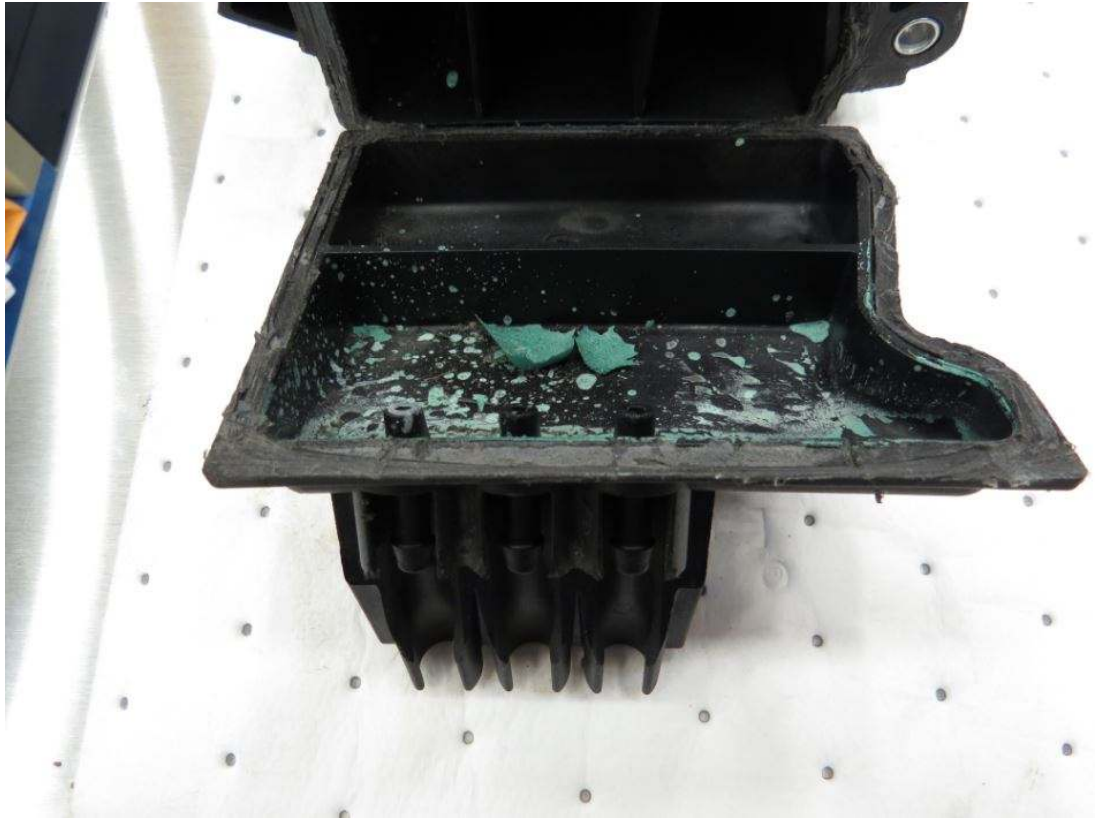
Vacuum reservoir 2 angle.JPG:

| Vacuum reservoir 2 angle.JPG | Vacuum resevoir 2 angled |

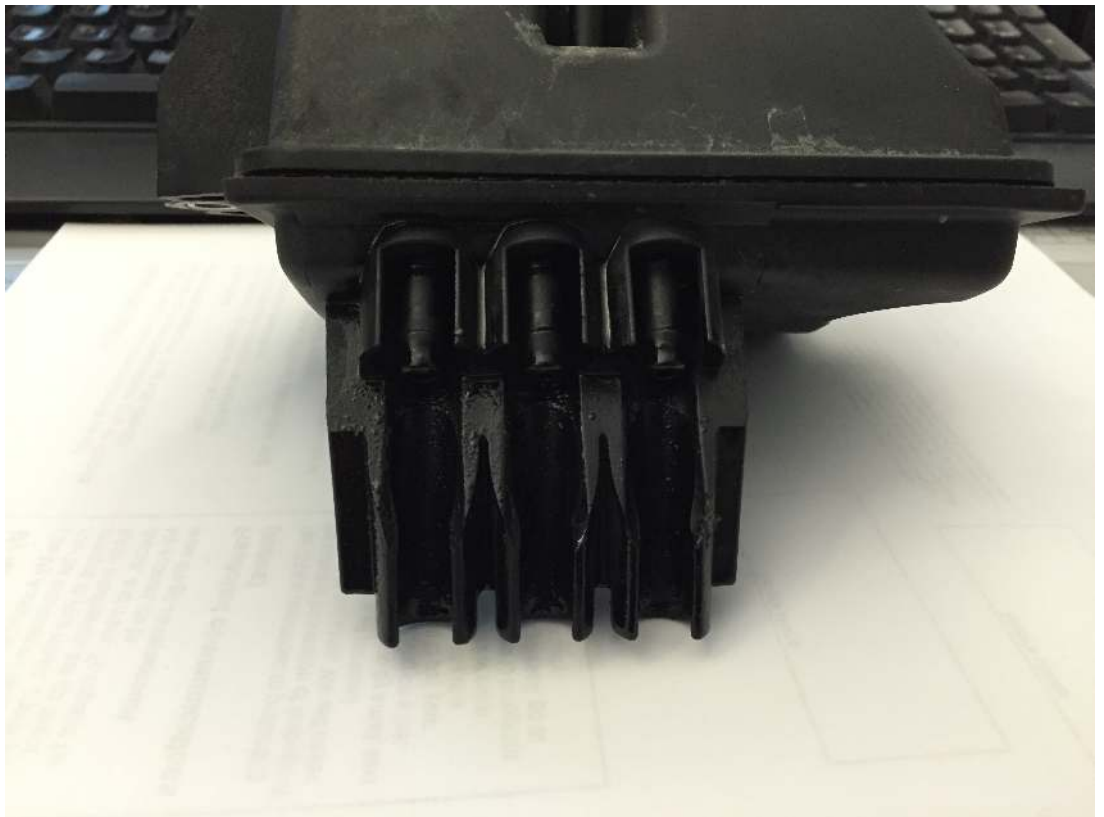
Liquid contamination vacuum reservoir.jpg:

| Liquid contamination vacuum reservoir.jpg | Liquid contamination coming from the vacuum reservoir |

4 - If coolant is found in the vacuum system replace the water pump, vacuum reservoir, change-over valve and clean the vacuum lines.

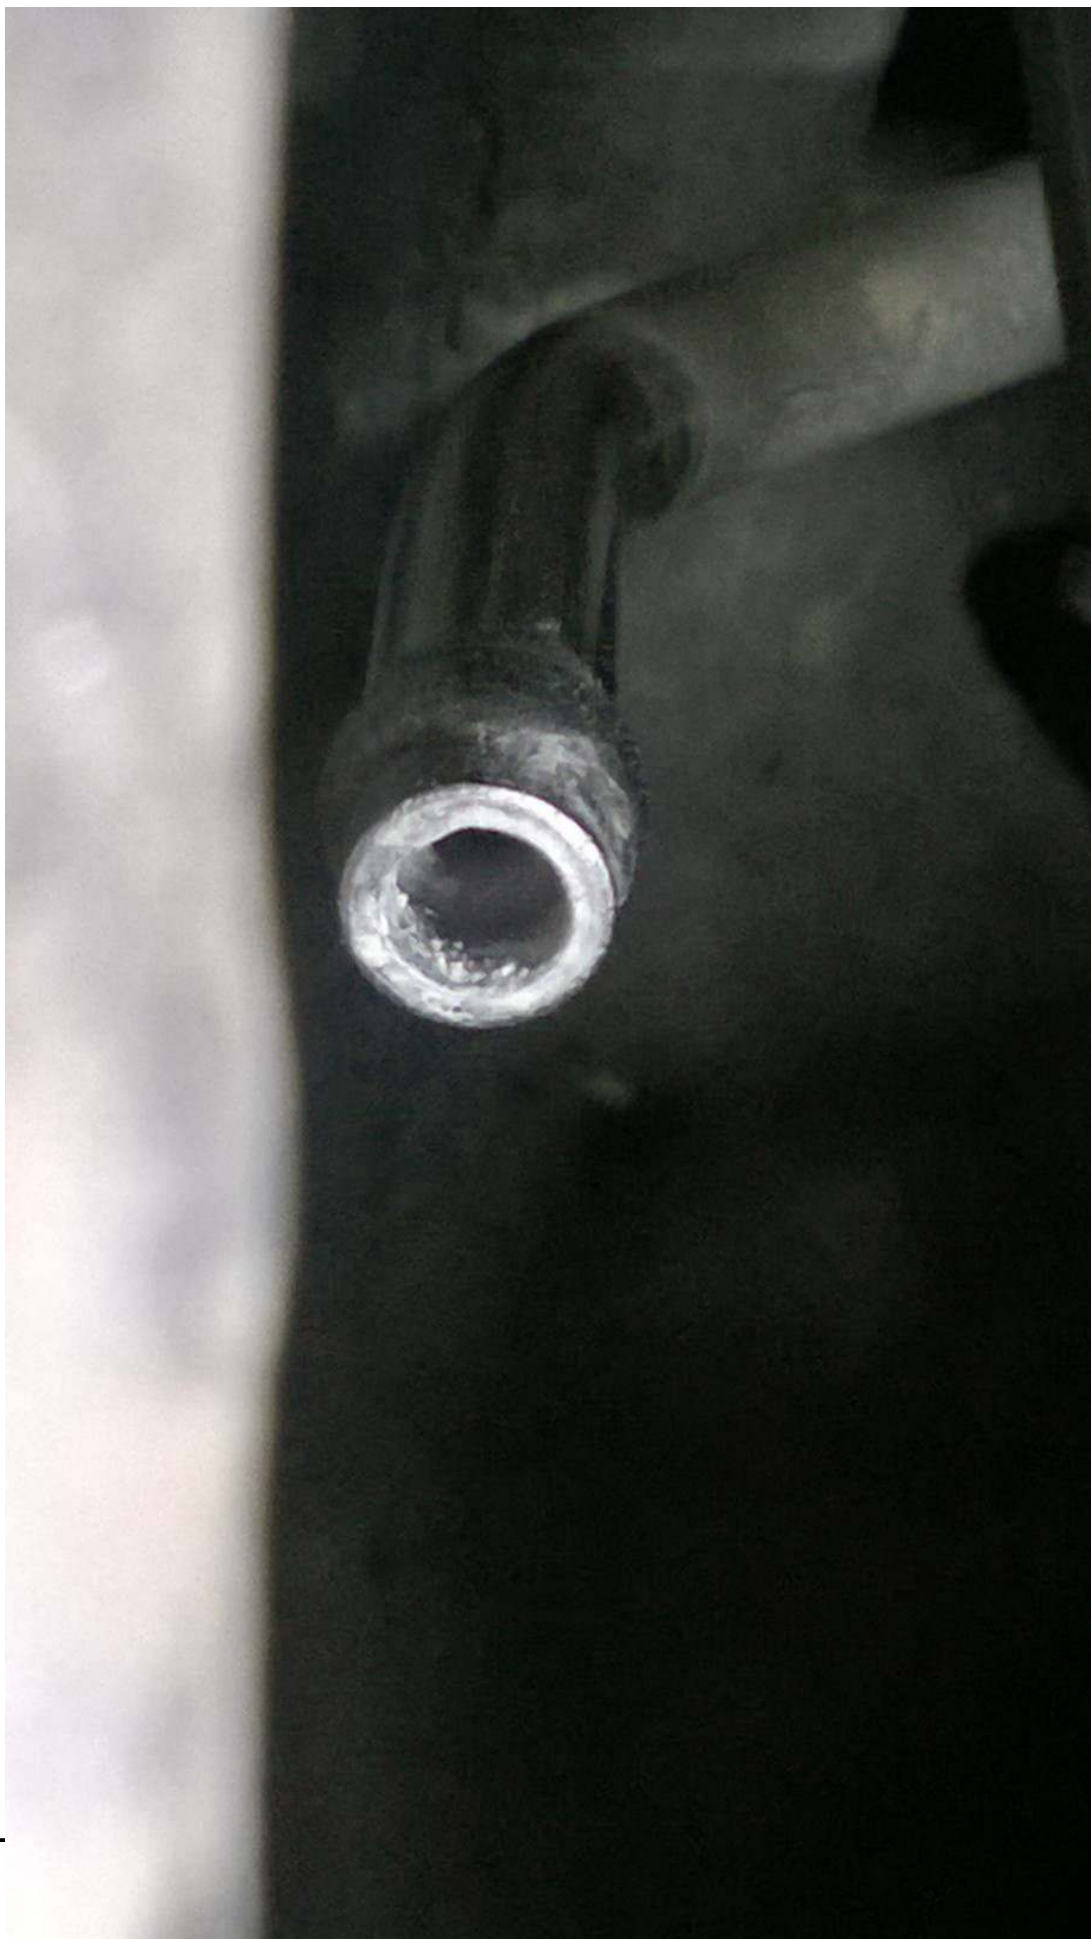
Contaminated water  
pump valve.jpg:

| Contaminated water pump valve.jpg | Contaminated water pump valve |

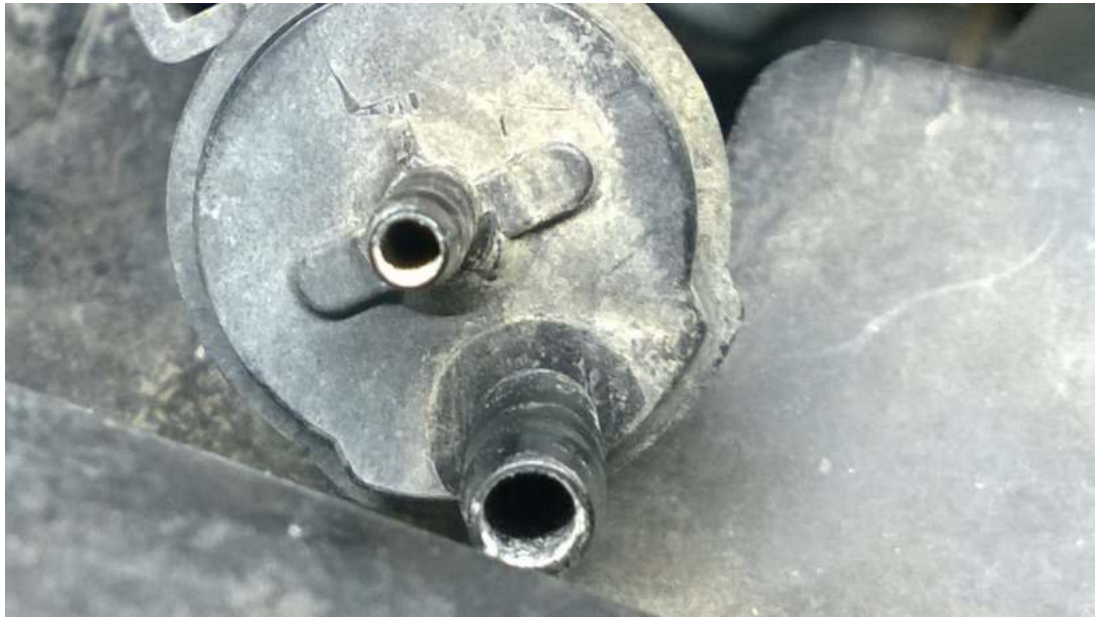
Contaminated EV Valve.  
jpg:

| Contaminated EV Valve.jpg | Contaminated EV Valve |

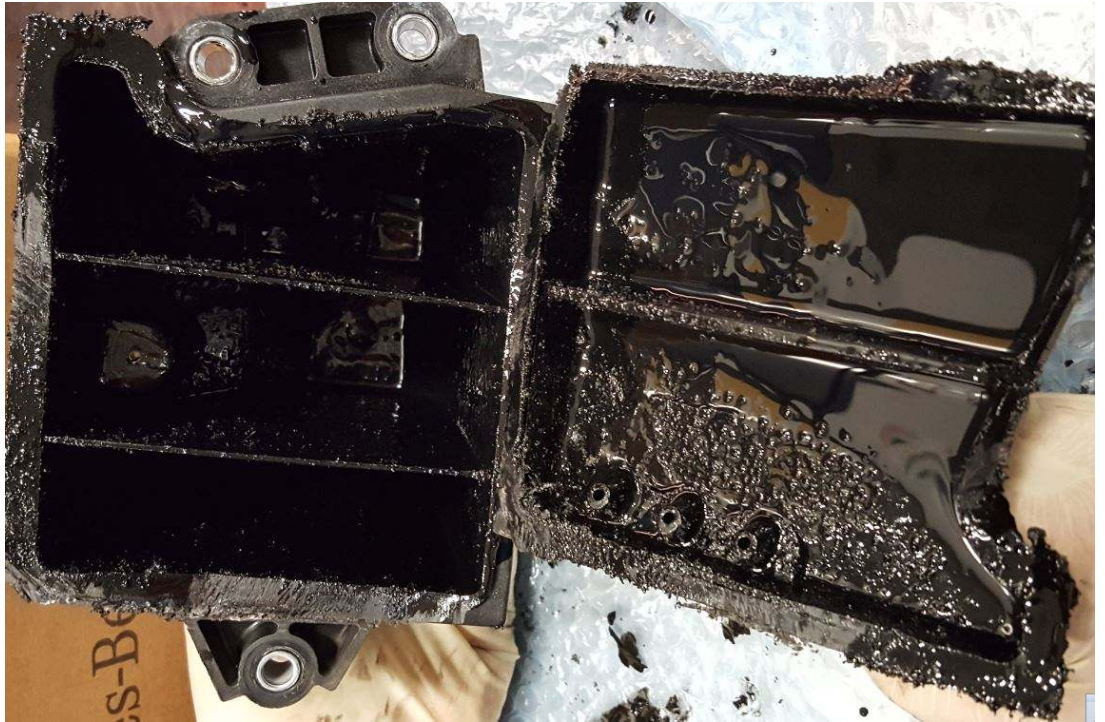
Vac Reservoir w oil.JPG:

| Vac Reservoir w oil.JPG | Vacuum Reservoir with oil contamination |

5 - If oil contamination is found in the vacuum system replace the vacuum pump, vacuum reservoir, brake booster and clean the vacuum lines.

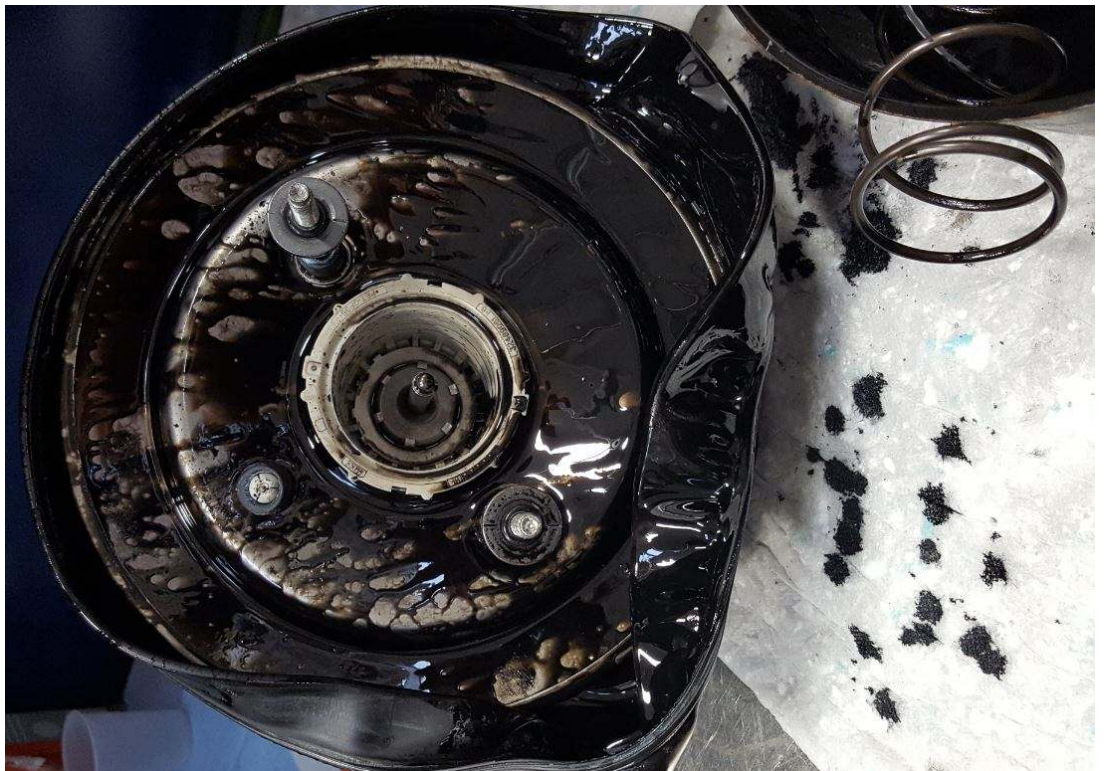
Brake Booster with oil.  
JPG:

| Brake Booster with oil.JPG | Brake booster with oil contamination |

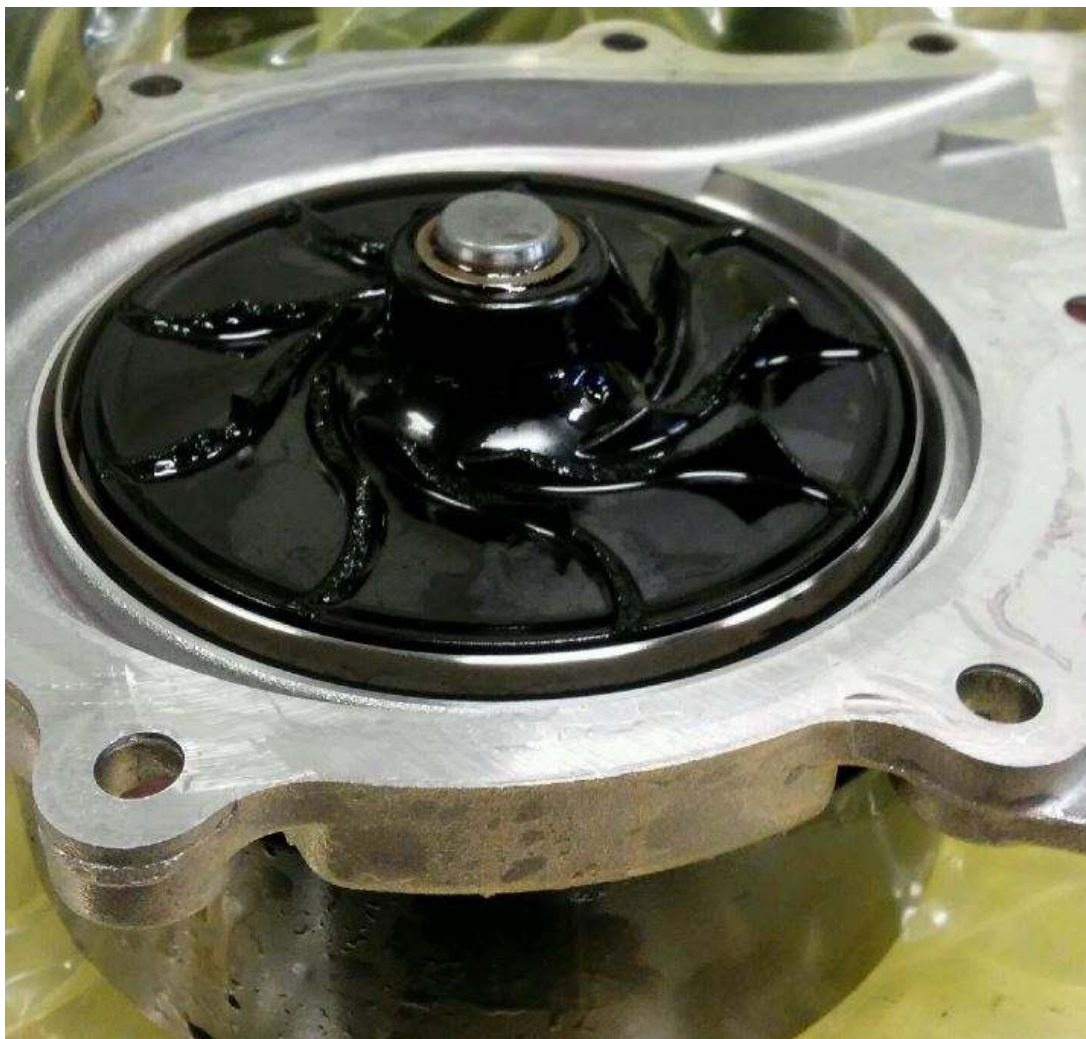
water pump impeller.  
JPG:

| water pump impeller.JPG | Damaged water pump impeller |

6 - Remove and inspect water pump impeller for damage, replace as needed.
