MODEL  
2018MY  
Forte (YDm)  
Rio (SC)

NUMBER  
186

DATE  
April 2018

**SUBJECT: SERVICE ACTION: SPARK PLUG REPLACEMENT (SA342)**

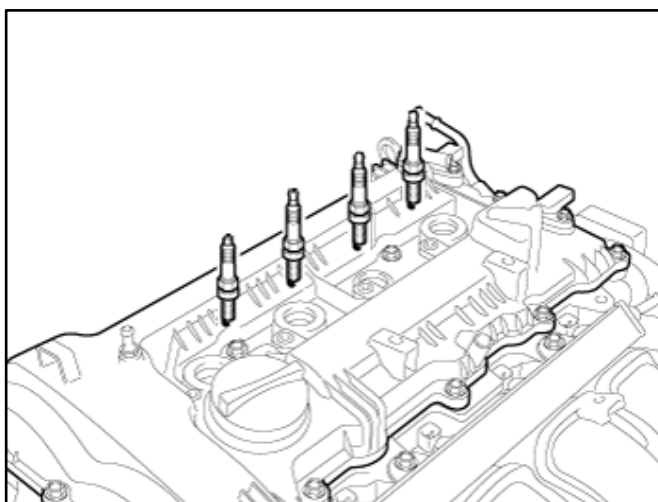
### DTCs P0300 – P0304: Random/Multiple Cylinder Misfire Detected

This bulletin provides the procedure to replace the spark plugs on some 2018MY Forte (YDm), produced from November 21, 2017 through April 12, 2018, and 2018MY Rio (SC) vehicles, both produced from November 22, 2017 through February 6, 2018, which may exhibit a malfunction indicator lamp (MIL) ON with DTCs P0300 through P0304 due to the spark plug porcelain cracking during manufacturing. Follow the procedure outlined in this bulletin to replace all four spark plugs, whether or not the MIL is ON. Before conducting the procedure, verify that the vehicle is included in the list of affected VINs.
