# Technical Service Bulletin

**ENGINE MISFIRE DURING ACCELERATION WITH CHECK ENGINE  
LIGHT FLASHING AND DTCs P0302:00, P0303:00 AND/OR U0401:00**

**Bulletin No.:** 01-010/18

2016-2017 CX-9 vehicles with VINs lower than JM3TC\*\*\*\*\*135222 (produced before Dec. 27, 2016)

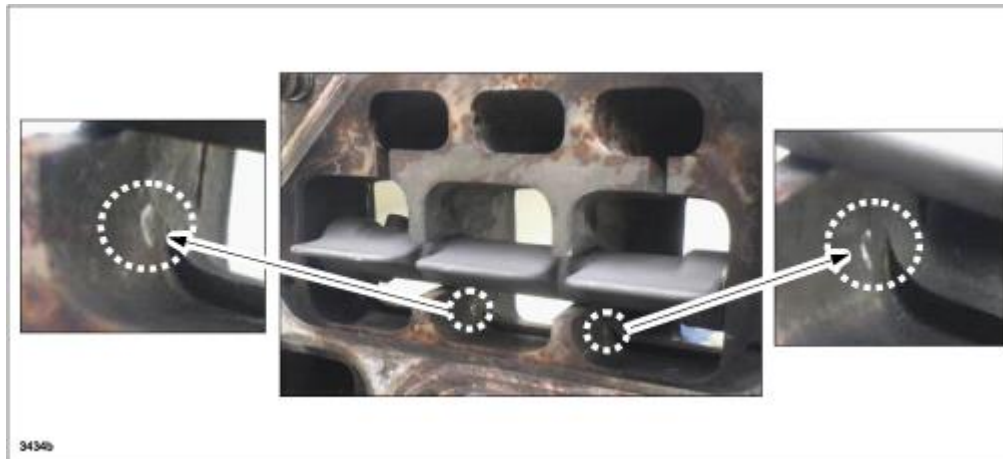
2. If one or both of the above conditions are met, remove the exhaust manifold and verify that there are contact mark(s) on the exhaust manifold variable housing caused by the variable valve, as shown below.

3. If contact mark(s) are found, replace the exhaust manifold with a modified one according to the instructions on MGSS online (EXHAUST SYSTEM REMOVAL/INSTALLATION [SKYACTIV-G 2.5T]).

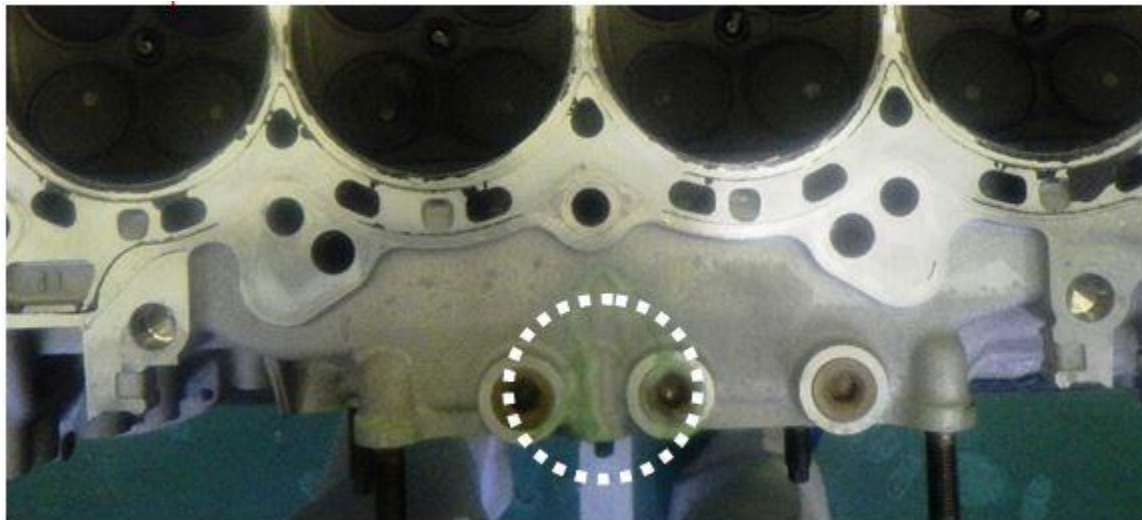
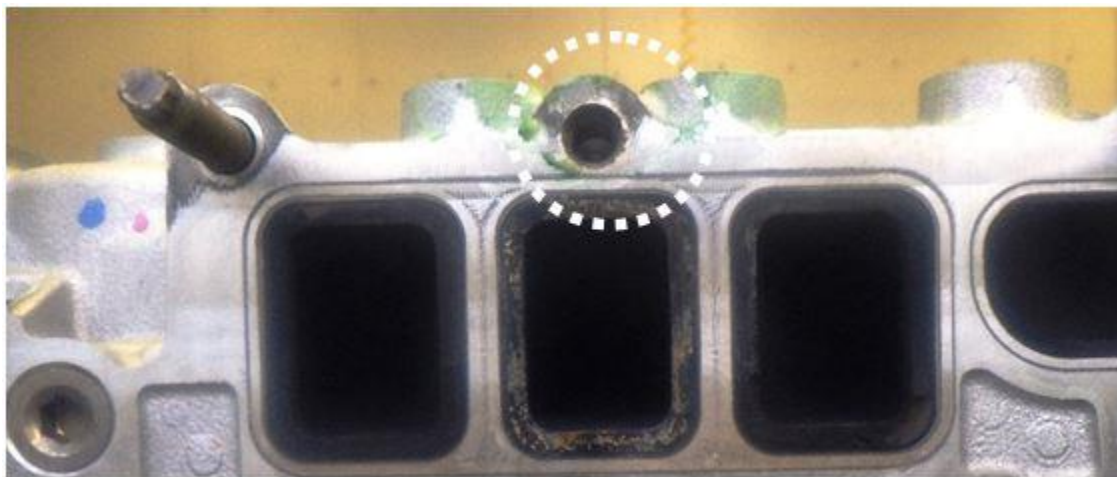
**CAUTION:** When tightening nuts, do not allow the stud bolt to rotate over 270 degrees, otherwise, it could cause the cylinder head to crack, as shown below. If cylinder head is cracked, replace it with a new one. (TOP VIEW)

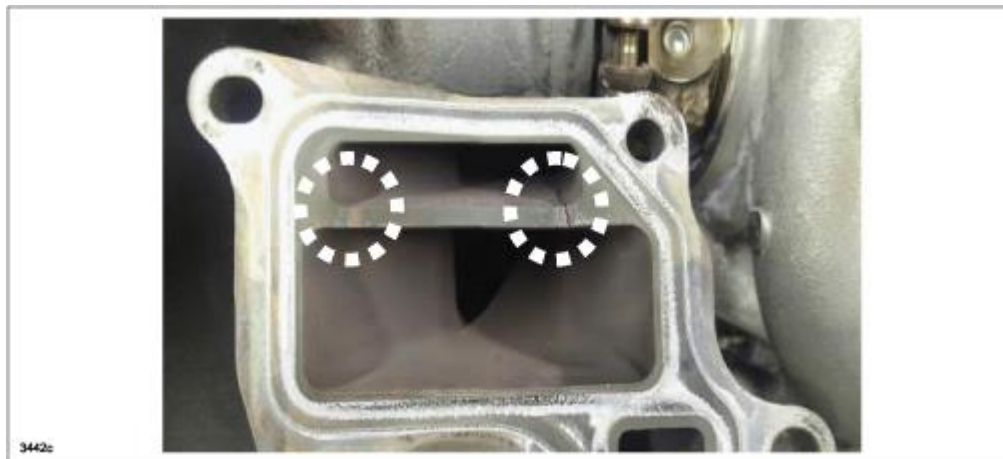
**NOTE:** There may be a crack found in the turbocharger housing, as shown below. The crack does not affect engine performance or cause any noise, so turbocharger replacement is not necessary.
