**NUMBER:** 25-001-13 REV. A

**GROUP:** Emissions Control

MIL Illumination Due to P2000, P2A00 and/or P2A01

This bulletin involves inspecting both Oxygen (O2) sensors and either cleaning or replacing the sensors and installing an O2 Sensor Heat Shield on the exhaust pipe in the area of the **FRONT** O2 sensor.

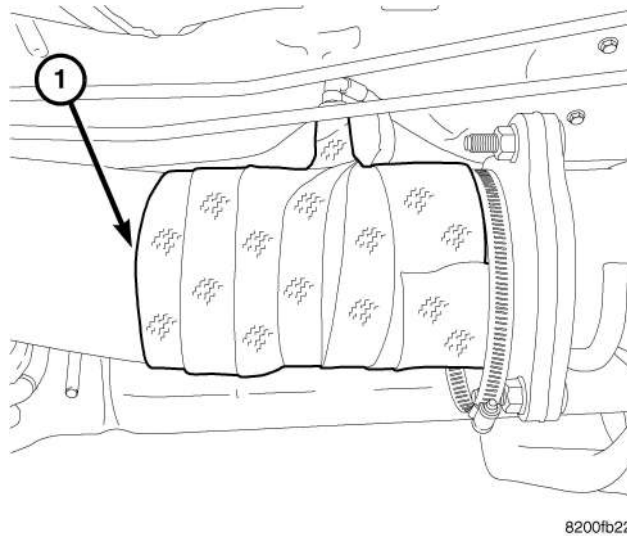
**Fig. 1 O2 SENSOR WRAP**

2. Inspect the front O2 sensor area of the exhaust for the presence of either a wrap or blanket (Fig. 1).

- 
3. Is there a wrap or blanket around the exhaust pipe in the area of the front O2 sensor?
    - a. YES>>>Proceed to the next step.
    - b. NO>>>Proceed to the Repair Procedure.
  4. Was the wrap/blanket installed properly and is not damaged or torn/tattered?
    - a. YES>>>This bulletin will not address the symptom/condition. Follow the diagnostic information provided in DealerCONNECT>TechCONNECT>Service Info>Group 28 DTC Based Diagnostics>Module, Engine control (ECM), 6.7L>Standard Procedure>PRE-DIAGNOSTIC TROUBLE SHOOTING PROCEDURE, 6.7L or DealerCONNECT>TechCONNECT>Service Info>Group 29 Non-DTC Diagnostics>Drivability - Diesel, 6.7L>Diagnosis and Testing>PRE-DIAGNOSTIC TROUBLE SHOOTING PROCEDURE, 6.7L.
    - b. NO>>>Proceed to the Repair Procedure.\*\*

1. Raise the vehicle on a hoist.
2. If the vehicle is already equipped with a wrap or blanket but this bulletin is being performed because they are damaged, remove the damaged wrap or blanket from the exhaust pipe.
3. Remove both upstream and downstream Oxygen (O2) sensors.
4. Remove the exhaust pipe. Refer to the procedures identified in DealerCONNECT>TechCONNECT>Service Info>11 - Exhaust System>PIPE, Exhaust>Removal>6.7L DIESEL for additional information.
5. Install heat shield (p/n 68102274AA). Refer to the procedures identified in the Instruction Sheet (p/n K6855747) for additional information.

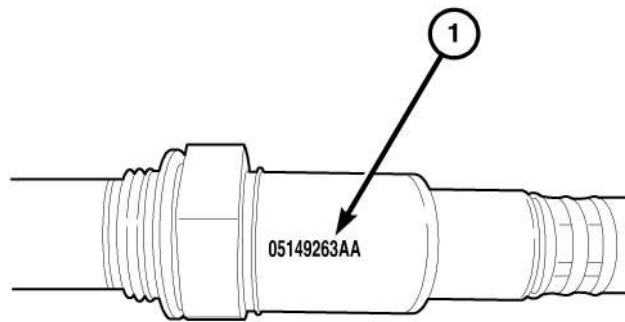
**Fig. 2 O2 SENSOR PART NUMBER LOCATION**

6. Install the exhaust pipe. Refer to the procedures identified in DealerCONNECT>TechCONNECT>Service Info>11 - Exhaust System>PIPE, Exhaust>Installation>6.7L DIESEL for additional information.
7. Inspect both O2 sensors to ensure that the latest sensors are installed in the vehicle. O2 sensors that have p/n 05149263AA (or later) scribed on the sensor, (Fig. 2) are the newer style sensor. If it is difficult to read the part number, the newer style sensor can easily be identified by the soot shield design on the sensor, (Fig. 3).
